SHOE NAIL 2637 1370.B. - HYPOEUTECTOID STEEL - ROMAN TIMES - SWITZERLAND

Artefact name Shoe nail 2637 1370.B.

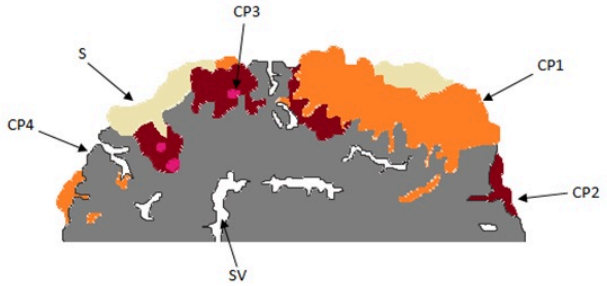
S = compact sand-clay soil.
CP1 = powdery soil, orange-coloured by corrosion products.
CP2 = dark-red corrosion crust, breaks into bits.
CP3 = vivid pink-red and globular corrosion products.
CP4 = dark grey to black and very hard corrosion products, results in an dark-orange powder when scratched.
SV = structural void near the center of the cross section, seems to draw a square shape.

Fig. 3: Preliminary stratigraphy of the corrosion layers based on the observation of a broken nail,

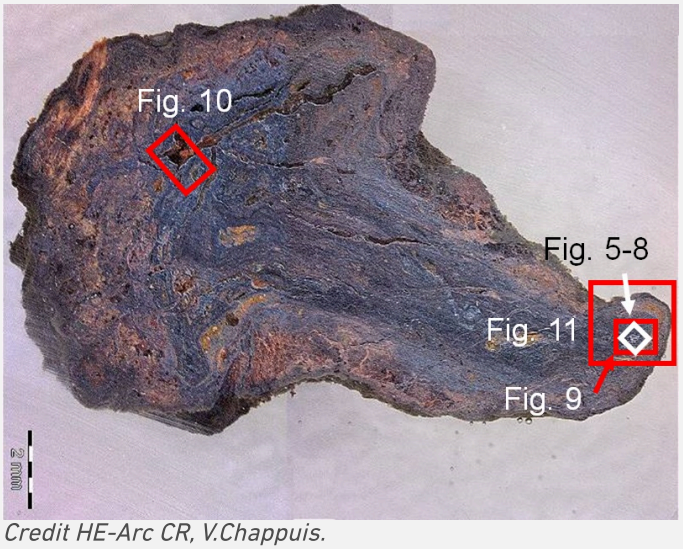
Fig. 4: Micrograph of the cross-section of the nail showing the location of figs. 5 to 11,

The metal is heavily corroded and the thickness of the corrosion crust is irregular, varying from 0.8 to 3.8mm, with an average of about 2mm. The corrosion has replaced most of the metal (Fig. 4). Between corrosion layers the limit of the original structure is visible. Some leather fibers seem to be preserved as pseudomorphic structures in voids of the metal core (POM1, Figs. 9 and 10). The carbon mapping (Fig.11) shows the presence of carbon in these areas. This can also be due to the penetration of the mounting resin in the cracks.

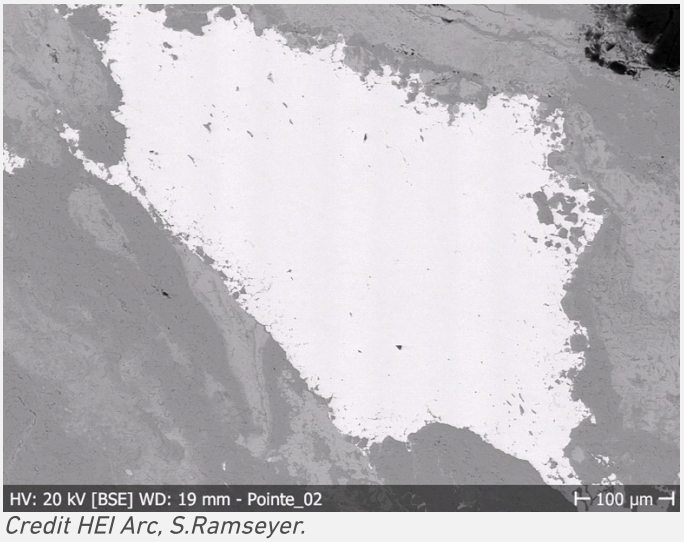
The remaining metal is an hypoeutectoid steel (Fig. 5 and 6), containing Fe, Si and O slags inclusions (possibly fayalite FeO,SiO2), and consisting of less than 1% of the total volume of the highly mineralized nail. After Nital etching, it shows intergranular corrosion on one of its sides (Figs. 7 and 8).

Fig. 5: SEM, BSE-mode picture of remaining metal from cross-section of Fig. 4,

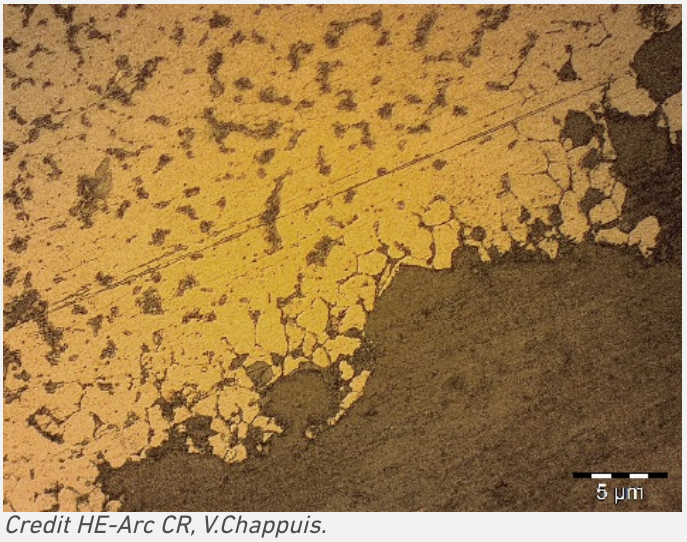
Fig. 7: Micrograph of the metal sample from Fig. 5 (detail, rotated 90°), Nital etched, bright field, with indication of Fig. 8 (red rectangle)

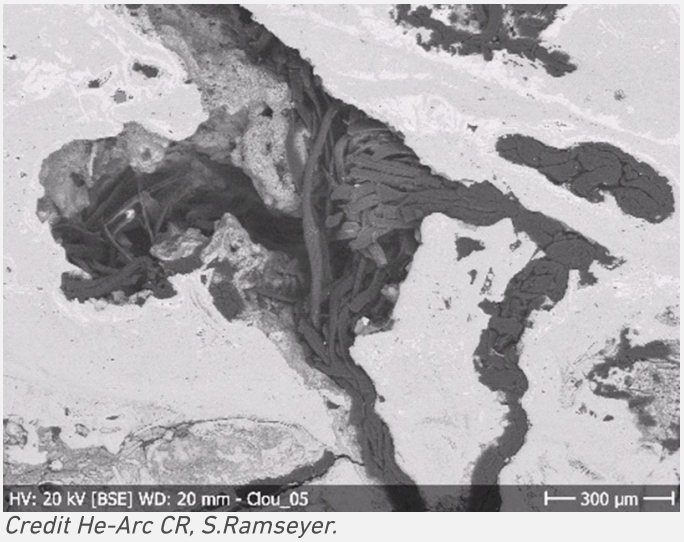
Fig. 9: Micrograph of the metal sample from Fig. 4, bright field. The deliminated zone shows what could be leather pseudomorphic fibers filling a void,

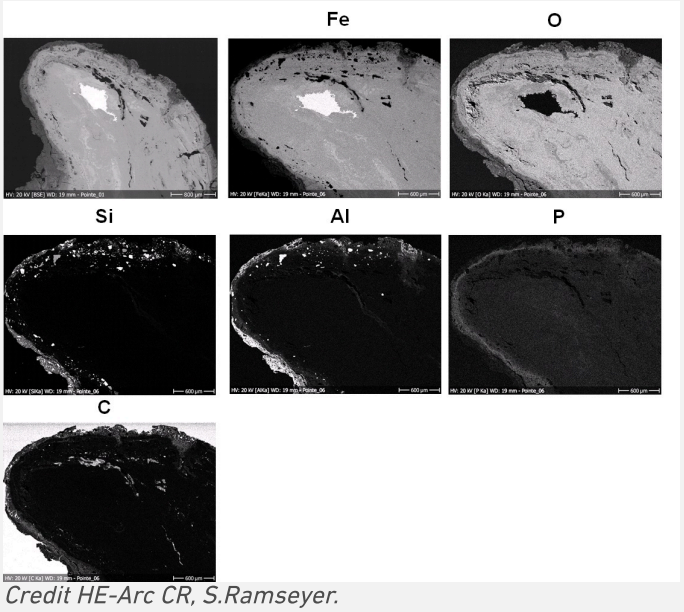
Fig. 10: SEM - BSE-mode picture of another void filled with fibers in the head of the nail (see Fig. 4),

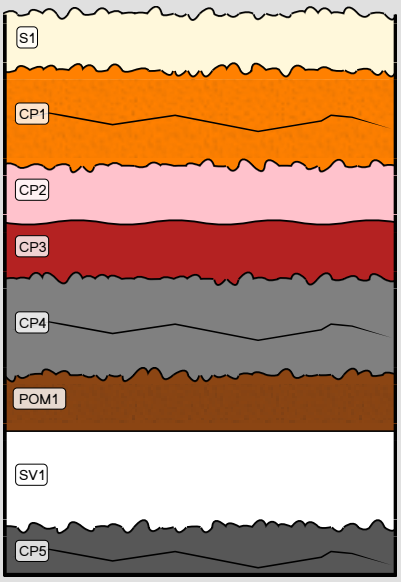
Fig. 12: Stratigraphic representation of the nail in cross-section (dark field) using the MiCorr application. The characteristics of the strata are only accessible by clicking on the drawing that redirects you to the search tool by stratigraphy representation. This representation can be compared to Fig. 14, Credit HE-Arc CR, V.Chappuis.

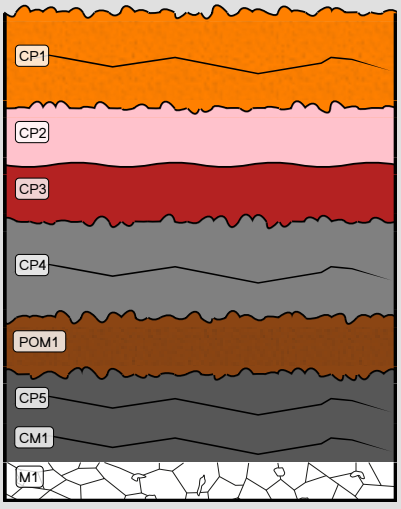
Fig. 13: Stratigraphic representation of the nail in cross-section (dark field) using the MiCorr application. The characteristics of the strata are only accessible by clicking on the drawing that redirects you to the search tool by stratigraphy representation. This representation can be compared to Fig. 14, Credit HE-Arc CR, V.Chappuis.

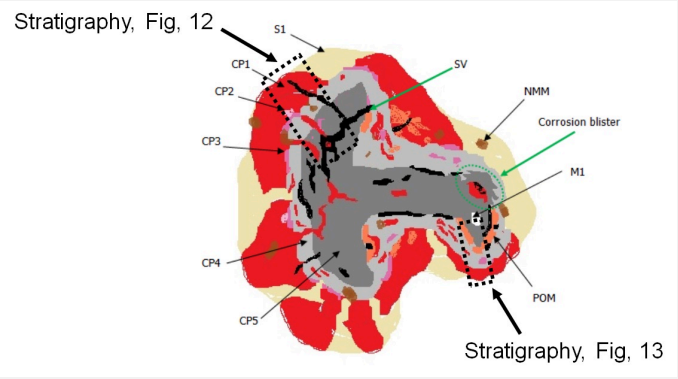
The schematic representation of corrosion layers of Fig. 3 integrating additional information based on the analyses carried out is given in Fig. 14. The following strata were identified:

Fig. 14: Improved stratigraphic representation of the nail from visual observations and analyses and visualization of the two stratigraphies of Figs, 12 and 13,
