AXE HEAD N11 – TIN BRONZE – BRONZE AGE

Artefact name   Axe head N11

Authors   Christian. Degrigny (HE-Arc CR, Neuchâtel, Neuchâtel, Switzerland) & Valentin. Boissonnas (HE-Arc CR, Neuchâtel, Neuchâtel, Switzerland)

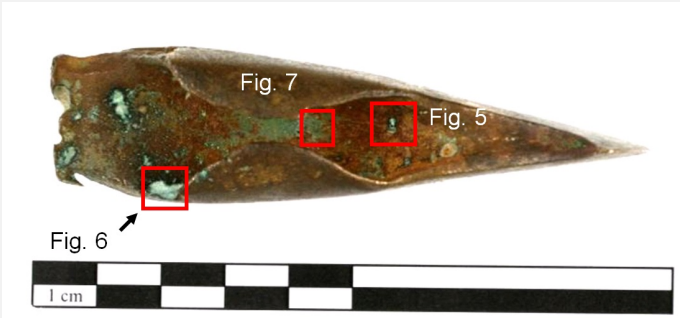
Fig. 1: Axe head n°11,

Description of the artefact   Axe head covered with a brown patina (Fig. 1). A uniform darker green corrosion product as well as a green powdery corrosion product appear locally in some areas. Dimensions: L = 90 mm; W max = 40 mm ; WT = 154.32 g.

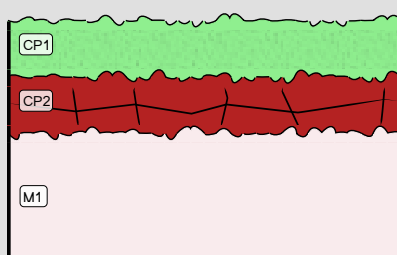
Fig. 8: Stratigraphic representation of corrosion products of the axe head (based on visual observations),

CP2 represents a brown patina that covers virtually all of the axe head. In places, the non-corroded metal can be observed through the patina. It seems to be a stable corrosion product.

CP1c is a light green and powdery corrosion product located within pits. It is located mostly on the edge of the axe. The dimension of the pits varies.

CP1b is a red-orange corrosion product only located in-and near the pitting corrosion.

CP1a is a dark green corrosion product located above CP2. It is present only on the edge of the axe head.

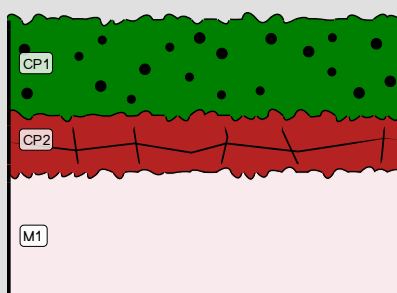
Fig. 9: Stratigraphic representation of the axe (sample 3) under binocular using the MiCorr application. The characteristics of the strata are only accessible by clicking on the drawing that redirects you to the search tool by stratigraphy representation. This presentation can be compared to Fig. 18. CP1 corresponds to CP1c, Credit HE-Arc CR, C.Degrigny.

Fig. 10: Stratigraphic representation. of the axe (sample 4) under binocular using the MiCorr application. The characteristics of the strata are only accessible by clicking on the drawing that redirects you to the search tool by stratigraphy representation. This presentation can be compared to Fig. 18. CP1 corresponds to CP1a, Credit HE-Arc CR, C.Degrigny.

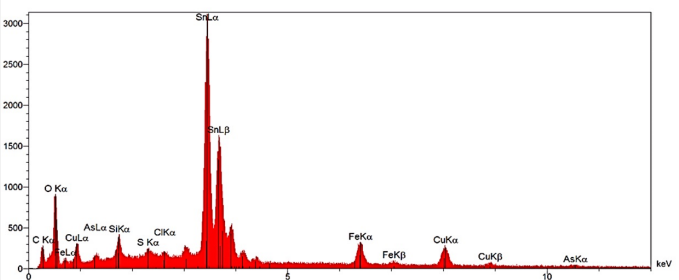
Fig, 12: EDS spectrum of sample 1 (yellow powder),

Analyses by SEM/EDS indicate that the light yellow particles of sample 1 are predominantly composed of Sn and O with minor presence of C, Cu, Fe, S, Cl and As (Fig. 12), while the green and red particles of sample 2 are respectively composed of O, Cu, Cl, and Sn, with a minor presence of Fe and S (Fig. 13) and Cu, O (Fig. 14, possibly cuprite). Sample 3 consists of green particles composed mostly of Sn, Cl, Cu and O with S, Al and Fe as minor elements (Fig. 15). Sample 4 is constituted of green and white particles. The former have the same composition as the particles of

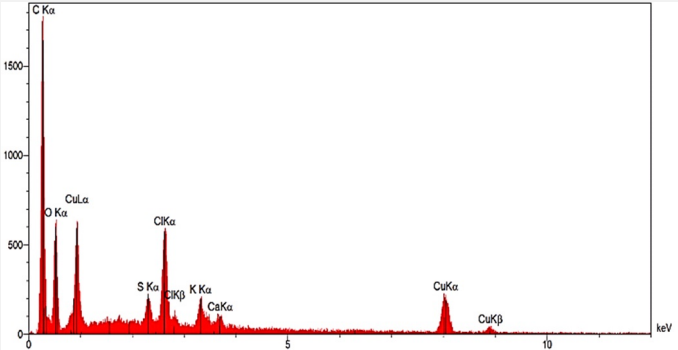
Fig. 16: EDS spectrum of sample 4 (white particle),

sample 3 while the white particles are significantly different in composition: containing a large amount of C with a small amount of O, Cl, S, K and Cu (Fig. 16). The FTIR spectrum of the white particles (Fig. 17) shows several characteristic peaks of an organic compound: 2919 cm-1 and 2850 cm-1 (C-H- bond), 3445 cm-1 and 3323 cm-1 (O-H- bond) or 1030cm-1, 1006cm-1 and 951cm-1 (C-O-C- bond).

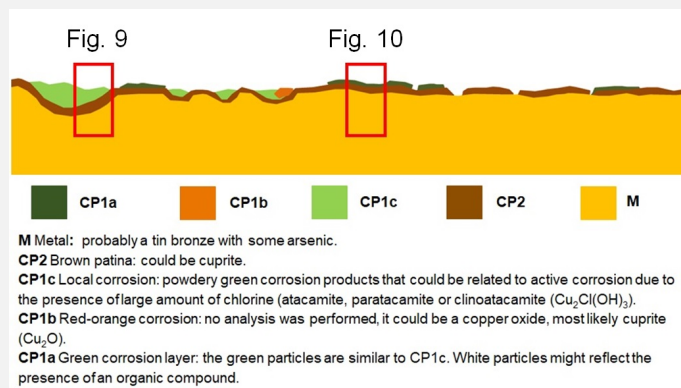
M Metal: probably a tin bronze with some arsenic.
CP2 Brown patina: could be cuprite.
CP1c Local corrosion: powdery green corrosion products that could be related to active corrosion due to the presence of large amount of chlorine (atacamite, paratacamite or clinoatacamite ($Cu_2Cl(OH)_3$).
CP1b Red-orange corrosion: no analysis was performed, it could be a copper oxide, most likely cuprite (Cu_2O).
CP1a Green corrosion layer: the green particles are similar to CP1c. White particles might reflect the presence of an organic compound.

Fig. 18: Improved stratigraphic representation of a virtual cross-section through the axe head based on visual observations and additional analyses and visualization of the two stratigraphies of Figs. 9 and 10.

The axe head is probably a tin bronze containing a small amount of As. It is difficult to interpret the corrosion layer only by macroscopic observation. The analyses show that all green corrosion products contain chlorides that might originate from strip-cleaning by hydrochloric acid (although not documented). Active corrosion is not proved but we suspect the presence of atacamite, paratacamite or clinoatacamite (Cu2Cl(OH)3). FTIR revealed the presence of an organic compound on the metal surface (possibly a protective coating).
