AXE HEAD N11 - TIN BRONZE - BRONZE AGE

Artefact name Axe head N11

Authors Christian. Degrigny (HE-Arc CR, Neuchâtel, Neuchâtel, Switzerland) & Valentin. Boissonnas (HE-Arc CR, Neuchâtel, Neuchâtel, Switzerland)

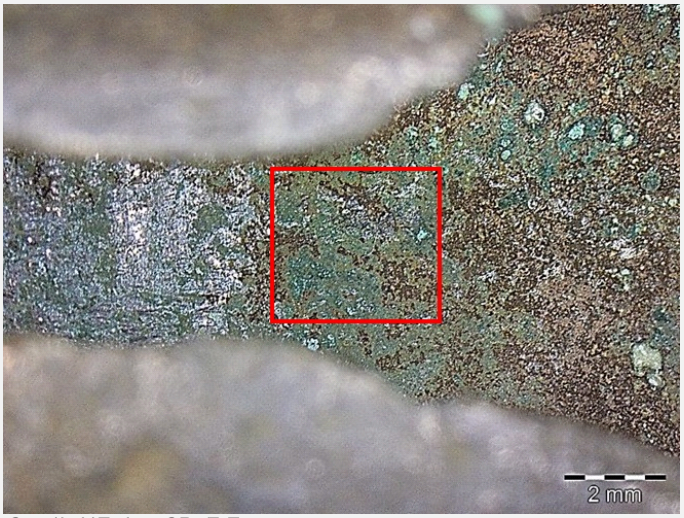
Fig. 6: Local corrosion (length max: 10 mm) where sample 3 has been taken,

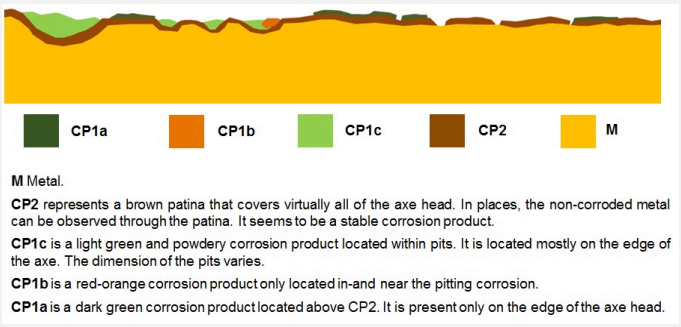
Fig. 8: Stratigraphic representation of corrosion products of the axe head (based on visual observations),

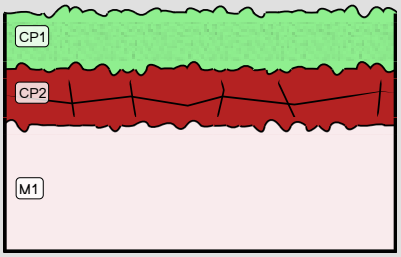
Fig. 9: Stratigraphic representation of the axe (sample 3) under binocular using the MiCorr application. The characteristics of the strata are only accessible by clicking on the drawing that redirects you to the search tool by stratigraphy representation. This presentation can be compared to Fig. 18. CP1 corresponds to CP1c, Credit HE-Arc CR, C.Degrigny.

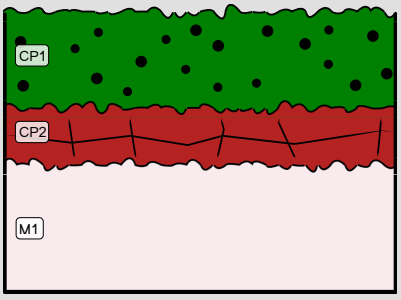
Fig. 10: Stratigraphic representation. of the axe (sample 4) under binocular using the MiCorr application. The characteristics of the strata are only accessible by clicking on the drawing that redirects you to the search tool by stratigraphy representation. This presentation can be compared to Fig. 18. CP1 corresponds to CP1a, Credit HE-Arc CR, C.Degrigny.

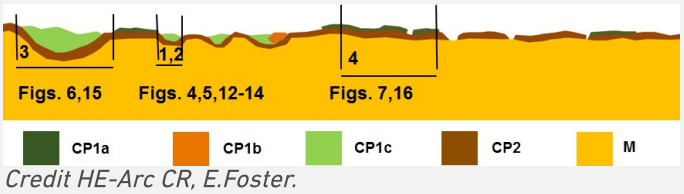
Fig. 11: Location of the samples on the stratigraphic representation of Fig. 8 with indication of the corresponding figures,

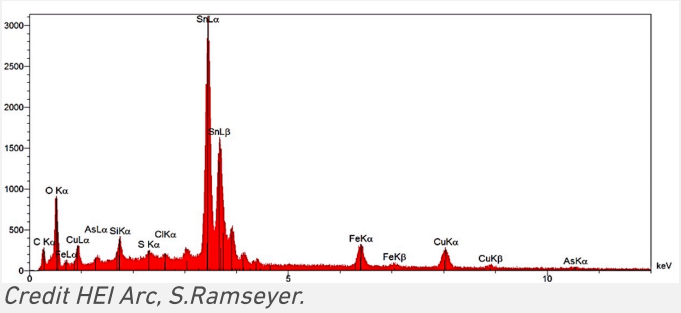
Sample / particles	Major elements	Minor elements
Green powdery corrosion product	Sample 1	Sn + O	C + Cu + Fe + S + Cl + As
	Sample 2 – CP1c (Fig. 11) - Green particles	O + Cu + Cl + Sn	Fe + S
	Sample 2 – CP2 (Fig.11) - Red-brown particles	Cu + O	
	Sample 3 - CP1c (Fig. 11)	Sn + Cl+ Cu + O	S + Al + Fe
Darker green corrosion product	Sample 4 – CP1a (Fig. 11) - Green particles	Cl + Sn + Cu + O	S + C
	Sample 4 – CP1a (Fig. 11) - White particles	C	O + Cl + S + K + Cu

Table 1: Identification of chemical elements in the corrosion products on the head axe. Method of analysis: SEM/EDS, HEI-Arc.

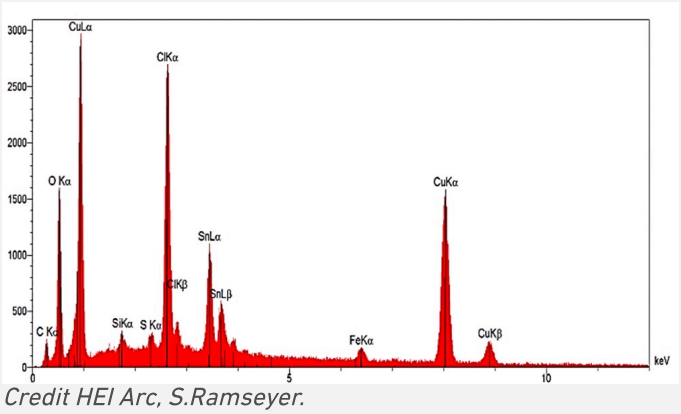
Analyses by SEM/EDS indicate that the light yellow particles of sample 1 are predominantly composed of Sn and O with minor presence of C, Cu, Fe, S, Cl and As (Fig. 12), while the green and red particles of sample 2 are respectively composed of O, Cu, Cl, and Sn, with a minor presence of Fe and S (Fig. 13) and Cu, O (Fig. 14, possibly cuprite). Sample 3 consists of green particles composed mostly of Sn, Cl, Cu and O with S, Al and Fe as minor elements (Fig. 15). Sample 4 is constituted of green and white particles. The former have the same composition as the particles of

Fig, 12: EDS spectrum of sample 1 (yellow powder),

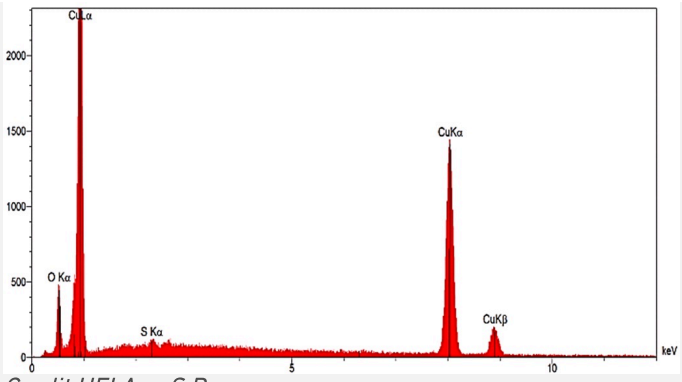
Fig. 14: EDS spectrum of sample 2 (red particle),

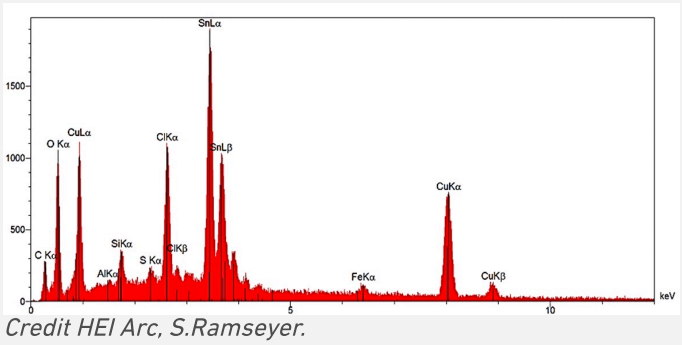
Fig. 15: EDS spectrum of sample 3 (green corrosion product),

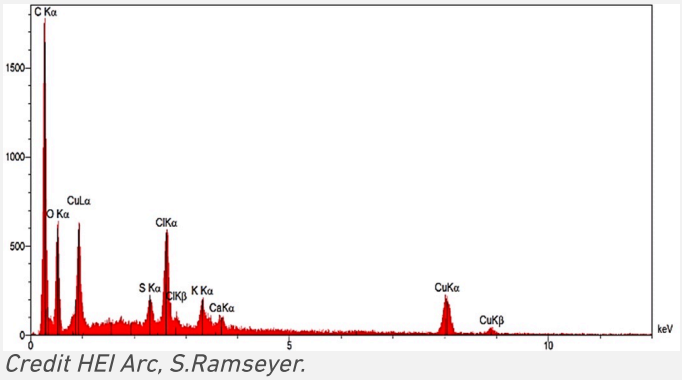
sample 3 while the white particles are significantly different in composition: containing a large amount of C with a small amount of O, Cl, S, K and Cu (Fig. 16). The FTIR spectrum of the white particles (Fig. 17) shows several characteristic peaks of an organic compound: 2919 cm-1 and 2850 cm-1 (C-H- bond), 3445 cm-1 and 3323 cm-1 (O-H- bond) or 1030cm-1, 1006cm-1 and 951cm-1 (C-O-C- bond).

Fig. 16: EDS spectrum of sample 4 (white particle),

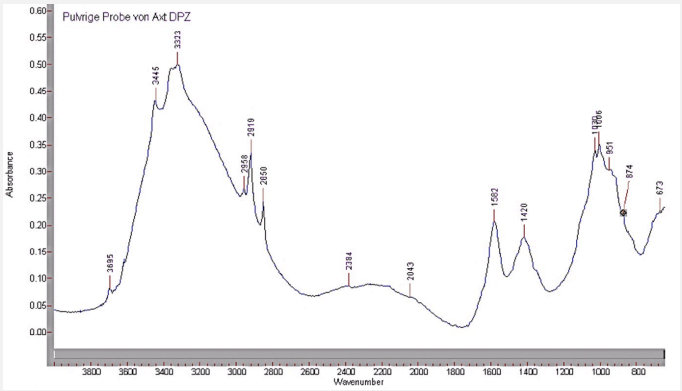
Fig. 17: FTIR spectrum of sample 4 (white particle),

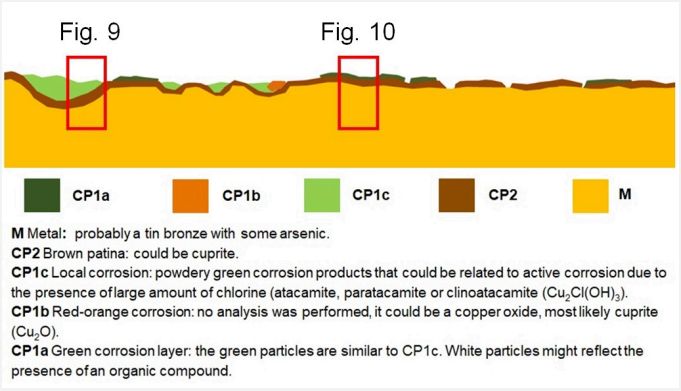
The schematic representation of corrosion layers of Fig. 8 integrating additional information based on the analyses carried out is given in Fig. 18.

Fig. 18: Improved stratigraphic representation of a virtual cross-section through the axe head based on visual observations and additional analyses and visualization of the two stratigraphies of Figs. 9 and 10.

The axe head is probably a tin bronze containing a small amount of As. It is difficult to interpret the corrosion layer only by macroscopic observation. The analyses show that all green corrosion products contain chlorides that might originate from strip-cleaning by hydrochloric acid (although not documented). Active corrosion is not proved but we suspect the presence of atacamite, paratacamite or clinoatacamite (Cu2Cl(OH)3). FTIR revealed the presence of an organic compound on the metal surface (possibly a protective coating).
