AXE HEAD N11 - TIN BRONZE - BRONZE AGE

Artefact name Axe head N11

Authors Christian. Degrigny (HE-Arc CR, Neuchâtel, Neuchâtel, Switzerland) & Valentin. Boissonnas (HE-Arc CR, Neuchâtel, Neuchâtel, Switzerland)

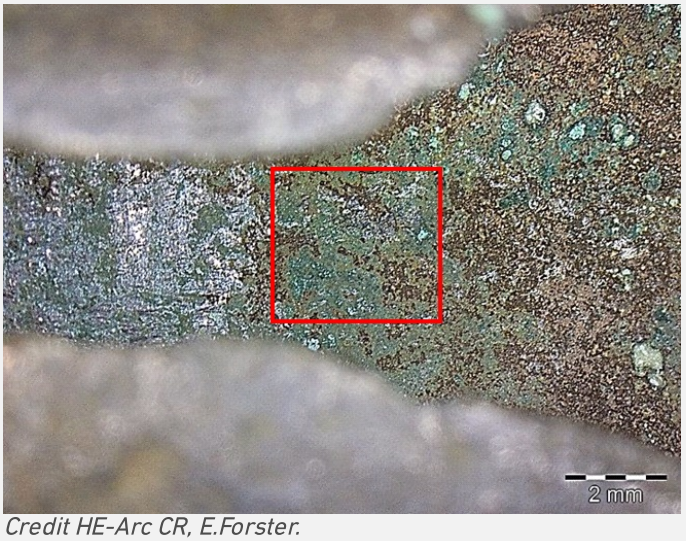
Fig. 6: Local corrosion (length max: 10 mm) where sample 3 has been taken,

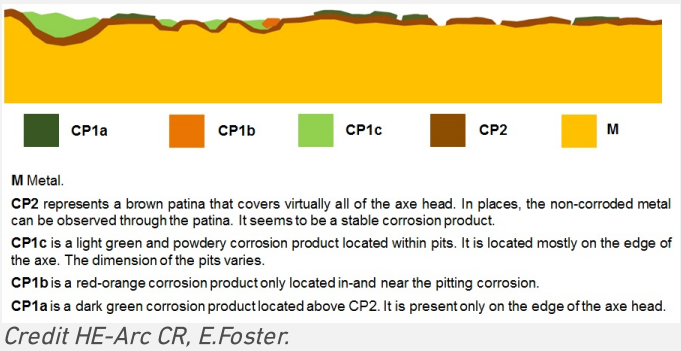
The schematic representation below gives an overview of the corrosion layers encountered on the head axe from a first visual macroscopic observation.

Fig. 8: Stratigraphic representation of corrosion products of the axe head (based on visual observations),

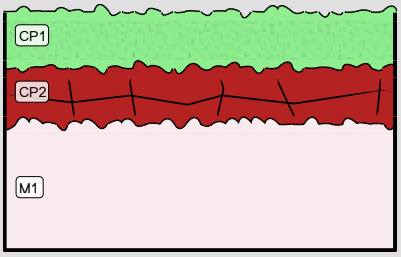
Fig. 9: Stratigraphic representation of the axe (sample 3) under binocular using the MiCorr application. The characteristics of the strata are only accessible by clicking on the drawing that redirects you to the search tool by stratigraphy representation. This presentation can be compared to Fig. 18. CP1 corresponds to CP1c, Credit HE-Arc CR, C.Degrigny.

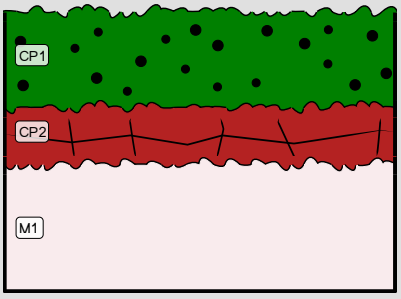
Fig. 10: Stratigraphic representation. of the axe (sample 4) under binocular using the MiCorr application. The characteristics of the strata are only accessible by clicking on the drawing that redirects you to the search tool by stratigraphy representation. This presentation can be compared to Fig. 18. CP1 corresponds to CP1a, Credit HE-Arc CR, C.Degrigny.

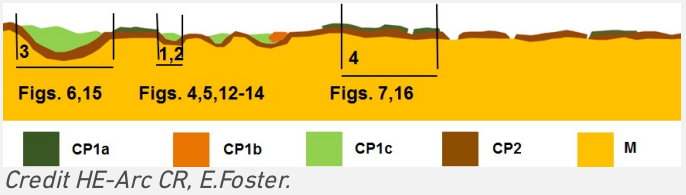
Fig. 11: Location of the samples on the stratigraphic representation of Fig. 8 with indication of the corresponding figures,

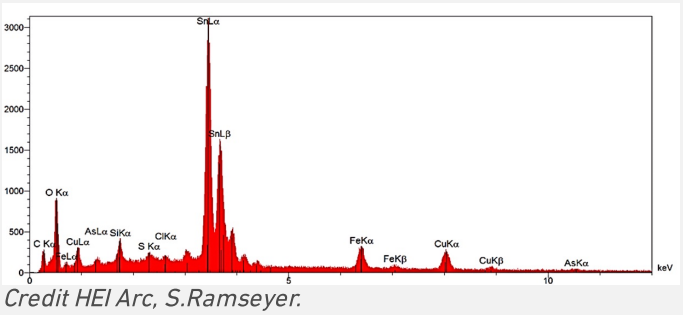
Analyses by SEM/EDS indicate that the light yellow particles of sample 1 are predominantly composed of Sn and O with minor presence of C, Cu, Fe, S, Cl and As (Fig. 12), while the green and red particles of sample 2 are respectively composed of O, Cu, Cl, and Sn, with a minor presence of Fe and S (Fig. 13) and Cu, O (Fig. 14, possibly cuprite). Sample 3 consists of green particles composed mostly of Sn, Cl, Cu and O with S, Al and Fe as minor elements (Fig. 15). Sample 4 is constituted of green and white particles. The former have the same composition as the particles of

Fig, 12: EDS spectrum of sample 1 (yellow powder),

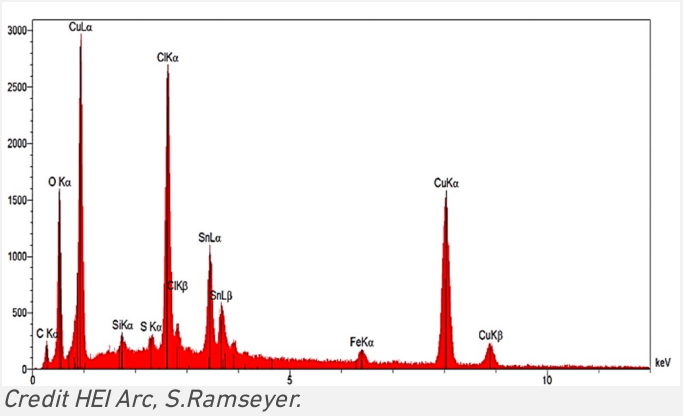
Fig. 13: EDS spectrum of sample 2 (green particle),

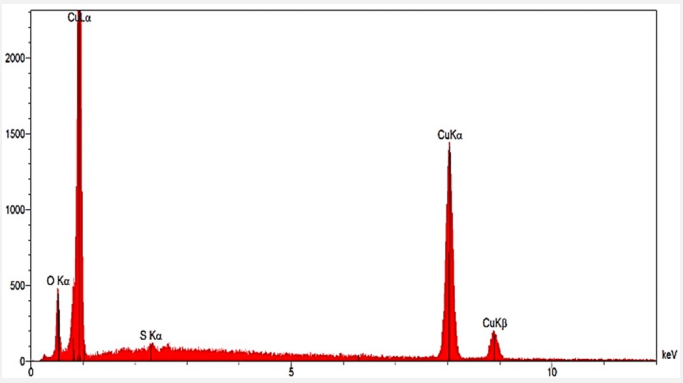
Fig. 14: EDS spectrum of sample 2 (red particle),

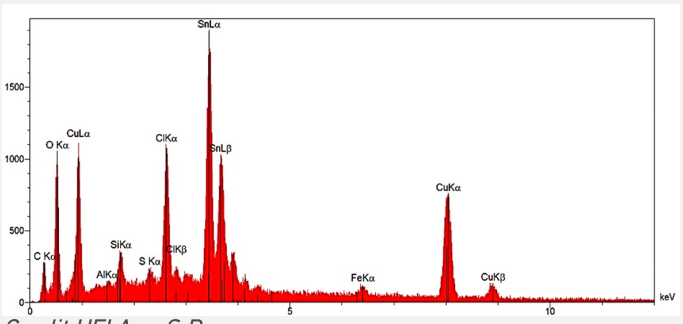
Fig. 15: EDS spectrum of sample 3 (green corrosion product),

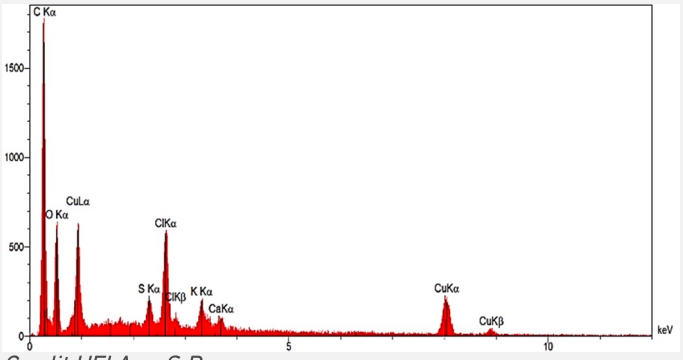
sample 3 while the white particles are significantly different in composition: containing a large amount of C with a small amount of O, Cl, S, K and Cu (Fig. 16). The FTIR spectrum of the white particles (Fig. 17) shows several characteristic peaks of an organic compound: 2919 cm-1 and 2850 cm-1 (C-H- bond), 3445 cm-1 and 3323 cm-1 (O-H- bond) or 1030cm-1, 1006cm-1 and 951cm-1 (C-O-C- bond).

Fig. 16: EDS spectrum of sample 4 (white particle),

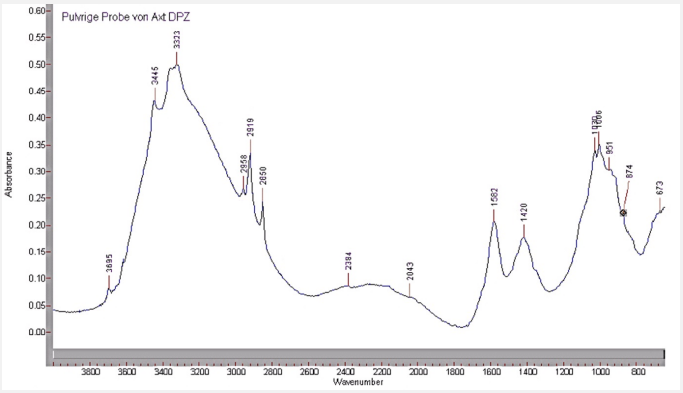
Fig. 17: FTIR spectrum of sample 4 (white particle),

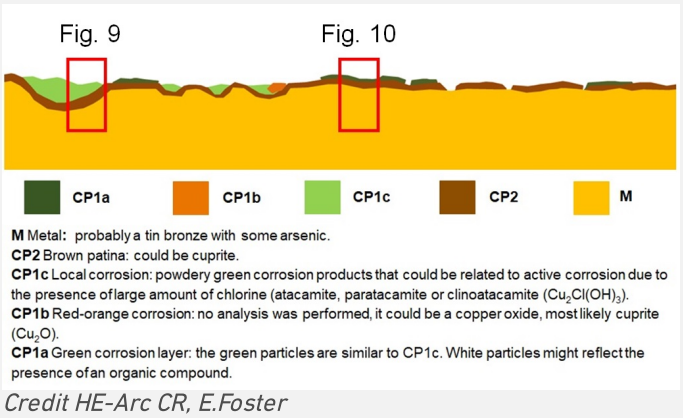
The schematic representation of corrosion layers of Fig. 8 integrating additional information based on the analyses carried out is given in Fig. 18.

Fig. 18: Improved stratigraphic representation of a virtual cross-section through the axe head based on visual observations and additional analyses and visualization of the two stratigraphies of Figs. 9 and 10.

The axe head is probably a tin bronze containing a small amount of As. It is difficult to interpret the corrosion layer only by macroscopic observation. The analyses show that all green corrosion products contain chlorides that might originate from strip-cleaning by hydrochloric acid (although not documented). Active corrosion is not proved but we suspect the presence of atacamite, paratacamite or clinoatacamite (Cu2Cl(OH)3). FTIR revealed the presence of an organic compound on the metal surface (possibly a protective coating).
