PIN OR NEEDLE FRAGMENT HR-3031 - TIN BRONZE - LATE BRONZE AGE - SWITZERLAND

Artefact name	Pin or needle fragment HR-3031
Authors	Marianne. Senn (EMPA, Dübendorf, Zurich, Switzerland) & Christian. Degrigny (HE-Arc CR, Neuchâtel, Neuchâtel, Switzerland)
Url	/artefacts/910/

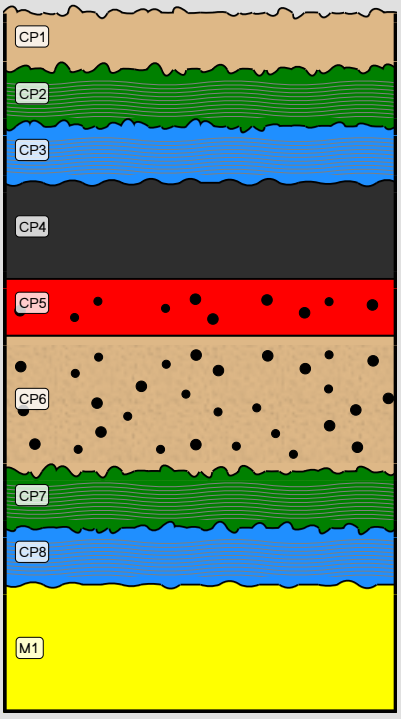
Fig. 3: Stratigraphic representation of the pin or needle fragment with green-blue patina under binocular using the MiCorr application. The characteristics of the strata are only accessible by clicking on the drawing that redirects you to the search tool by stratigraphy representation, Credit HE-Arc CR.

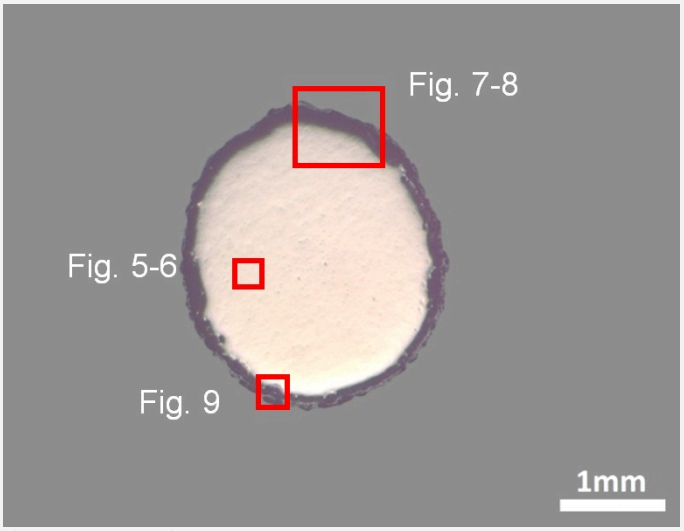
Fig. 4: Micrograph of the cross-section of the sample taken from the pin or needle fragment with green-blue patina showing the location of Figs. 5 to 9,

Description of sample	The cross-section is circular and is a complete section through the pin (Fig. 2). The surface is completely covered with a rather thin corrosion crust of irregular thickness (Fig. 4).
Alloy	Tin Bronze
Technology	Cold worked after annealing
Lab number of sample	MAH 87-195
Sample location	Musées d'art et d'histoire, Genève, Geneva
Responsible institution	Musées d'art et d'histoire, Genève, Geneva
Date and aim of sampling	1987, metallography and corrosion characterisation

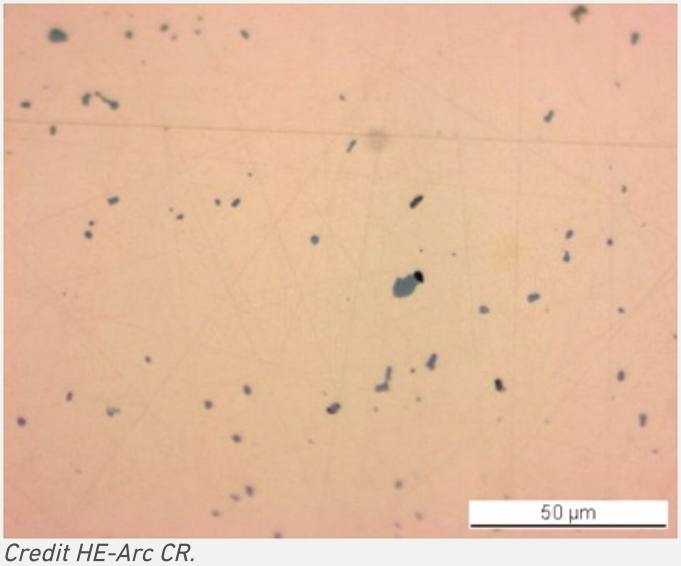
The remaining metal is a tin bronze and contains small copper sulphide and Pb-rich inclusions evenly distributed throughout the metal (Fig. 5, Tables 1 and 2). The Pb-rich inclusions are only visible with SEM appearing as white particles. The etched structure of the tin bronze shows re-crystallised and angular grains, some of them with twins (Fig. 6). Strain or slip lines are visible, especially near the metal surface. They indicate a final cold working. Copper sulphide inclusions are found both at the grain boundaries and inside the grains (Fig. 6). The average hardness of the metal is about HV1 120.

Fig. 5: Micrograph of the metal sample from Fig. 4 (detail), unetched, bright field. Grey copper sulphide inclusions are clearly visible,

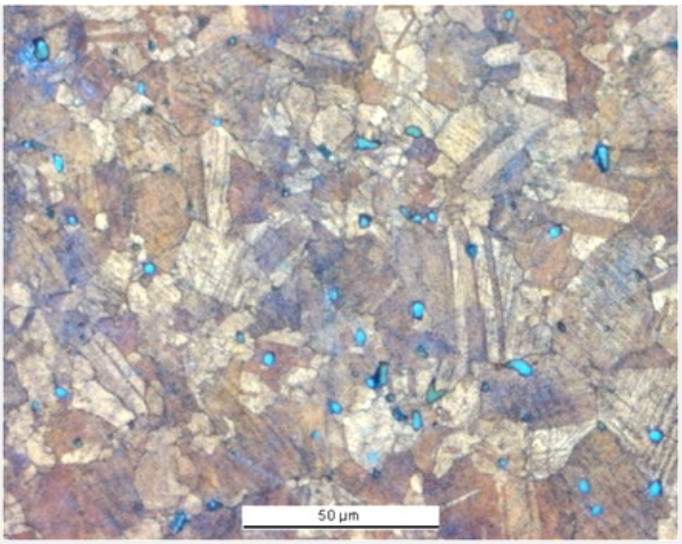
Fig. 6: Micrograph of the metal sample from Fig. 4 (detail), etched, bright field. Small angular re-crystallised grains (some with twins) with slip lines are observed. Copper sulphide inclusions appear in blue,

Microstructure	Polygonal and twinned grains + strain lines (metal surface)
First metal element	Cu
Other metal elements	Ni, As, Ag, Sn, Sb, Pb

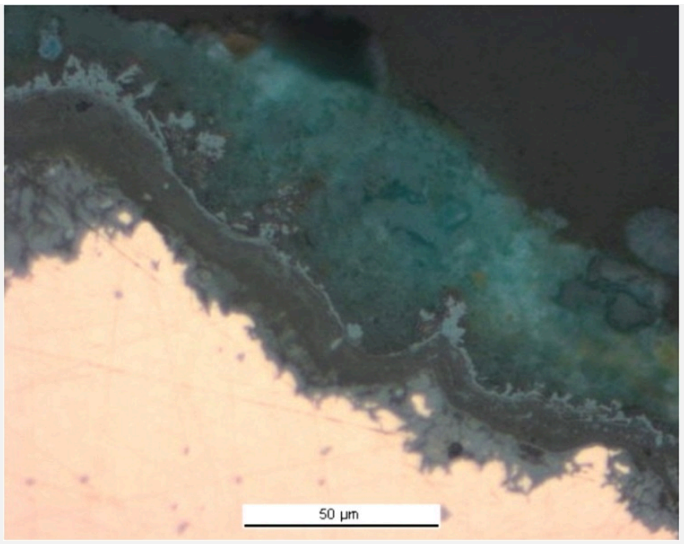
The corrosion crust has an average thickness of about 50µm (Fig. 7). In polarised light (Fig. 8), the corrosion stratigraphy is more clearly visible: it is composed of an inner dark red-green-yellow corrosion layer (CP6 to CP8, an agglomerate of nanoscale stannic oxides with cuprite) directly on the metal core (Table 3 and Fig. 9, already studied by Piccardo et al. 2007), an intermediate multi-layered black-grey bands (CP3 to CP5) and an outer turquoise-green layer (CP1-CP2) analysed with XRD by Schweizer and identified as malachite/CuCO3Cu(OH)2 (Schweizer 1994). In some areas the dark-red layers (CP8) can also be found in between the black-grey bands (CP3 to CP5) and the malachite (CP1-CP2). Elemental chemical distribution of the SEM image of Fig. 9 shows that the black-grey layers are enriched in Sn but also contain Fe. Superior markers such as contextual Al and Si are present in the outer malachite layers. S is present both on the rim of the outer black-grey layers and in the malachite (Fig. 9, Table 3).

Table 3: Chemical composition (mass %) of orange corrosion products (from Figs. 8 and 9). Method of analysis: SEM/EDS, Laboratory of Analytical Chemistry, Empa.

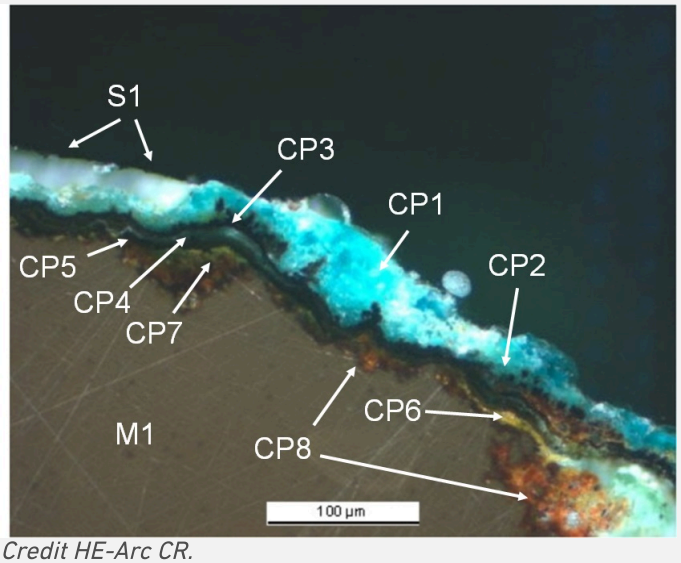
Fig. 7: Micrograph of the metal sample from Fig. 4 (detail) and corresponding to the stratigraphy of Fig. 10, unetched, bright field. Stratigraphy of the corrosion crust: inner light grey layer (CP3), intermediate dark grey layer with a light-grey rim (CP2) and outer grey-green layer (CP1),

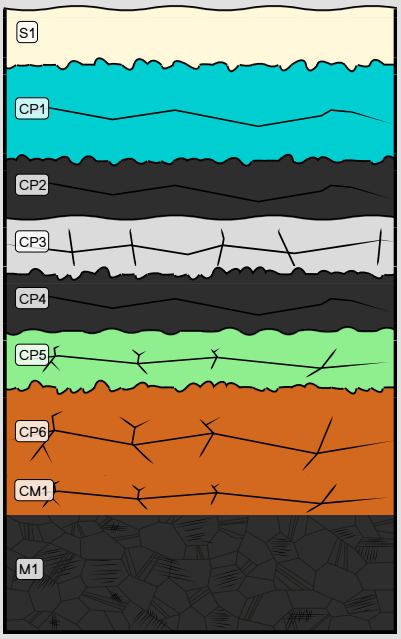
Fig. 10: Stratigraphic representation of the sample taken from the pin or needle fragment with green-blue patina in cross-section (dark field) using the MiCorr application. The characteristics of the strata are only accessible by clicking on the drawing that redirects you to the search tool by stratigraphy representation. This representation can be compared to Figs. 7 and 8, Credit HE-Arc CR.

The two corrosion structures observed under binocular and on cross-sections look rather different. It might be due to some disruption during the cutting process.
