PIN WITHOUT HEAD HR-18152 - TIN BRONZE - LATE BRONZE AGE - SWITZERLAND

Artefact name Pin without head HR-18152

Authors Marianne. Senn (Empa, Dübendorf, Zurich, Switzerland) & Christian. Degrigny (HE-Arc CR, Neuchâtel, Neuchâtel, Switzerland)

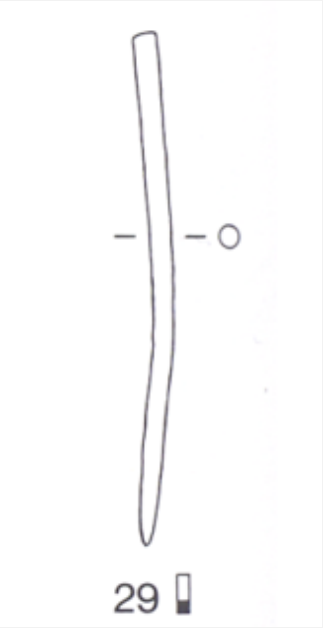
Fig. 1: Pin without head (after Rychner-Faraggi 1993, plate 74.29),

Description of the artefact	Pin without head and smooth brown-yellow patina typical of lake context (Figs. 1-2). Dimensions: L = 7,5cm; Ø = 3.3mm; WT = 4g.
Type of artefact	Pin
Origin	Hauterive - Champréveyres, Neuchâtel, Neuchâtel, Switzerland
Recovering date	Excavation 1983-1985, object from layer 3 to 5
Chronology category	Late Bronze Age
chronology tpq	1054 B.C.
chronology taq	1000 B.C.
Chronology comment	Hallstatt B1 (1054/1037BC _ 1000BC)
Burial conditions / environment	Lake
Artefact location	Laténium, Neuchâtel, Neuchâtel
Owner	Laténium, Neuchâtel, Neuchâtel
Inv. number	Hr 18152
Recorded conservation data	N/A

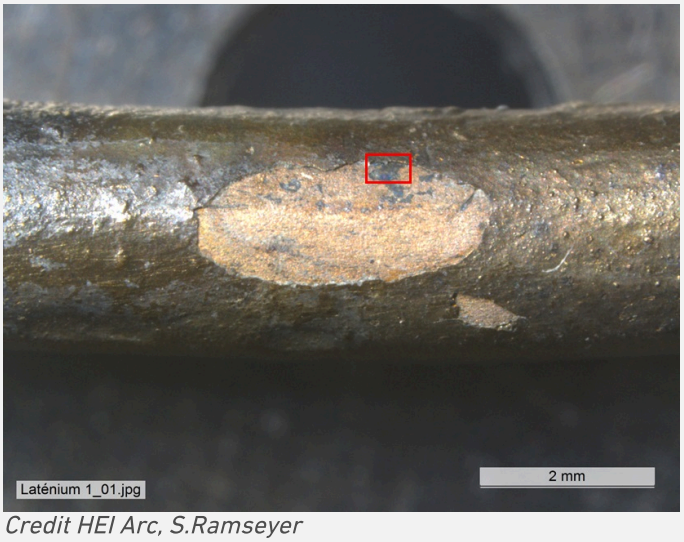
Fig. 2: Dense and smooth brown-yellow patina (detail) of the pin with lacuna showing the underlying metal with location of Fig. 4 (red rectangle),

The corrosion crust (patina) is regular in thickness (around 50µm, Fig. 4). It presents lacuna (Fig. 2) and in some areas it is missing completely (Fig. 9). At the metal - corrosion crust interface, there is a crack showing that the latter has separated from the metal core along its whole length (Figs. 4, 9, 10, 13-14). The corrosion crust can be divided into three distinct layers (CP1-3). Directly above the crack is a first dense but cracked and irregular inner layer (CP3, Figs. 4, 13-14). In bright field it appears brown (Fig. 15), in normal and polarised light dark brown (Figs. 2 and 16). It is separated from the adjacent layer by a clear line (Figs. 14 and 15). The second layer (CP2) is dense with little porosity (Figs. 13 and 14). In bright field it appears light brown (fig. 15), in polarised dark dark yellow (Fig. 16). The third and outermost layer (CP1) appears light brown under normal light (Fig. 3) and in bright field (Fig. 15), contains particles (Fig. 14) and is very porous (visible as golden reflections under polarized light, Fig. 16). These results are entirely consistent with Schweizer's observations (Schweizer 1994). The elemental chemical distribution of the SEM image selected reveals that the inner layer (CP3) is depleted in Cu, but rich in Sn,O and Si (Fig. 17 and Table 2) and its interface with the intermediate layer (CP2) could represent the limit of the original surface (Figs. 14 and 17). The second and third layer (CP2 and CP1) are Fe, Cu and S-rich (Fig. 17) and have a composition similar to chalcopyrite/$CuFeS_2$ (Table 2). This was confirmed by XRD. The particles (inclusions) have a composition similar to covelline or covellite/CuS (Table 2). Both chalcopyrite and covelline have been identified by Raman spectroscopy (Figs. 18 and 19).

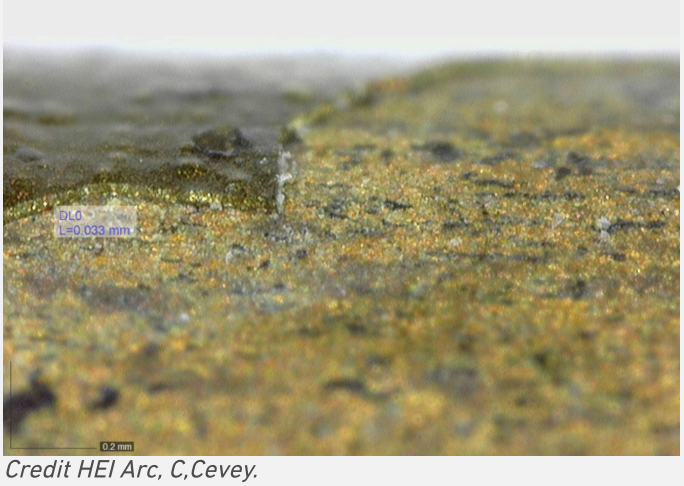
Fig. 3: Side view of a lacuna with the stratigraphy of the brown-yellow patina.

The cross-section is circular and is a complete section through the pin (Figs. 5 and 6). It is covered with a rather thin and regular (in thickness) corrosion crust (Figs. 3 and 4). One third of the corrosion crust is missing (Fig. 9).

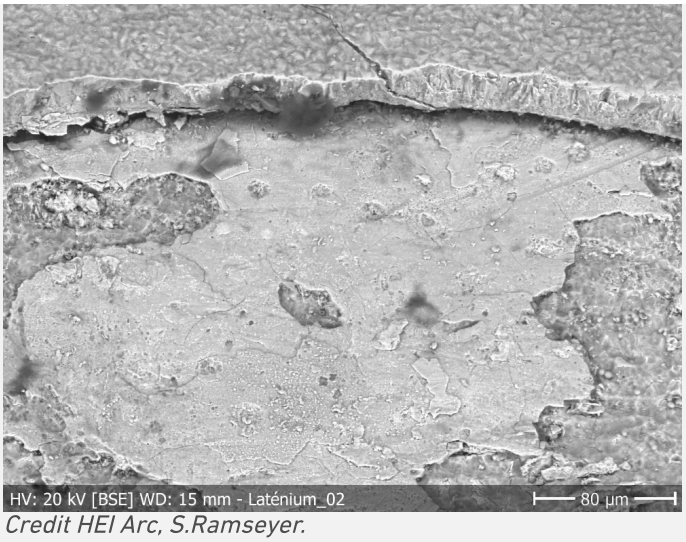
Fig. 4: SEM image of the pin from Fig. 2 (detail), BSE -mode. The crack between the remaining metal and the corrosion layers is clearly visible and the smooth layer below is CP3,

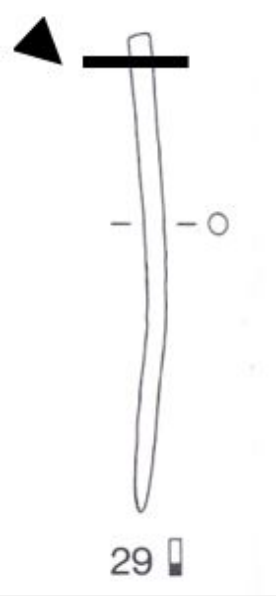
Fig. 5: Location of sampling area,

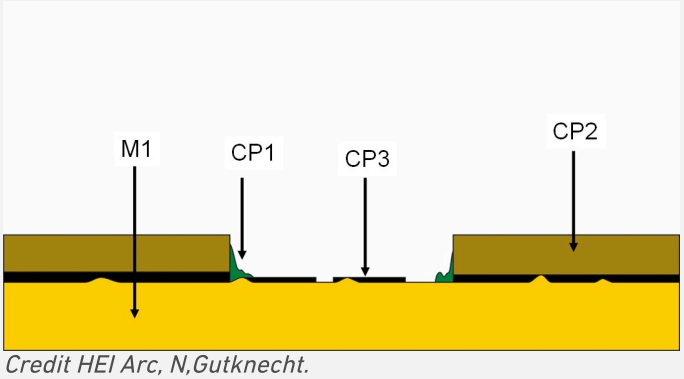
The schematic representation below gives an overview of the corrosion layers encountered on the pin from a first visual macroscopic observation.

Fig. 7: Stratigraphic representation of the pin without head by macroscopic observation (under binocular),

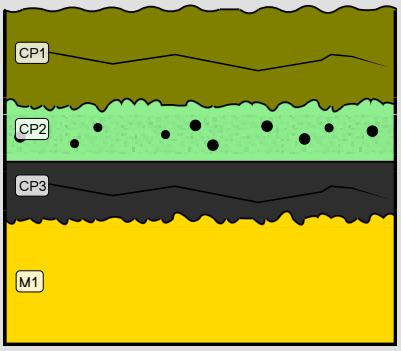
Fig. 8: Stratigraphic representation of the pin without head under binocular using the MiCorr application. The characteristics of the strata are only accessible by clicking on the drawing that redirects you to the search tool by stratigraphy representation, Credit HE-Arc CR.

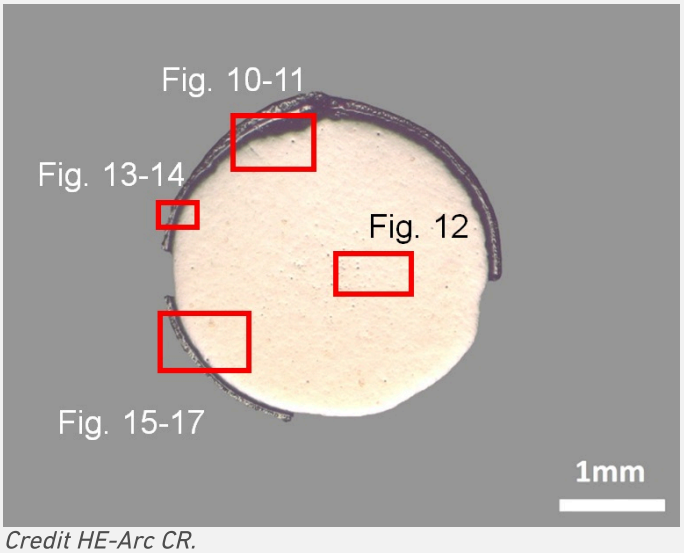
Fig. 9: Micrograph of the cross-section of the sample taken from the pin without head showing the location of Figs. 10 to 17,

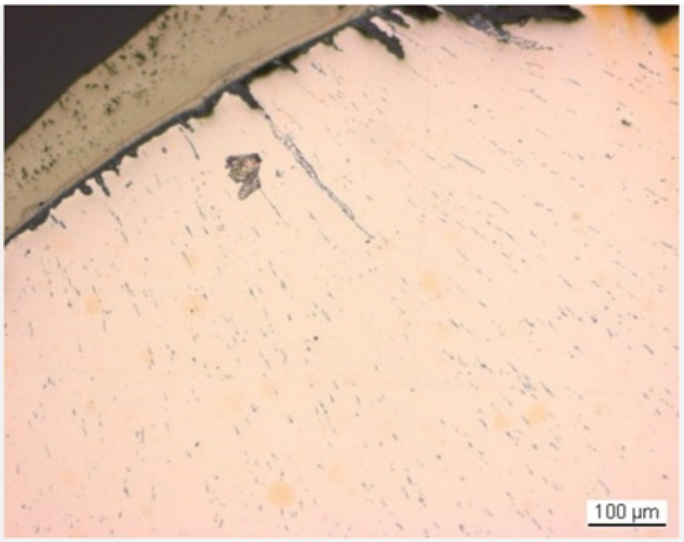
The remaining metal is a tin bronze and contains copper sulphide as well as heavy metal (Pb-rich) inclusions (Table 1, Figs. 10 and 11). Close to the surface of the remaining metal, copper sulphide inclusions are elongated and form rows (Fig. 10). The etched structure of the tin bronze shows polygonal grains; some of them are twinned (Fig. 12). In the centre of the sample and on the edges, the grains are smaller. The copper sulphide inclusions are located at the grain boundaries and in the grains. The average hardness of the metal is about HV1 110.

Fig. 10: Micrograph of the metal sample from Fig. 9 (detail), unetched, bright field. Rows of elongated copper sulphide inclusions can be observed,

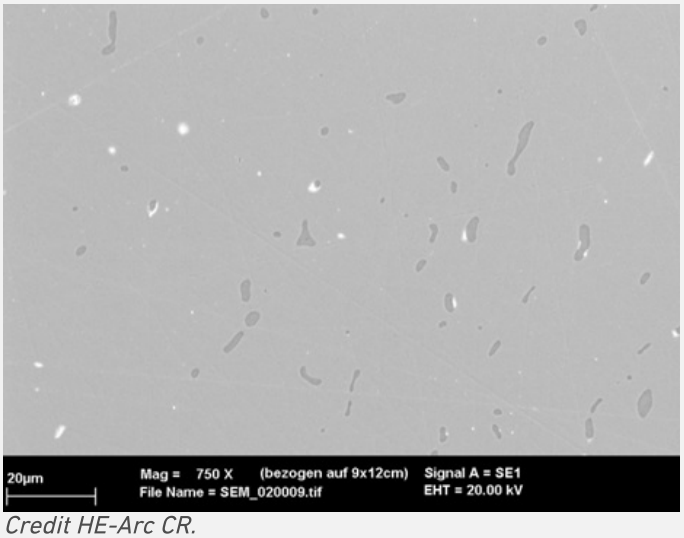
Fig. 11: SEM image of the metal sample from Fig. 9 (detail), SE-mode. Elongated copper sulphide inclusions (dark-grey) are visible as well as heavy metal (Pb-rich) inclusions (white),

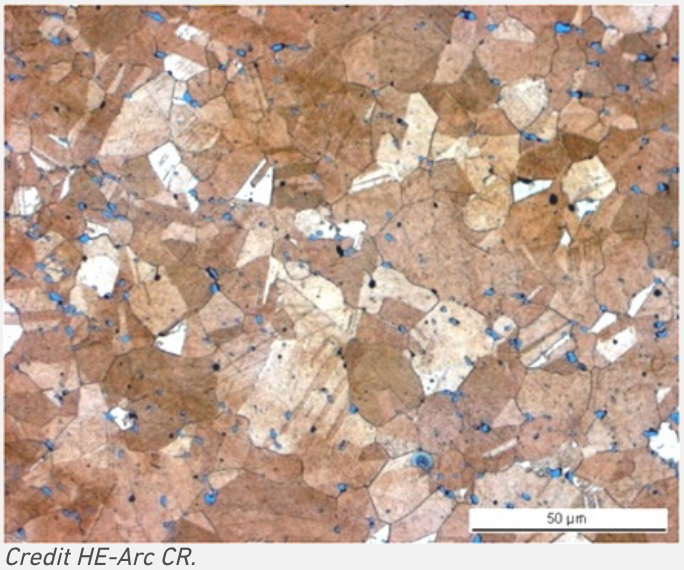
Fig. 12: Micrograph of the metal sample from Fig. 9 (detail), etched, bright field. The metal shows a structure of polygonal and twinned grains. Copper sulphide inclusions are visible as blue spots,

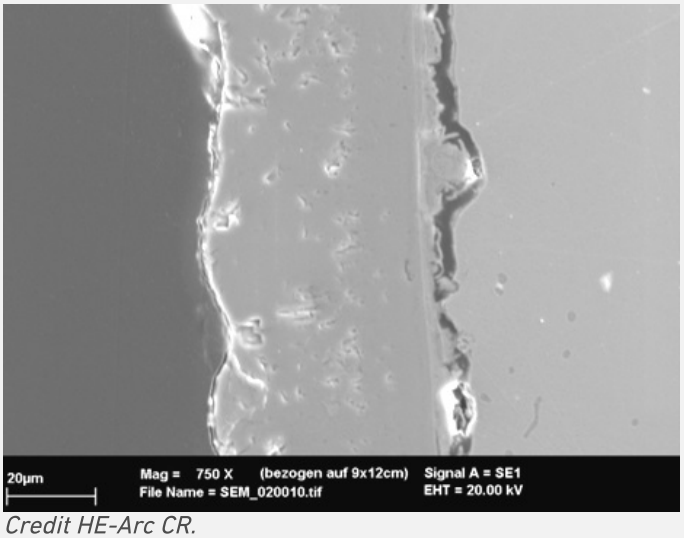
Fig. 13: SEM image of the metal sample from Fig. 9 (detail), SE-mode. The crack between the remaining metal and the corrosion layers is clearly visible,

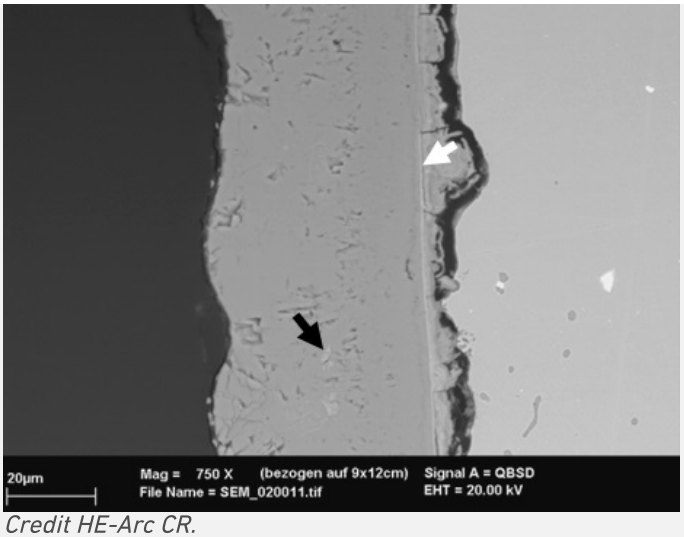
Fig. 14: SEM image similar to Fig. 13, BSE-mode. A thin line is visible (white arrow) differentiating the inner Sn-rich layer from the intermediate and outer chalcopyrite layers. The latter contains bright covelline inclusions (black arrow) and pores,

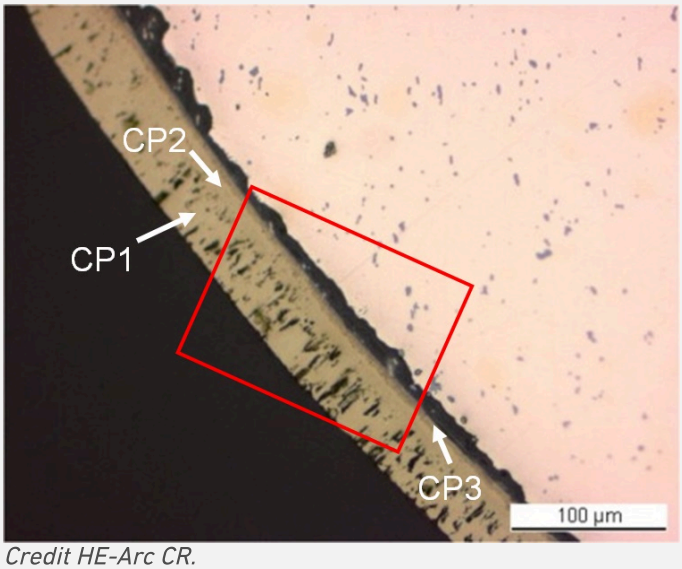
Table 2: Chemical composition (mass %) of the corrosion layers from Fig. 15. Method of analysis: SEM/EDS, Laboratory of Analytical Chemistry, Empa.

Fig. 15: Micrograph of the metal sample from Fig. 9 (detail) and corresponding to the stratigraphy of Fig. 20, unetched, bright field. The area selected for elemental chemical distribution (Fig. 17) is marked by a red rectangle,

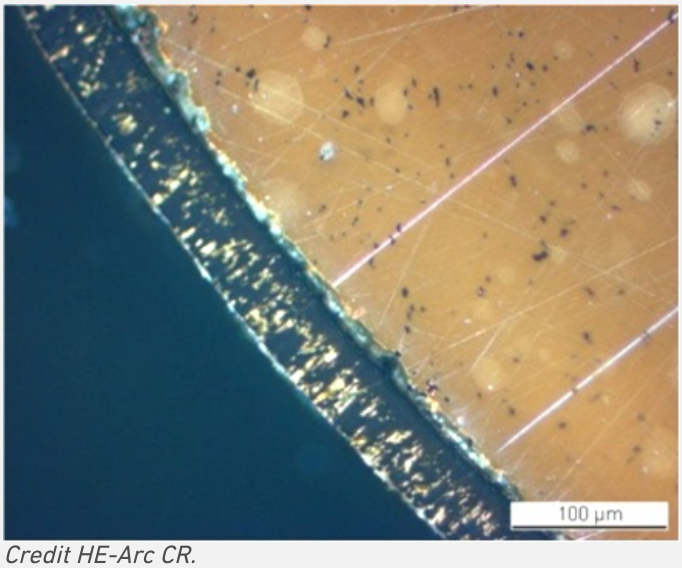
Fig. 16: Micrograph similar to Fig. 15, polarised light,

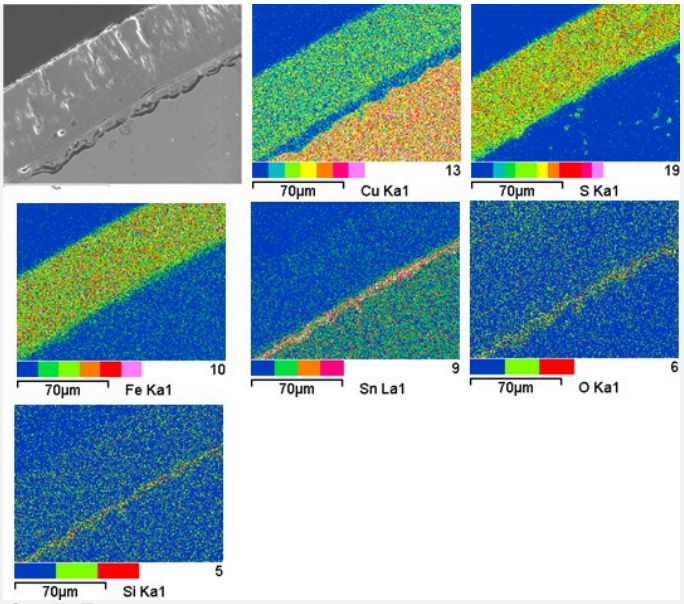
Fig. 17: SEM image and elemental chemical distribution of a selected area of Fig. 15 (rotated by 90°). Method of examination: SEM/EDS, Laboratory of Analytical Chemistry, Empa,

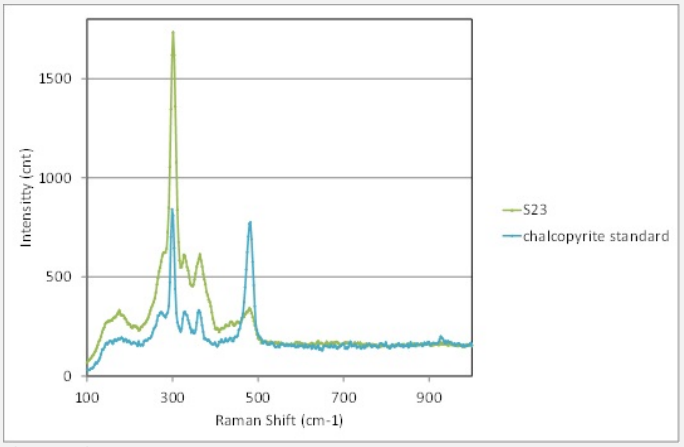
Fig. 18: Raman spectrum of the outermost layer (S23) of Fig.14 compared to a chalcopyrite standard spectrum. Settings: laser wavelength 532nm, acquisition time 50s, 4 accumulations, filter D2 (0.75-0.8mW), hole 1000, slit 100, grating 600. Method of analysis: Raman spectroscopy, Lab of Swiss National Museum, Affoltern a. Albis ZH,

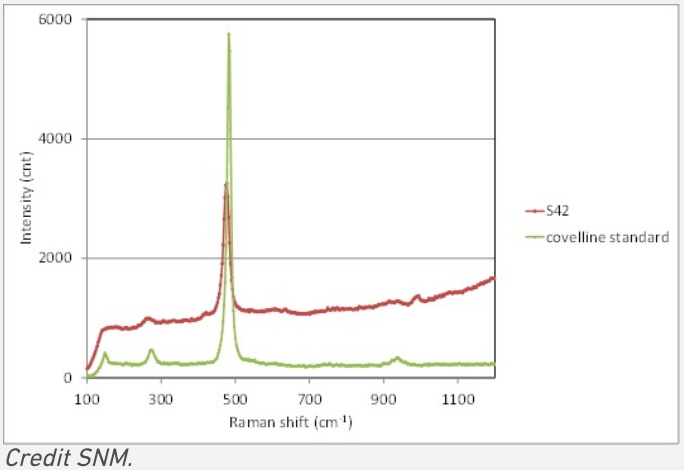
Fig. 19: Raman spectrum of the inclusions of the outermost layer (S42) of Fig. 14 compared to a covelline / covellite standard spectrum. Settings: laser wavelength 532nm, acquisition time 10s, 5 accumulations, D2 (0.75-0.8mW), hole 500, slit 80, grating 600. Method of analysis: Raman spectroscopy, Lab of Swiss National Museum, Affoltern a. Albis ZH,6

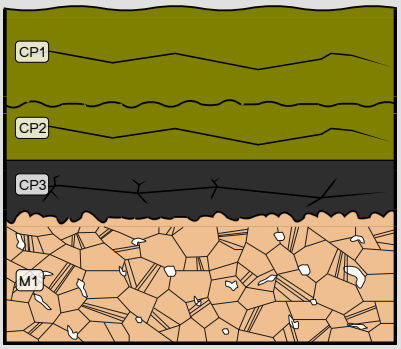
Fig. 20: Stratigraphic representation of the sample taken from the pin without head in cross-section (dark field) using the MiCorr application. The characteristics of the strata are only accessible by clicking on the drawing that redirects you to the search tool by stratigraphy representation. This representation can be compared to Fig. 15, Credit HE-Arc CR.

The stratigraphies observed under binocular and cross-section are rather similar. It is not possible though to distinguish the compact underlayer (CP2 in cross-section) under binocular.
