PIN WITHOUT HEAD HR-18152 - TIN BRONZE - LATE BRONZE AGE - SWITZERLAND

Artefact name Pin without head HR-18152

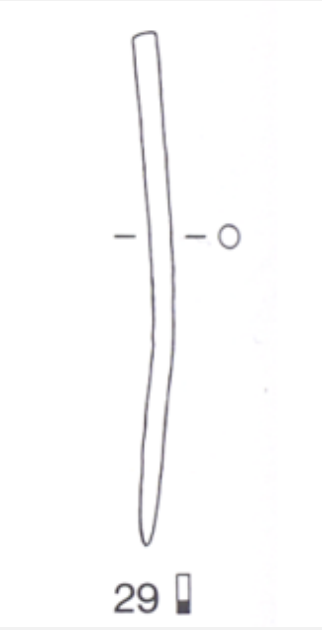
Fig. 1: Pin without head (after Rychner-Faraggi 1993, plate 74.29),

Description of the artefact	Pin without head and smooth brown-yellow patina typical of lake context (Figs. 1-2). Dimensions: L = 7,5cm; Ø = 3.3mm; WT = 4g.
Type of artefact	Pin
Origin	Hauterive - Champréveyres, Neuchâtel, Neuchâtel, Switzerland
Recovering date	Excavation 1983-1985, object from layer 3 to 5
Chronology category	Late Bronze Age
chronology tpq	1054 B.C.
chronology taq	1000 B.C.
Chronology comment	Hallstatt B1 (1054/1037BC _ 1000BC)
Burial conditions / environment	Lake
Artefact location	Laténium, Neuchâtel, Neuchâtel
Owner	Laténium, Neuchâtel, Neuchâtel
Inv. number	Hr 18152
Recorded conservation data	N/A

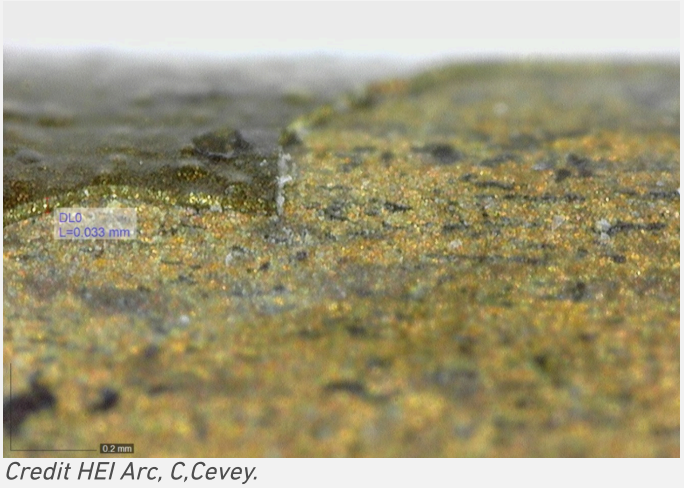
Fig. 3: Side view of a lacuna with the stratigraphy of the brown-yellow patina.

The cross-section is circular and is a complete section through the pin (Figs. 5 and 6). It is covered with a rather thin and regular (in thickness) corrosion crust (Figs. 3 and 4). One third of the corrosion crust is missing (Fig. 9).

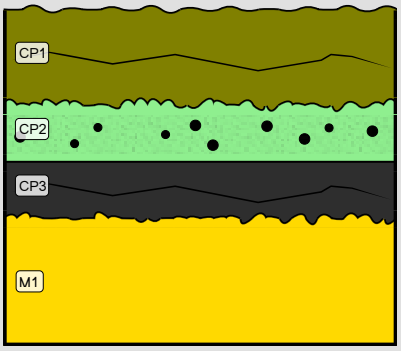
Fig. 8: Stratigraphic representation of the pin without head under binocular using the MiCorr application. The characteristics of the strata are only accessible by clicking on the drawing that redirects you to the search tool by stratigraphy representation, Credit HE-Arc CR.

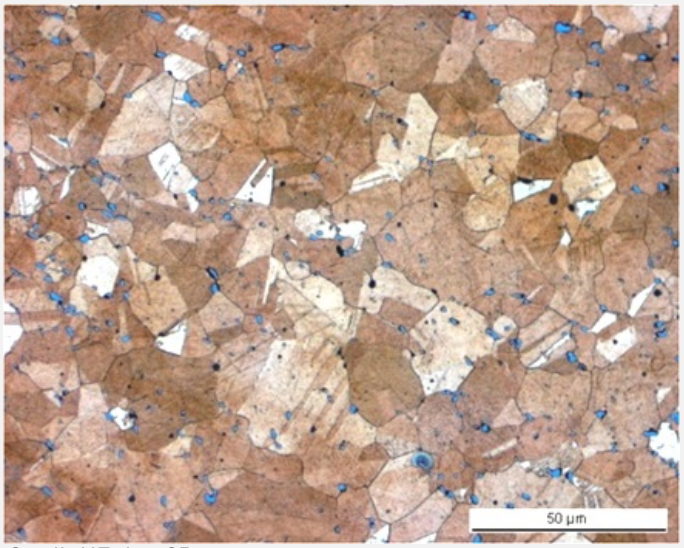
Fig. 12: Micrograph of the metal sample from Fig. 9 (detail), etched, bright field. The metal shows a structure of polygonal and twinned grains. Copper sulphide inclusions are visible as blue spots,

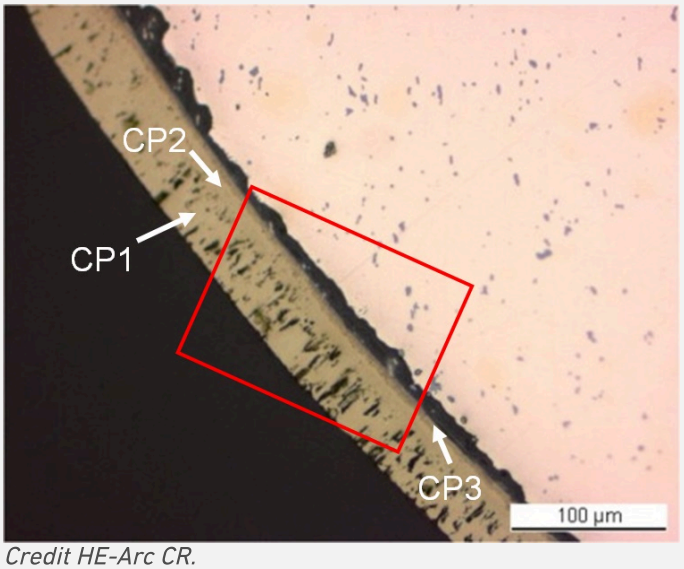
Table 2: Chemical composition (mass %) of the corrosion layers from Fig. 15. Method of analysis: SEM/EDS, Laboratory of Analytical Chemistry, Empa.

Fig. 15: Micrograph of the metal sample from Fig. 9 (detail) and corresponding to the stratigraphy of Fig. 20, unetched, bright field. The area selected for elemental chemical distribution (Fig. 17) is marked by a red rectangle,

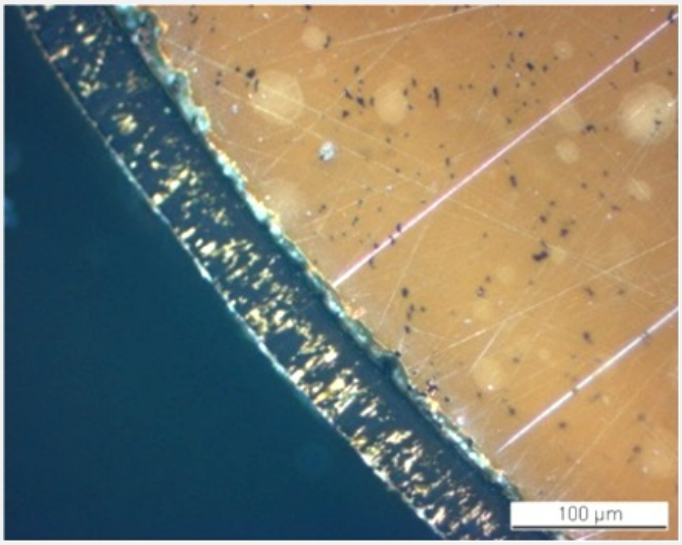
Fig. 16: Micrograph similar to Fig. 15, polarised light,

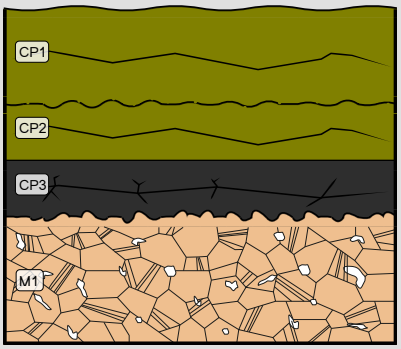
Fig. 20: Stratigraphic representation of the sample taken from the pin without head in cross-section (dark field) using the MiCorr application. The characteristics of the strata are only accessible by clicking on the drawing that redirects you to the search tool by stratigraphy representation. This representation can be compared to Fig. 15, Credit HE-Arc CR.

The stratigraphies observed under binocular and cross-section are rather similar. It is not possible though to distinguish the compact underlayer (CP2 in cross-section) under binocular.
