TOWEL BAR - AL ALLOY - MODERN TIMES - FRANCE

Artefact name Towel bar

Authors Christian. Degrigny (HE-Arc CR, Neuchâtel, Neuchâtel, Switzerland)

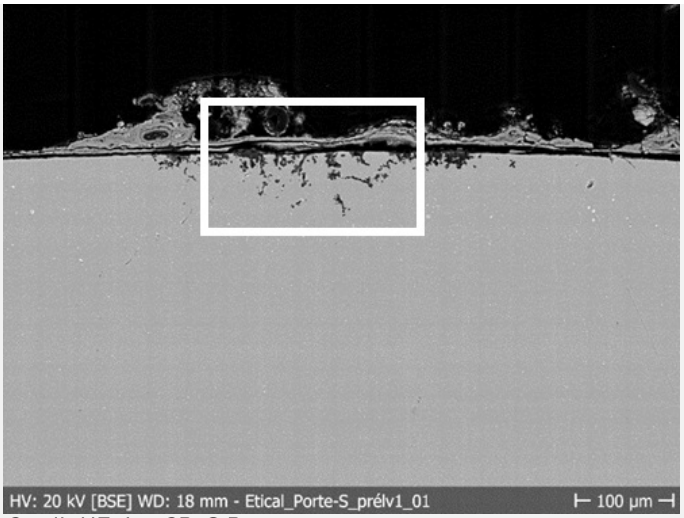
Fig. 3: SEM image of the cross-section of the fragment sampled from the towel bar showing the location of Fig. 4,

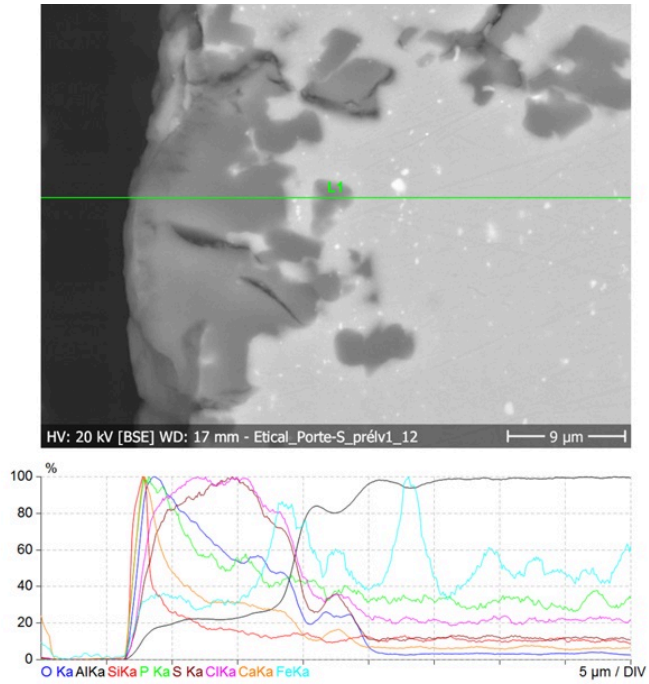
Fig. 10: EDS Linescan from CM1 to M1,

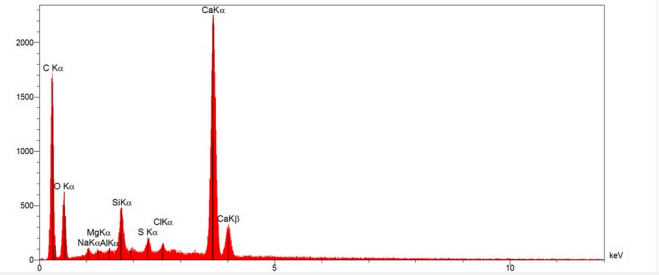
Fig. 11: EDS spectrum of area 4 of Fig. 6,

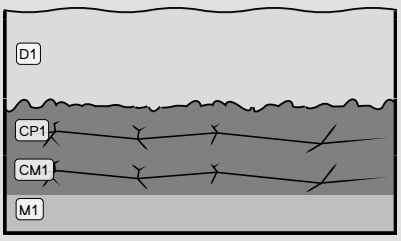
Fig. 12: Stratigraphic representation of the fragment sampled from the towel bar in cross-section (SEM-BSE) using the MiCorr application. The characteristics of the strata are only accessible by clicking on the drawing that redirects you to the search tool by stratigraphy representation. This representation can be compared to Fig. 6, Credit HE-Arc CR, C.Degrigny.
