TANG FRAGMENT OF A KNIFE HR-6567 - LEADED BRONZE - LATE BRONZE AGE - SWITZERLAND

Artefact name Tang fragment of a knife HR-6567

Authors Marianne. Senn (Empa, Dübendorf, Zurich, Switzerland) & Christian. Degrigny (HE-Arc CR, Neuchâtel, Neuchâtel, Switzerland)

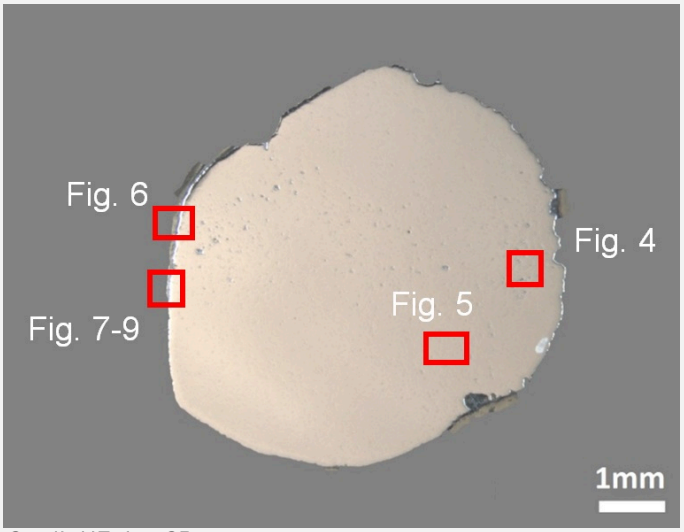
Fig. 3: Micrograph of the cross-section of the sample taken from the tang fragment of a knife with brown patina showing the location of Figs. 4 to 9,

Description of sample	This cross-section shows a lateral cut through the tang (Fig. 2). Most of the corrosion crust is absent (Fig. 3).
Alloy	Leaded Bronze
Technology	Cold worked after annealing
Lab number of sample	MAH 87-196
Sample location	Musées d'art et d'histoire, Genève, Geneva
Responsible institution	Musées d'art et d'histoire, Genève, Geneva
Date and aim of sampling	1987, metallography and corrosion characterisation

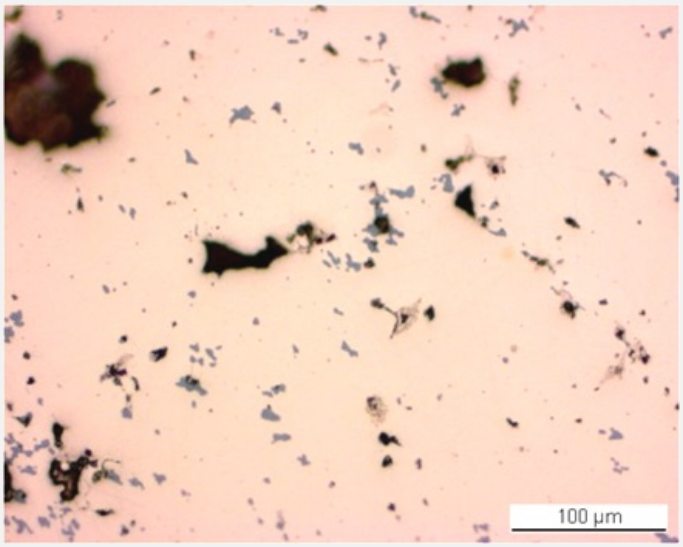
The remaining metal is a leaded bronze (Table 1) containing numerous copper sulphide and tiny Pb inclusions (Figs. 4-6, 9 and Table 2). The porosity within the metal is high, particularly along a band through the middle of the sample (Figs. 3 and 4). The etched structure of the leaded bronze shows small, regular polygonal grains, some with twinning (Fig. 5). Strain lines appear in grains close to the metal surface (Fig. 6). The average hardness of the metal is HV1 120.

Fig. 4: Micrograph of the metal sample from Fig. 3 (detail), unetched, bright field. In pink the metal, in black the porosity and in dark-grey copper sulphide inclusions,

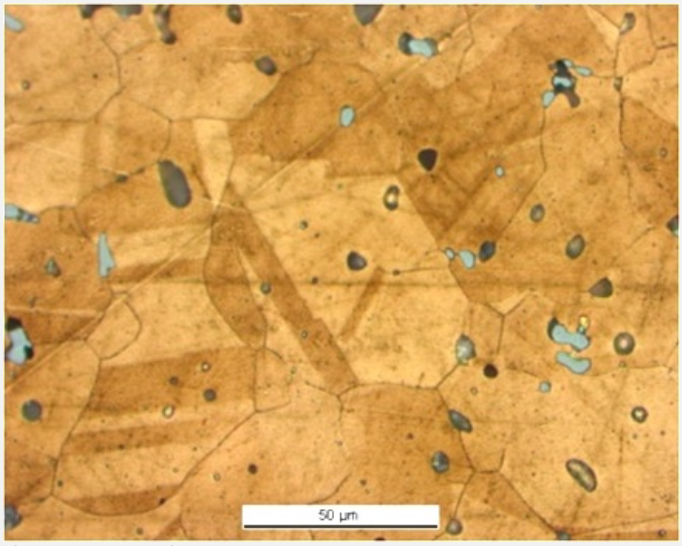
Fig. 5: Micrograph of the metal sample from Fig. 3 (detail), etched, bright field. Angular and twinned grains are revealed as well as copper sulphide inclusions in grey,

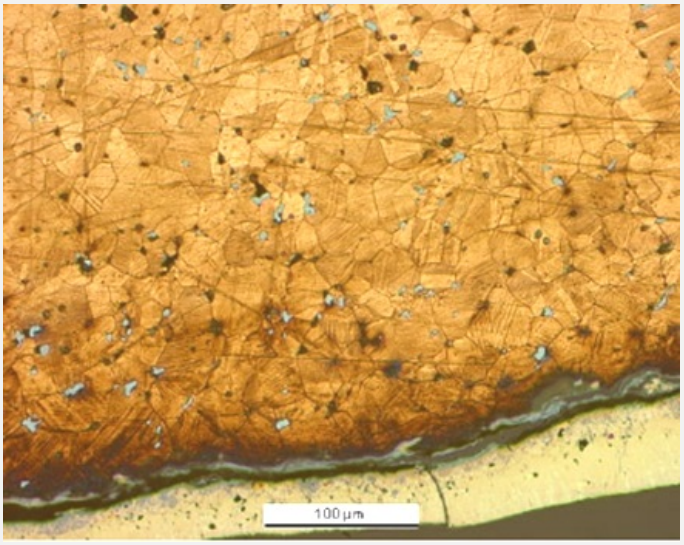
Fig. 6: Micrograph of the metal sample from Fig. 3, etched, bright field (rotated by 270°, detail). Angular grains with strain lines can be seen as well as copper sulphide inclusions in grey,

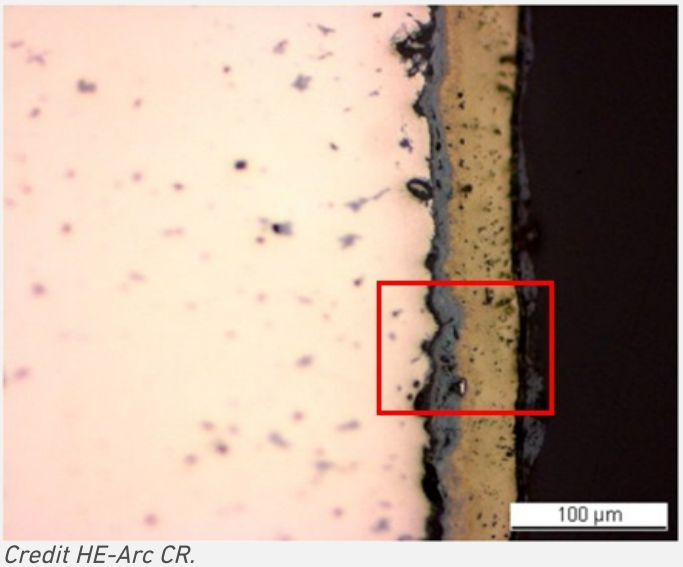
The metal has lost most of its original corrosion crust, the remainder having an average thickness between 60 and 190µm (Fig. 3). In some areas up to three corrosion layers are visible (Fig. 7). In polarised light (Fig. 8), the corrosion stratigraphy appears more clearly: it is composed of a dense black inner layer, an intermediate thick brown layer with bright spots (indicating porosity) and an outer red layer with white particles. The elemental chemical distribution of the SEM image reveals that the black inner layer (CP3) is Sn-rich, but contains Cu, O, Fe, Si, P, Pb, Ni, As, Ca and S (Table 3, Fig. 9). The brown layer (CP2) contains S, Fe and Cu and has a composition similar to chalcopyrite/$CuFeS_2$ (Table 3, Fig. 9). This was confirmed by past XRD analyses carried out by Schweizer (1994, museum report (1987)). The red layer (CP1) is an iron oxide (main elements Fe and O) and is contaminated with calcite/$CaCO_3$ particles (Table 3, Fig. 9).

Fig. 7: Micrograph of the metal sample from Fig. 3 (reversed picture, detail), unetched, bright field. From left to right: metal (in pink), inner light-grey layer, intermediate brown layer and top dark-grey layer. The area selected for elemental chemical distribution (Fig. 9) is marked by a red rectangle,

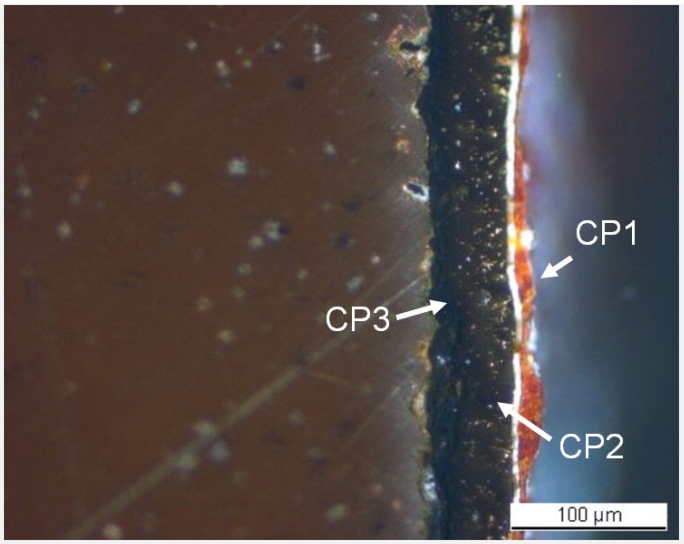
Fig. 8: Micrograph of the same area as Fig. 7 and corresponding to the stratigraphy of Fig. 10, polarized light. From left to right: metal (in brown) covered with a corrosion crust consisting of a black layer, an intermediate brown layer with bright spots, a crack (white line) and a red layer with white particles,

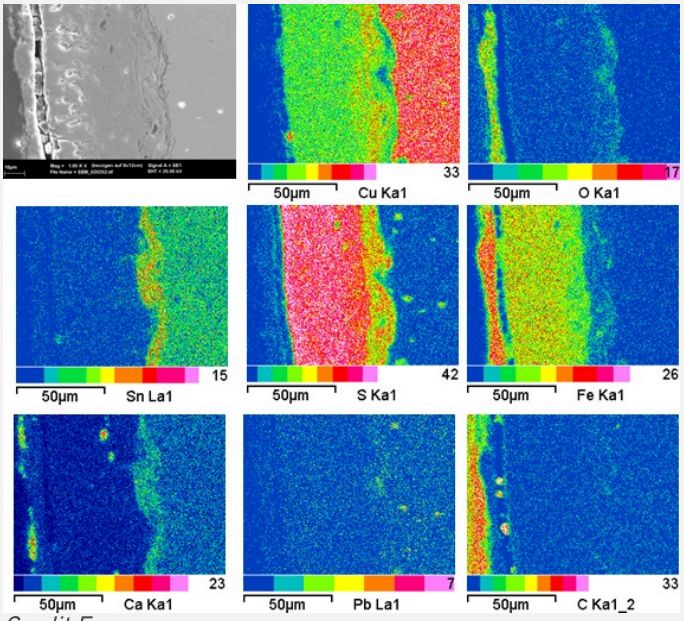
Fig. 9: SEM image, SE-mode, and elemental chemical distribution of the selected area of Fig. 7 (reversed picture). Method of examination: SEM/EDS, Laboratory of Analytical Chemistry, Empa,

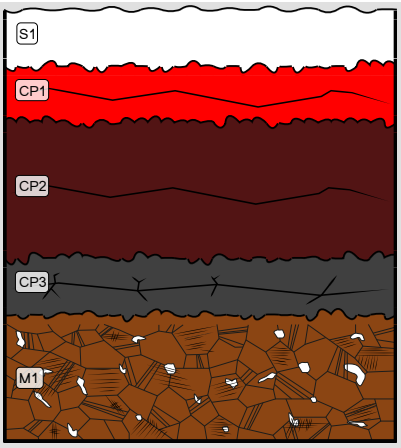
Fig. 10: Stratigraphic representation of the sample taken from the tang fragment of a knife with brown patina in cross-section (dark field) using the MiCorr application. The characteristics of the strata are only accessible by clicking on the drawing that redirects you to the search tool by stratigraphy representation. This representation can be compared to Fig. 8, Credit HE-Arc CR.
