TANG FRAGMENT OF A KNIFE HR-6567 - LEADED BRONZE - LATE BRONZE AGE - SWITZERLAND

Artefact name Tang fragment of a knife HR-6567

Authors Marianne. Senn (Empa, Dübendorf, Zurich, Switzerland) & Christian. Degrigny (HE-Arc CR, Neuchâtel, Neuchâtel, Switzerland)

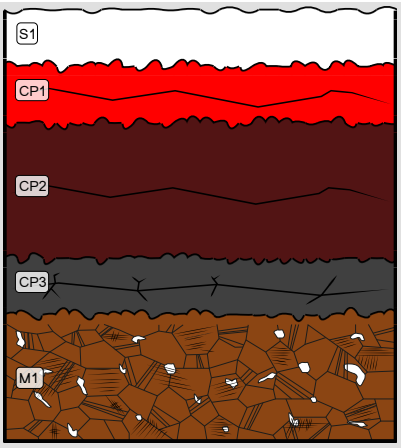
Fig. 10: Stratigraphic representation of the sample taken from the tang fragment of a knife with brown patina in cross-section (dark field) using the MiCorr application. The characteristics of the strata are only accessible by clicking on the drawing that redirects you to the search tool by stratigraphy representation. This representation can be compared to Fig. 8, Credit HE-Arc CR.
