AIRCRAFT REAR FASTENING PLATE VHS-497 - AL ALLOY - MODERN TIMES

Artefact name	Aircraft rear fastening plate VHS-497
Authors	Marianne. Senn (Empa, Dübendorf, Zurich, Switzerland) & Christian. Degrigny (HE-Arc CR, Neuchâtel, Neuchâtel, Switzerland)
Url	/artefacts/916/

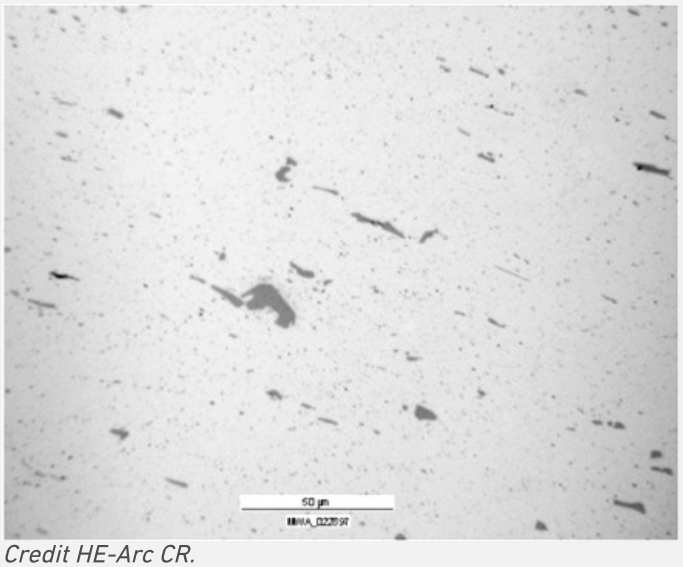
The metal is a relatively pure aluminium alloy with numerous inclusions (Table 1). From the chemical composition of the inclusions they can be interpreted as alpha-AlFeSi intermetallic compounds. In bright field we observe elongated inclusions indicating that the metal was rolled (Fig. 4). The alloy composition is similar to an unalloyed primary aluminium (Al content between 99 and 99.8 mass%). The O content reflects the immediate oxidation of the metal and is not part of the alloy. After etching the organisation of inclusions in rows is more easily seen (Fig. 5). The SEM image shows large grains formed after annealing (Fig. 6). The average hardness of the metal is HV1 40.

Fig. 4: Micrograph of the metal sample from Fig. 3 (detail), unetched, bright field. The metal matrix is in white, the elongated inclusions in grey,

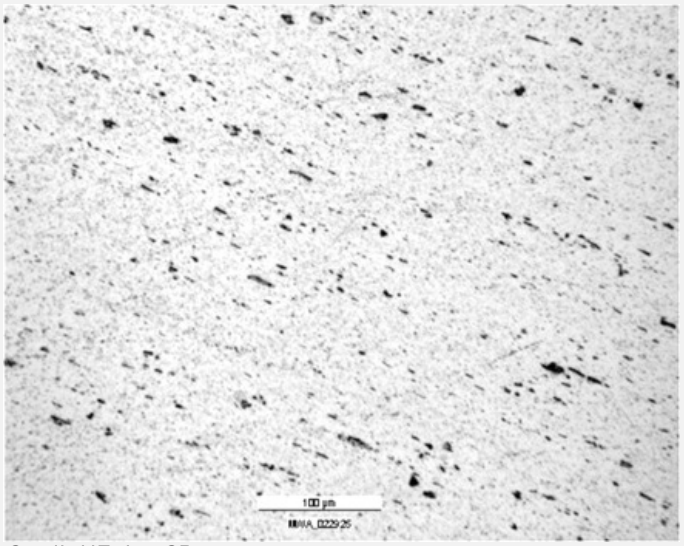
Fig. 5: Micrograph of the metal sample from Fig. 3 (detail), etched, bright field. The metal matrix is in white, the elongated inclusions in dark-grey and black,

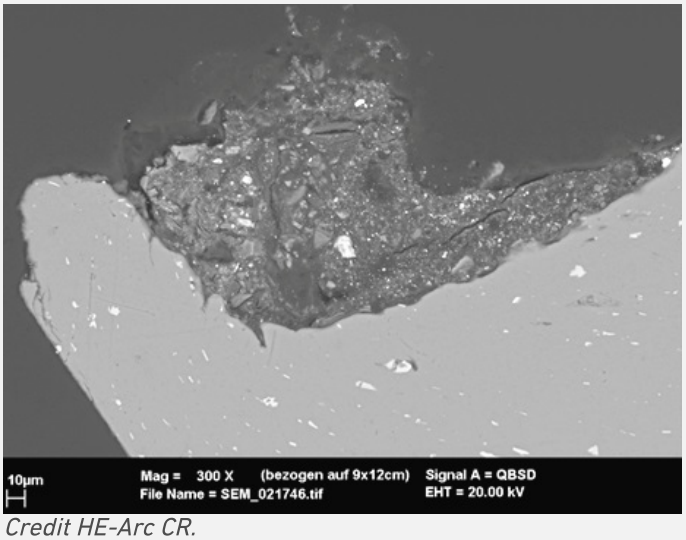
Fig. 9: SEM image (same as Fig. 7, inverted picture, detail), BSE-mode, unetched,

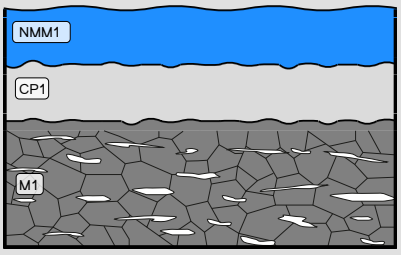
Fig. 11: Stratigraphic representation of the sample taken from the back fastening plate in cross-section (dark field) using the MiCorr application. The characteristics of the strata are only accessible by clicking on the drawing that redirects you to the search tool by stratigraphy representation. This representation can be compared to Fig. 8, Credit HE-Arc CR.
