AIRCRAFT FRONT FASTENING PLATE VHS-497 (2) - AL CU SN ZN SI ALLOY - MODERN TIMES

Artefact name	Aircraft front fastening plate VHS-497 (2)
Authors	Marianne. Senn (Empa, Dübendorf, Zurich, Switzerland) & Christian. Degrigny (HE-Arc CR, Neuchâtel, Neuchâtel, Switzerland)
Url	/artefacts/917/

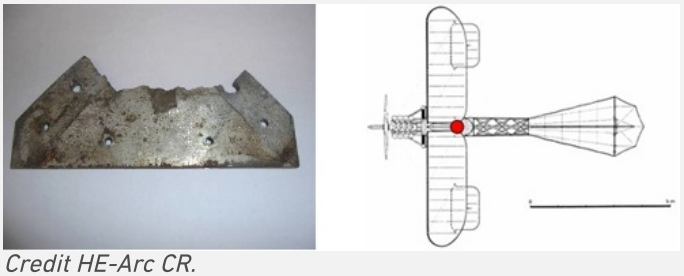
Fig. 1: Fastening plate from the front of the Dufaux IV (left) and top view of the aeroplane showing its location (red dot, right) (www.hepta.aero),

Description of the artefact	Metal fastening plate for the wooden construction of the front of the aeroplane, broken by use (Fig. 1) covered with a thin corrosion layer.
Type of artefact	Aeroplane part
Origin	Dufaux IV aeroplane
Recovering date	Biplane built by Henri and Armand Dufaux in 1909/10
Chronology category	Modern Times
chronology tpq	1909 A.D.
chronology taq	1910 A.D.
Chronology comment	
Burial conditions / environment	Outdoor to indoor atmosphere
Artefact location	Swiss Museum of Transport, Luzern, Lucerne

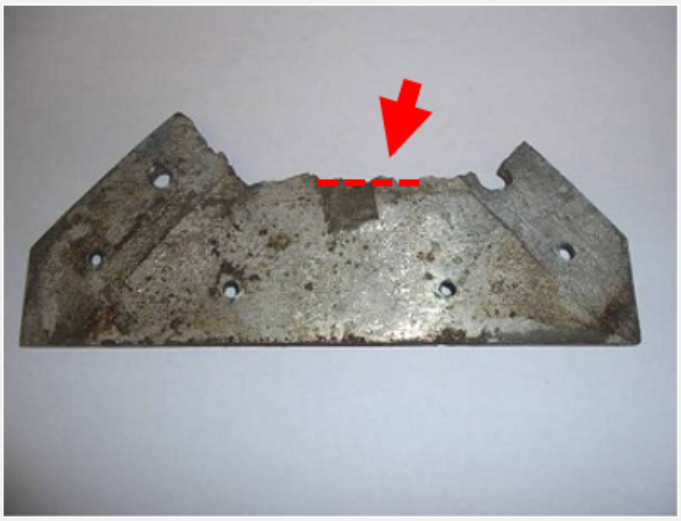
Fig. 2: Location of sampling area,

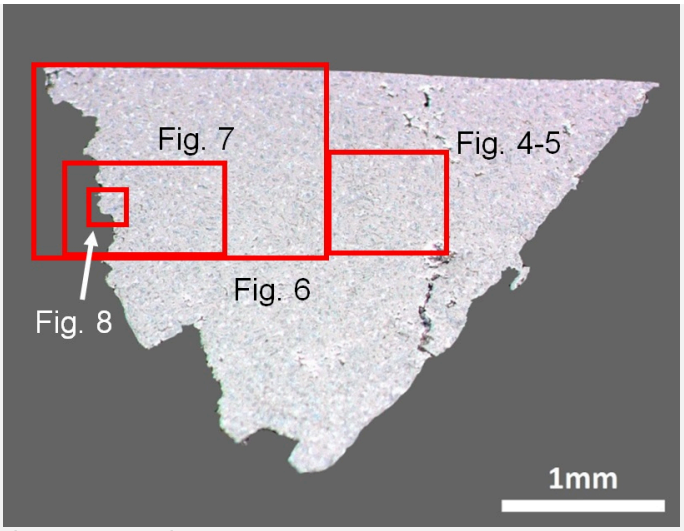
Fig. 3: Micrograph of the cross-section of the sample taken from the front fastening plate showing the location of Figs. 4 to 8,

Description of sample	The top part has been cut during sampling (Fig. 2). The more regular right side is the plate surface and the irregular side is the broken edge (Fig. 3). Dimensions: L = 4mm ; W = 4mm.
Alloy	Al Cu Sn Zn Si Alloy
Technology	As-cast
Lab number of sample	DUF-4
Sample location	HE-Arc CR, Neuchâtel, Neuchâtel
Responsible institution	Swiss Museum of Transport, Luzern, Lucerne
Date and aim of sampling	September 2007, metallography and alloy composition

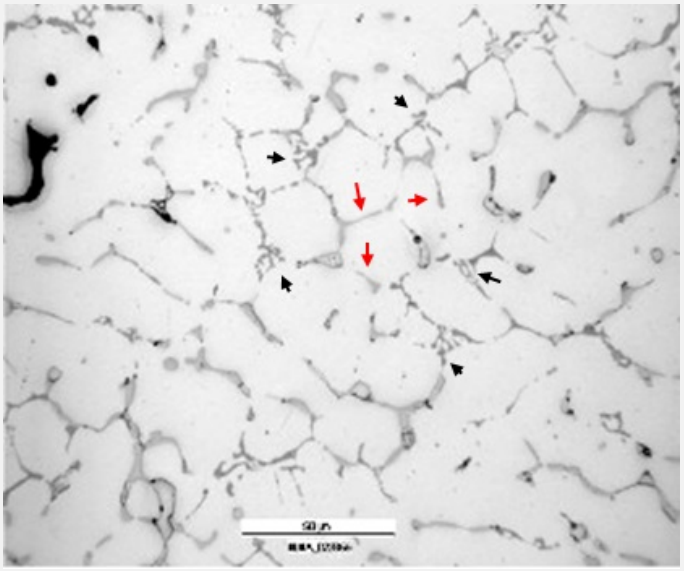
The metal is an aluminium alloy containing Cu, Sn, Zn and Si (Table 1). The unetched metal shows an as-cast structure consisting of the aluminium matrix with Sn (not soluble in Al) inclusions (Figs. 4 and 5), intermetallic compounds such as Al_2Cu (Fig. 4, red arrows) and clusters of Al,Fe,Cu & Si phases (Fig. 4, black arrows). There are porosities in the metal (Figs. 3 and 5). The average hardness of the metal is HV1 80.

Fig. 4: Micrograph of the metal sample from Fig. 3 (detail), unetched, bright field. The cast structure is revealed by light grey intermetallic compounds (Al2Cu, red arrows), dark-grey Al,Fe,Si & Cu phase clusters (black arrows) and Sn inclusions (nodules). On the top left some pores can be seen,

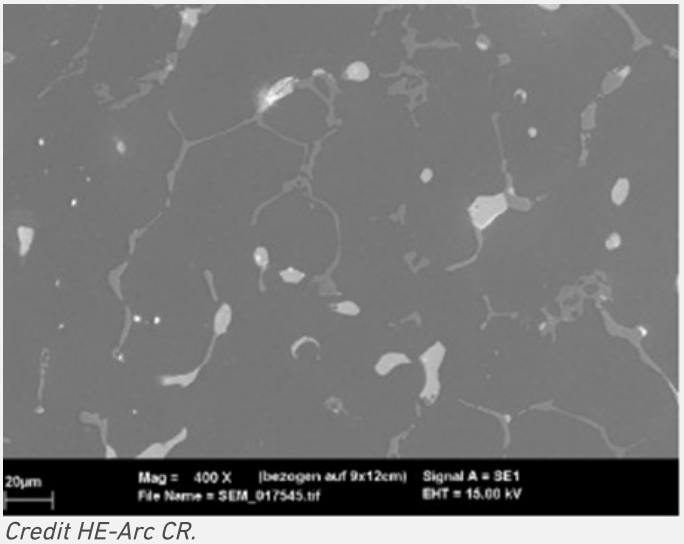
Fig. 5: SEM image of the metal sample from Fig. 3 (detail), SE-mode, unetched. We observe in dark-grey the metal matrix, in medium-grey the intermetallic compound Al2Cu as well as Al,Fe,Si & Cu phase clusters and in light-grey the Sn inclusions,

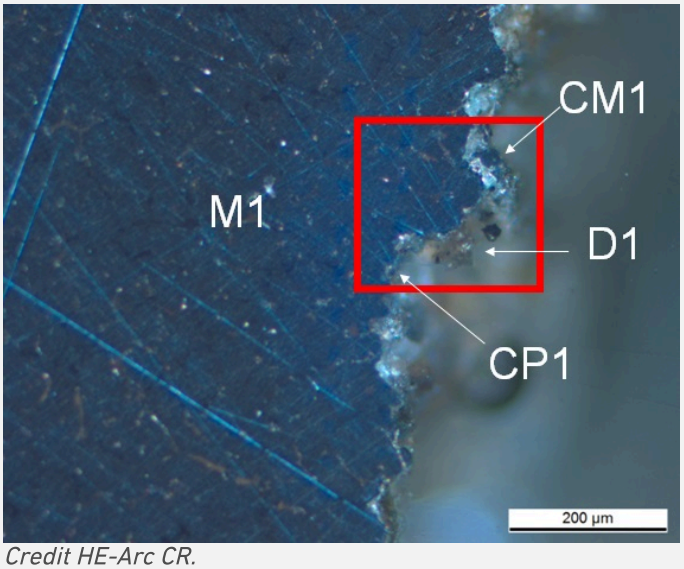
No corrosion layer can be seen on the metal surface (Figs. 3 and 6). Under polarized light small white and brown particles are visible on the broken edge (D1, Fig. 7). Their analysis reveals the presence of silica particles surrounded by dirt (Table 2 and Fig. 8). The metal surface is covered by a thin oxygen bearing skin (CP1, Fig. 8).

Fig. 6: Micrograph showing the metal - "corrosion products" interface from Fig. 3 (reversed picture, detail), unetched, bright field. We observe in white the metal matrix, in dark-grey Al,Fe, Si & Cu phase and light-grey Al2Cu intermetallic compounds. The micrograph of Fig. 7 is marked by a rectangle,

Fig. 7: Micrograph from Fig. 6 (detail) and corresponding to the stratigraphy of Fig. 9, unetched, polarised light. We observe in dark blue the metal matrix and blue-brown the adherent material. The area selected for elemental chemical distribution (Fig. 8) is marked by a rectangle,

Fig. 8: SEM image, BSE-mode, and elemental chemical distribution of the selected area from Fig. 7 (reversed picture, detail). Method of examination: SEM/EDS, Laboratory of Analytical Chemistry, Empa,

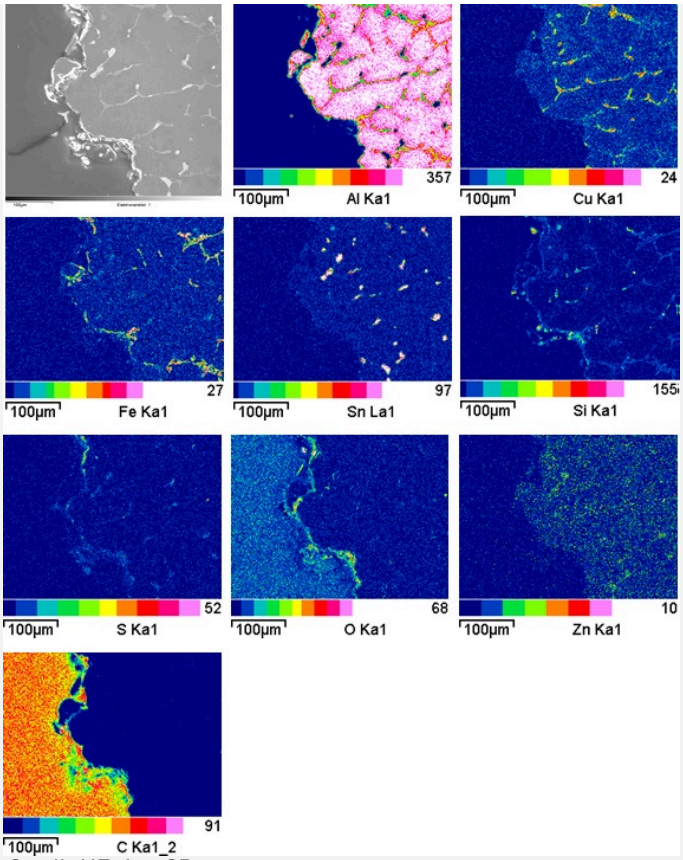
This front fastening plate of Dufaux IV plane is made in cast Al-Cu-Sn-Zn-Si, an alloy rather common at the beginning of the 20th century. No corrosion layer has been found on the metal surface except adherent silica-rich particles and the thin oxidised skin typical of Al alloys. The presence of these materials can be explained by the regular maintenance of the metal, probably using silicon carbide abrasive paper.

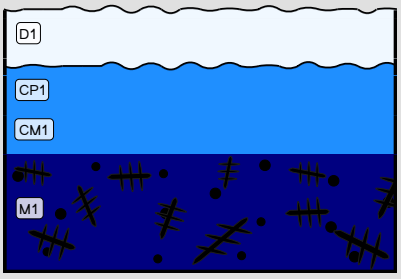
Fig. 9: Stratigraphic representation of the sample taken from the front fastening plate in cross-section (dark field) using the MiCorr application. The characteristics of the strata are only accessible by clicking on the drawing that redirects you to the search tool by stratigraphy representation. This representation can be compared to Fig. 7, Credit HE-Arc CR.
