AIRCRAFT FRONT FASTENING PLATE VHS-497 (2) - AL CU SN ZN SI ALLOY - MODERN TIMES

Artefact name	Aircraft front fastening plate VHS-497 (2)
Authors	Marianne. Senn (Empa, Dübendorf, Zurich, Switzerland) & Christian. Degrigny (HE-Arc CR, Neuchâtel, Neuchâtel, Switzerland)
Url	/artefacts/917/

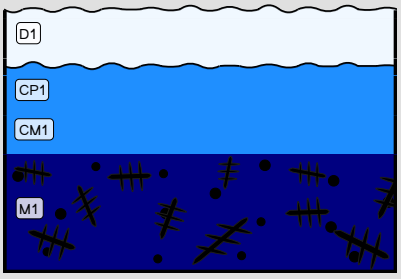
Fig. 9: Stratigraphic representation of the sample taken from the front fastening plate in cross-section (dark field) using the MiCorr application. The characteristics of the strata are only accessible by clicking on the drawing that redirects you to the search tool by stratigraphy representation. This representation can be compared to Fig. 7, Credit HE-Arc CR.
