BLADE FRAGMENT OF A WINGED AXE FK43 – TIN BRONZE – MIDDLE BRONZE AGE – SWITZERLAND

Artefact name	Blade fragment of a winged axe FK43
Authors	Marianne. Senn (Empa, Dübendorf, Zurich, Switzerland) & Christian. Degrigny (HE-Arc CR, Neuchâtel, Neuchâtel, Switzerland)
Url	/artefacts/918/

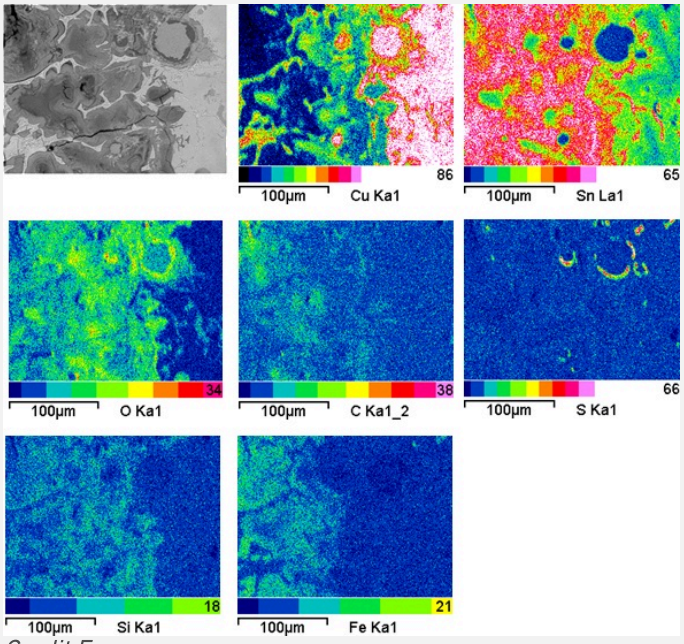
Table 3: Chemical composition (mass %) of the corrosion crust from Fig. 9. Method of analysis: SEM/EDS, Laboratory of Analytical Chemistry, Empa.

Fig. 9: SEM image, SE-mode, and elemental chemical distribution of the selected area of Fig. 6 (reversed picture rotated by 270°). Method of examination: SEM/EDS, Laboratory of Analytical Chemistry, Empa,

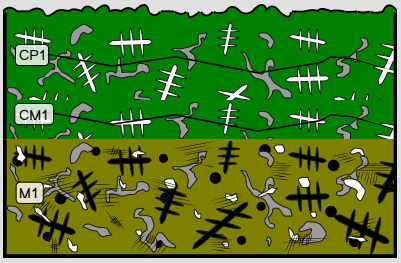
Fig. 11: Stratigraphic representation of the sample taken from the blade fragment of the winged axe in cross-section (dark field) using the MiCorr application. The characteristics of the strata are only accessible by clicking on the drawing that redirects you to the search tool by stratigraphy representation. This representation can be compared to Fig. 7, Credit HE-Arc CR.

The evenly corroded tin bronze contains numerous sulphide inclusions and shows signs of interdendritic corrosion penetrating the metal structure. The Sn enriched surface is decuprified and polluted by the environmental elements such as O, Si, Fe, C, Al (?) and Cl (?). The corrosion crust is composed mainly of a dark green layer with local orange-red cuprite aggregates at the interface with the remaining metal. Both the remnant metallic phases and the Sn-rich corrosion layer can be interpreted as inferior markers, defining the limit of the original surface which is located above. For the above mentioned reasons, the corrosion is thought to be of type 1 according to Robbiola et al. 1998.
