OVAL BRACELET WITH SURFACE DECORATIONS OF LINES AND INDENTATIONS MAH ANC. 2662 - LEADED BRONZE - LATE BRONZE AGE - SWITZERLAND

Artefact name	Oval bracelet with surface decorations of lines and indentations MAH anc. 2662
Authors	Marianne. Senn (Empa, Dübendorf, Zurich, Switzerland) & Christian. Degrigny (HE-Arc CR, Neuchâtel, Neuchâtel, Switzerland)
Url	/artefacts/920/

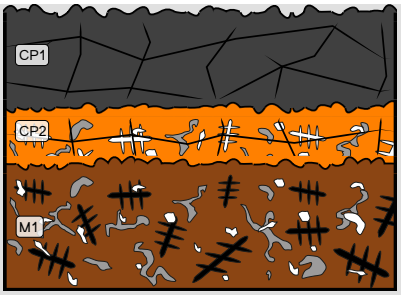
Fig. 8: Stratigraphic representation of the sample taken from the bracelet with a dense, black lake patina in cross-section (dark field) using the MiCorr application. The characteristics of the strata are only accessible by clicking on the drawing that redirects you to the search tool by stratigraphy representation. This representation can be compared to Fig. 6, Credit HE-Arc CR.

The surface of the cast leaded bronze has been replaced by a Fe/Sn-rich corrosion that retains a dendritic ghost structure. It is composed of a mixture of copper oxides (cuprite?) and a Sn-rich corrosion product (cassiterite?). The outer corrosion layer is composed of Fe-O and Sn-O-Fe areas depleted of Cu, but contaminated with Si. The enrichment in Fe seems to be the same as for the formation of patinas from lake contexts. However the outer corrosion layer was not formed in anaerobic conditions. Since the original surface is absent (destroyed) we refer to type corrosion 2 after Robbiola et al. 1998.
