FRAGMENT OF A BED STRUCTURE 03 12751-20.2.5 - TIN BRONZE - ROMAN TIMES - SWITZERLAND

Artefact name	Fragment of a bed structure 03 12751-20.2.5
Authors	Marianne. Senn (Empa, Dübendorf, Zurich, Switzerland) & Christian. Degrigny (HE-Arc CR, Neuchâtel, Neuchâtel, Switzerland)
Url	/artefacts/922/

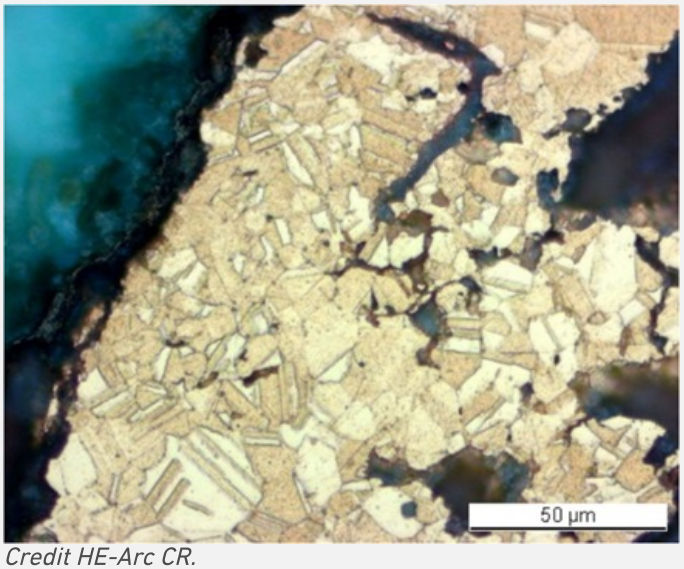
The remaining metal is a porous tin bronze (Table 1) with tiny iron oxides inclusions (Table 2) and secondary re-deposited copper. Intergranular corrosion has developed locally inside the metal (Figs. 4 and 5). The etched alloy shows a structure principally consisting of large polygonal grains, some of which include strain lines (Fig. 6). Locally an isolated alpha + delta eutectoid can be seen. Much smaller twinned grains can be found on the left side of the sample (Fig. 5). The average hardness of the metal is HV1 100. However on the left side of the sample, where the grains are smaller and twinned, the hardness is much higher (more cold work followed by annealing).

Fig. 5: Micrograph of the metal sample from Fig. 3 (detail of Fig. 4), etched, bright field. The metal shows a structure of mostly small polygonal grains with twins,

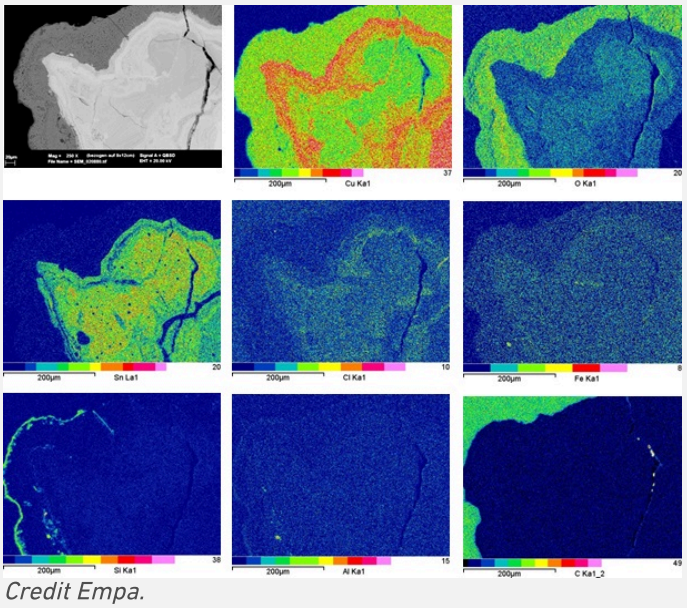
Fig. 8: SEM image, BSE-mode, and elemental chemical distribution of the selected area from Fig. 3 (reversed picture, detail). Method of examination: SEM/EDS, Laboratory of Analytical Chemistry, Empa,

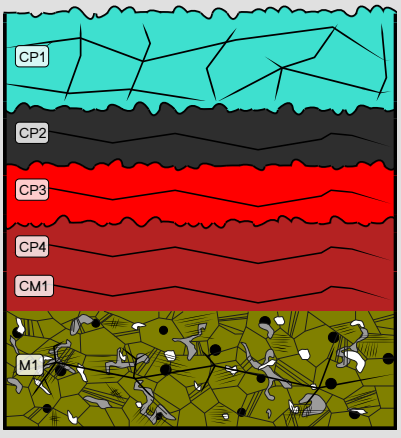
Fig. 12: Stratigraphic representation of the sample taken from the bed structure in cross-section (dark field) using the MiCorr application. The characteristics of the strata are only accessible by clicking on the drawing that redirects you to the search tool by stratigraphy representation. This representation can be compared to Fig. 7, Credit HE-Arc CR.
