FRAGMENT OF A BED STRUCTURE 03 12751-20.2.5 - TIN BRONZE - ROMAN TIMES - SWITZERLAND

Artefact name	Fragment of a bed structure 03 12751-20.2.5
Authors	Marianne. Senn (Empa, Dübendorf, Zurich, Switzerland) & Christian. Degrigny (HE-Arc CR, Neuchâtel, Neuchâtel, Switzerland)
Url	/artefacts/922/

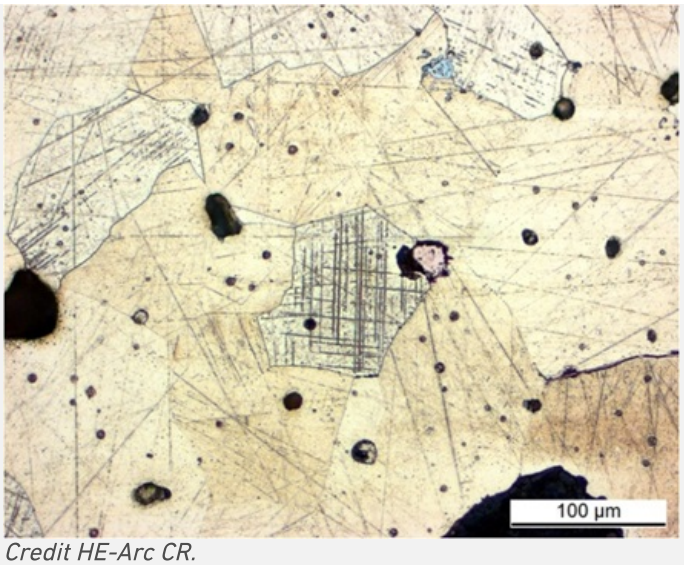
Fig. 6: Micrograph of the metal sample from Fig. 3, etched, bright field. The metal shows a structure consisting of large polygonal grains including strain lines. Pores are in black, remnants of the Sn-rich eutectoid phase in grey and secondary deposited copper in pink,

Microstructure	Large and small polygonal grains with few twins + strain lines
First metal element	Cu
Other metal elements	Sn

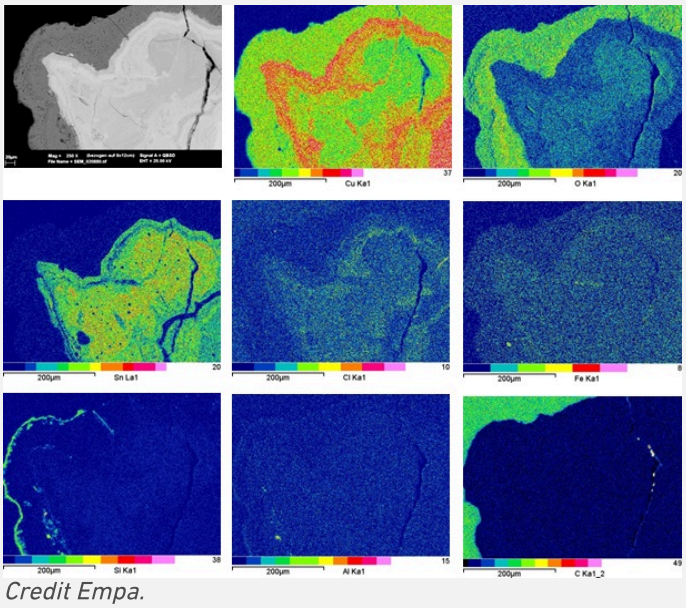
Fig. 8: SEM image, BSE-mode, and elemental chemical distribution of the selected area from Fig. 3 (reversed picture, detail). Method of examination: SEM/EDS, Laboratory of Analytical Chemistry, Empa,

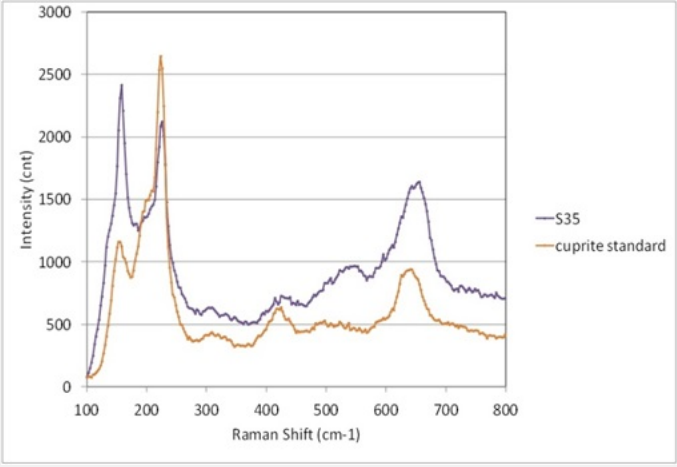
Fig. 9: Raman spectrum of CP3 (S35) from Fig. 7 compared to a cuprite standard spectrum. Settings: laser wavelength 532nm, acquisition time 20s, one accumulation, filter D2 (0.75-0.8mW), hole 1000, slit 100, grating 600. Method of analysis: Raman spectroscopy, Lab of Swiss National Museum, Affoltern a. Albis ZH,

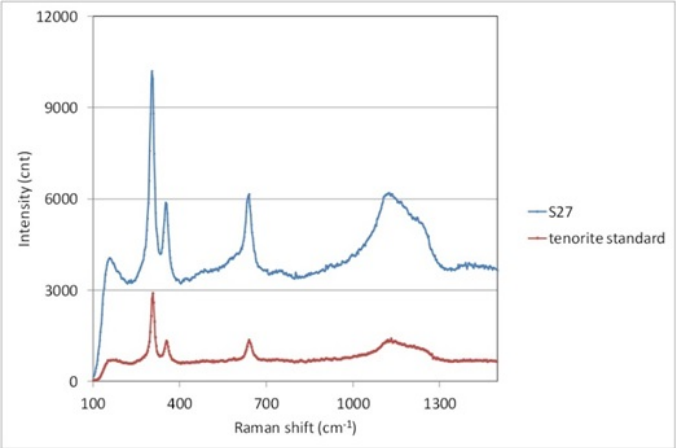
Fig. 10: Raman spectrum of the black layer (CP2) with pores (S27) from Fig. 7 compared to a tenorite standard spectrum. Settings: laser wavelength 532nm, acquisition time 100s, one accumulation, filter D1 (7.5-8mW), hole 500, slit 80, grating 600. Method of analysis: Raman spectroscopy, Lab of Swiss National Museum, Affoltern a. Albis ZH,

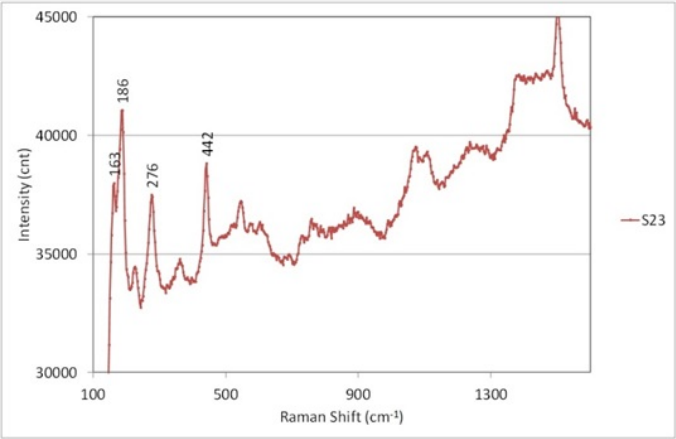
Fig. 11: Raman spectrum of the green outer corrosion layer (CP1) from Fig. 7. Settings: laser wavelength 532nm, acquisition time 80s, one accumulation, filter D2 (0.75-0.8mW), hole 500, slit 80, grating 600. Method of analysis: Raman spectroscopy, Lab of Swiss National Museum, Affoltern a. Albis ZH,

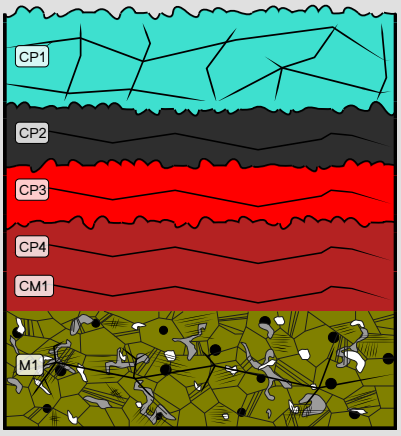
Fig. 12: Stratigraphic representation of the sample taken from the bed structure in cross-section (dark field) using the MiCorr application. The characteristics of the strata are only accessible by clicking on the drawing that redirects you to the search tool by stratigraphy representation. This representation can be compared to Fig. 7, Credit HE-Arc CR.
