BUST OF AN APPLIQUE 2005.054.F00265.1 - QUARTERNARY BRONZE ALLOY - ROMAN TIMES - SWITZERLAND

Artefact name Bust of an applique 2005.054.F00265.1

Authors Christian. Degrigny (HE-Arc CR, Neuchâtel, Neuchâtel, Switzerland) & Marie. Arnautou (HE-Arc CR, Neuchâtel, Neuchâtel, Switzerland) & Valentin. Boissonnas (HE-Arc CR, Neuchâtel, Neuchâtel, Switzerland)

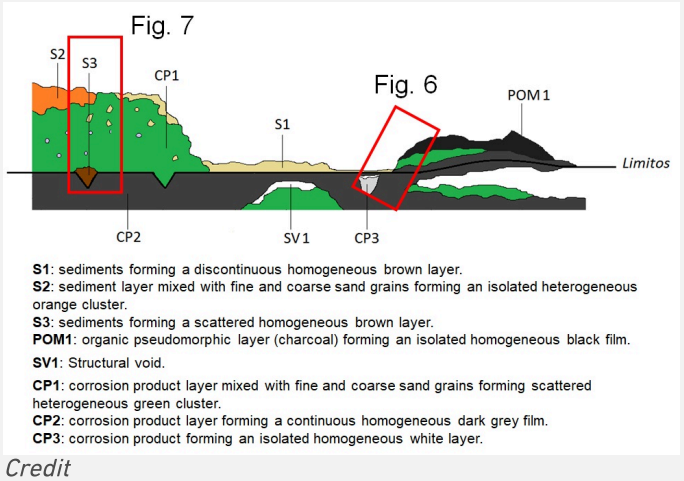
S1: sediments forming a discontinuous homogeneous brown layer.
S2: sediment layer mixed with fine and coarse sand grains forming an isolated heterogeneous orange cluster.
S3: sediments forming a scattered homogeneous brown layer.
POM1: organic pseudomorphic layer (charcoal) forming an isolated homogeneous black film.
SV1: Structural void.
CP1: corrosion product layer mixed with fine and coarse sand grains forming scattered heterogeneous green cluster.
CP2: corrosion product layer forming a continuous homogeneous dark grey film.
CP3: corrosion product forming an isolated homogeneous white layer.

Fig. 5: Stratigraphic representation based on visual observation and visualization of the stratigraphies of Figs. 6 and 7.

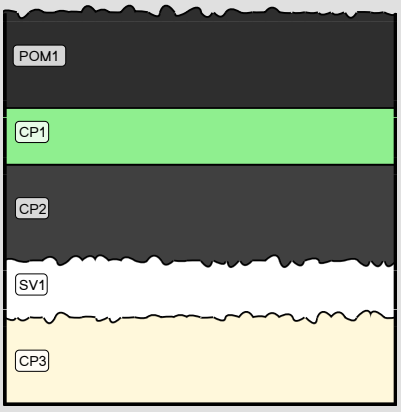
Fig. 6: Stratigraphic representation of the bust under binocular using the MiCorr application. The characteristics of the strata are only accessible by clicking on the drawing that redirects you to the search tool by stratigraphy representation. This representation can be compared to Fig. 5, Credit HE-Arc CR, C.Degrigny.

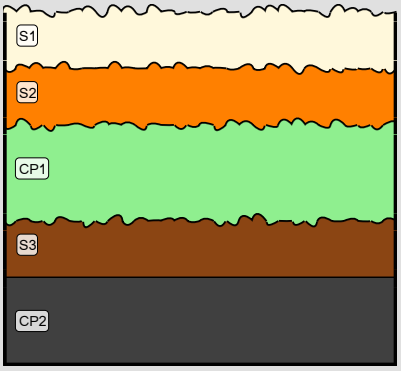
Fig. 7: Stratigraphic representation of the bust under binocular using the MiCorr application. The characteristics of the strata are only accessible by clicking on the drawing that redirects you to the search tool by stratigraphy representation. This representation can be compared to Fig. 5, Credit HE-Arc CR, C.Degrigny.
