DEFORMED FRAGMENT OF METAL SHEET WT10-M305 - TIN BRONZE - IRON AGE - SWITZERLAND

Artefact name Deformed fragment of metal sheet WT10-M305

Authors Marianne. Senn (EMPA, Dübendorf, Zurich, Switzerland) & Christian. Degrigny (HE-Arc CR, Neuchâtel, Neuchâtel, Switzerland)

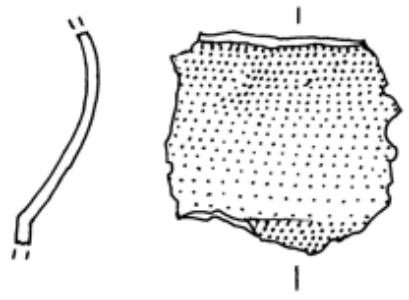
Fig. 1: Deformed fragment of metal sheet (section and front side) (after Department of Prehistory, University of Zurich),

Description of the artefact Deformed fragment of metal sheet with a dark green and grey powdery surface (patina) that might have been caused by exposure to high temperatures (Fig. 1). A green layer appears below the dark surface. Dimensions: L = 2.4cm; W = 2.3cm; WT = 4.8g.

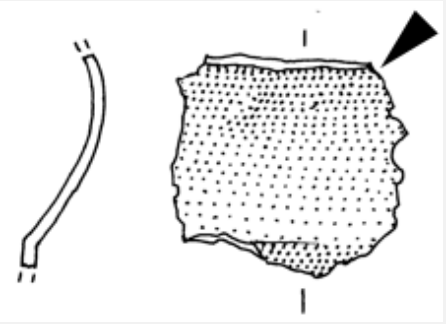
Fig. 2: Location of sampling area,

Description of sample	The sample is a section from the top right corner of the sheet (Fig. 2). Its dimensions are: L = 2.5mm and W = 2.3mm. The metal is surrounded on three sides by corrosion products. Intergranular corrosion has developed throughout the metal section (Fig. 3).
Alloy	Tin Bronze
Technology	Secondary recrystallization (produced by burning) after cold working
Lab number of sample	MAH 92-5-2-003
Sample location	Musées d'art et d'histoire, Genève, Geneva
Responsible institution	Musées d'art et d'histoire, Genève, Geneva
Date and aim of sampling	1992, examination of the corrosion layer

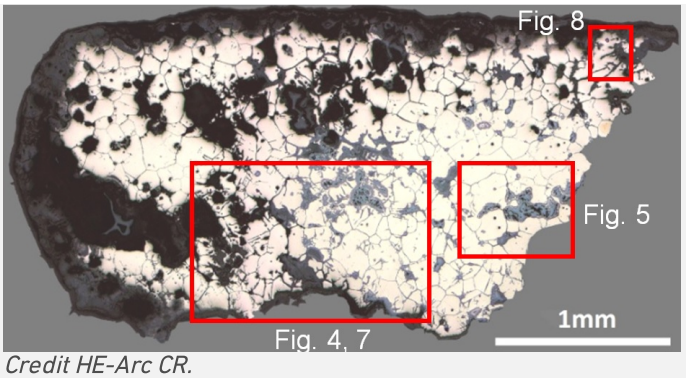
Fig. 3: Micrograph of the cross-section of the sample (Fig. 2) taken from the deformed fragment of metal sheet with dark green / grey patina showing the location of Figs. 4, 5, 7 and 8, unetched, bright field,

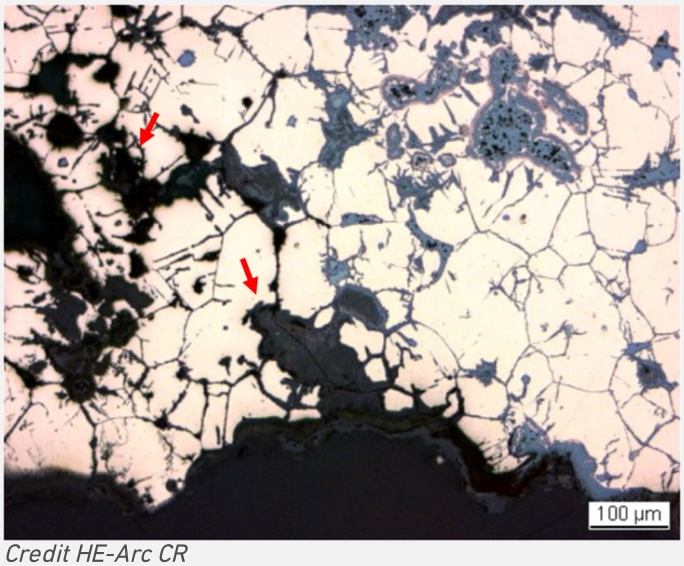
The remaining metal is a porous (red arrows on Fig. 4) tin bronze (Table 1). Five analyses were carried out. S was detected in the non-corroded part of the metal (2 measurements) while P was present only in the corroded metal (3 measurements). As no major difference in the composition was observed (comparison of relative standard deviation,

RSD) all analyses were used to calculate the median value. Inter- and transgranular corrosion has developed so extensively that all grain boundaries and twin lines are outlined (Fig. 4). After etching, the metal shows annealed polygonal grains with a few twins and slip lines below the surface (Fig. 5). The slip lines are restricted to the right side of the sample where the metal is best preserved (Fig. 4). The grain size varies between 50 and 170µm, due to an excessively long or hot annealing procedure leading to a grain coarsening. Small copper sulphide inclusions appear in blue (Fig. 4). The average hardness of the metal is HV1 90.

Fig. 4: Micrograph of the metal sample from Fig. 3 (detail), unetched, bright field. Extensive inter- and transgranular corrosion has developed within the metal. Possible large pores are visible (arrows) inside the remaining metal,

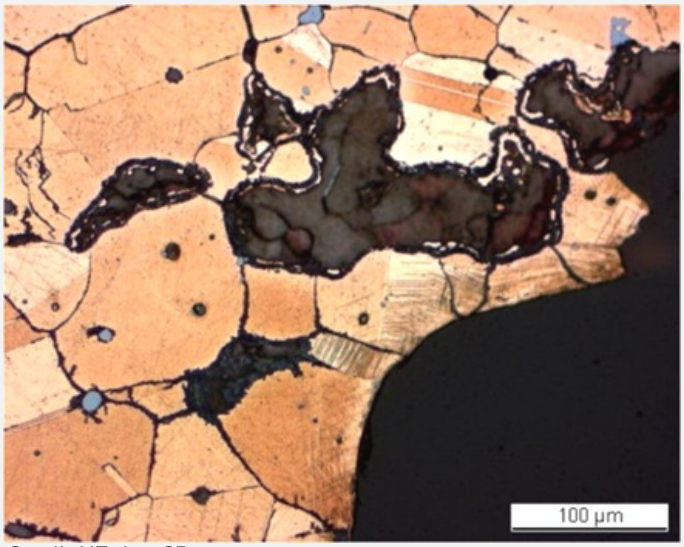
Fig. 5: Micrograph of the metal sample from Fig. 3 (detail), etched, bright field. We observe pink-orange polygonal grains with twins and slip lines as well as copper sulphide inclusions (in blue),

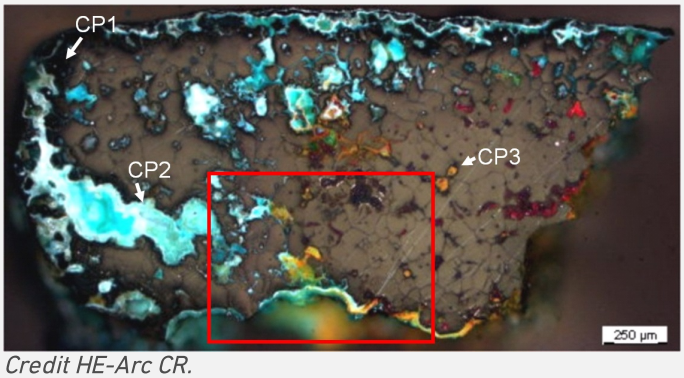
Fig. 6: Micrograph of the cross-section of the metal sample (same as Fig. 3) and corresponding to the stratigraphy of Fig. 10, polarised light, showing the location of Fig. 7,

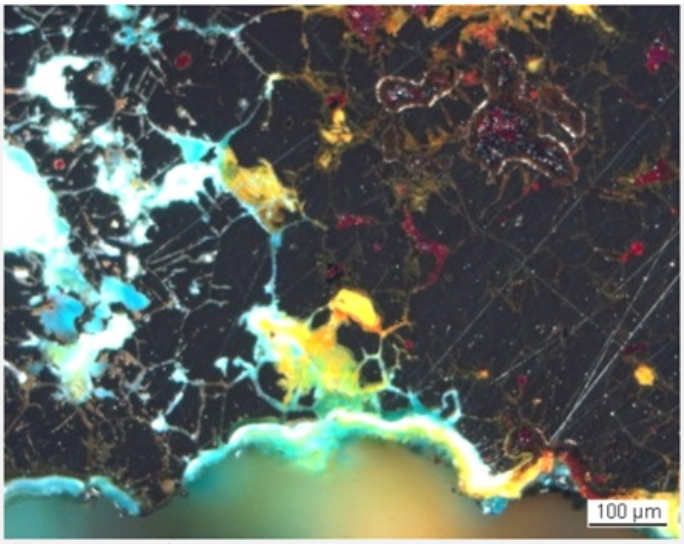
Elements	O	Cu	Sn	Si	Fe	P	As	Total
CP1, outer dark-grey corrosion layer. Fig 7	34	16	49	<	3.4	3.0	0.86	108
CP2, blue-green middle corrosion layer. Fig. 7	40	21	41	1.4	<	1.7	0.58	106
CP3, Red corrosion product (average of 2 similar analyses). Fig. 7	11	95	<	<	<	<	<	106
CP3, Orange corrosion product (average of 2 similar analyses). Fig. 7	24	54	30	0.6	<	<	0.59	109
Blue-green corrosion product. Fig. 8	32	21	51	1.1	<	<	1.0	106
Blue-green inner corrosion layer. Fig. 8	34	22	39	0.8	<	1.4	<	98

Fig. 7: Micrograph of the metal sample (same as Fig. 4), polarised light. In black the metal. Blue-green, orange and red corrosion products are found in the porous metal and along the grain boundaries,

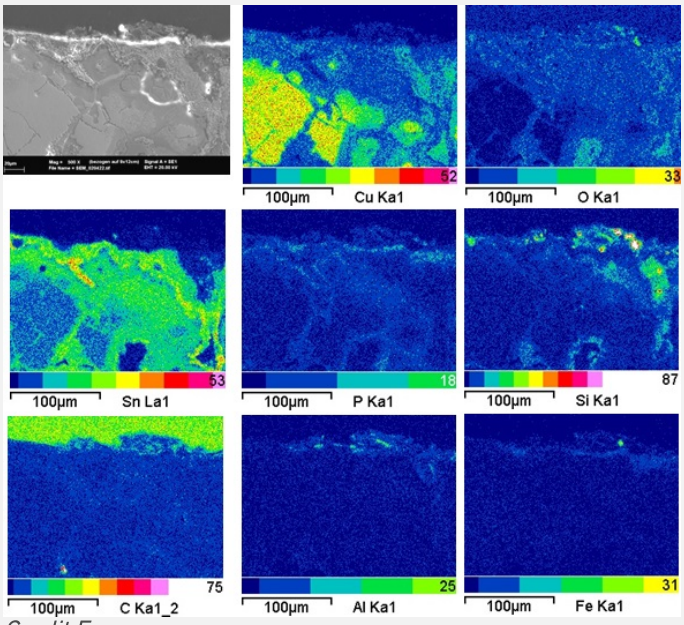
Fig. 8: SEM image, SE-mode, and elemental chemical distribution of the selected area from Fig. 3. Method of examination: SEM/EDS, Laboratory of Analytical Chemistry, Empa,

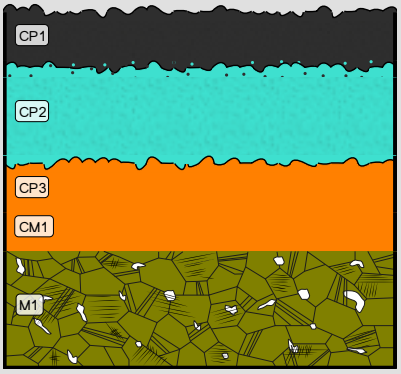
Fig. 10: Stratigraphic representation of the sample taken from the deformed fragment of metal sheet with dark green / grey patina in cross-section (dark field) using the MiCorr application. The characteristics of the strata are only accessible by clicking on the drawing that redirects you to the search tool by stratigraphy representation. This representation can be compared to Fig. 6, Credit HE-Arc CR.
