DEFORMED FRAGMENT OF METAL SHEET WT10-M305 - TIN BRONZE - IRON AGE - SWITZERLAND

Artefact name Deformed fragment of metal sheet WT10-M305

Authors Marianne. Senn (EMPA, Dübendorf, Zurich, Switzerland) & Christian. Degrigny (HE-Arc CR, Neuchâtel, Neuchâtel, Switzerland)

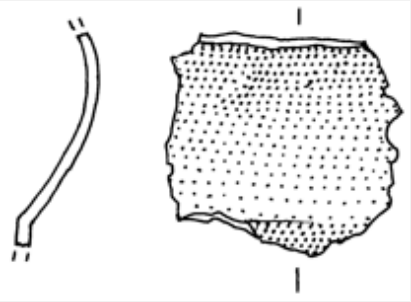
Fig. 1: Deformed fragment of metal sheet (section and front side) (after Department of Prehistory, University of Zurich),

Description of the artefact Deformed fragment of metal sheet with a dark green and grey powdery surface (patina) that might have been caused by exposure to high temperatures (Fig. 1). A green layer appears below the dark surface. Dimensions: L = 2.4cm; W = 2.3cm; WT = 4.8g.

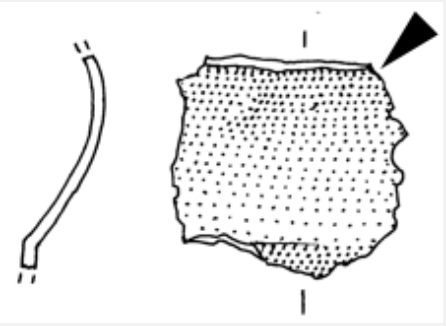
Fig. 2: Location of sampling area,

Description of sample	The sample is a section from the top right corner of the sheet (Fig. 2). Its dimensions are: L = 2.5mm and W = 2.3mm. The metal is surrounded on three sides by corrosion products. Intergranular corrosion has developed throughout the metal section (Fig. 3).
Alloy	Tin Bronze
Technology	Secondary recrystallization (produced by burning) after cold working
Lab number of sample	MAH 92-5-2-003
Sample location	Musées d'art et d'histoire, Genève, Geneva
Responsible institution	Musées d'art et d'histoire, Genève, Geneva
Date and aim of sampling	1992, examination of the corrosion layer

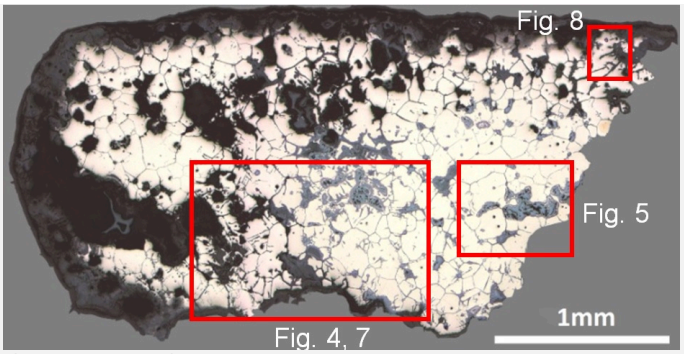
Fig. 3: Micrograph of the cross-section of the sample (Fig. 2) taken from the deformed fragment of metal sheet with dark green / grey patina showing the location of Figs. 4, 5, 7 and 8, unetched, bright field,

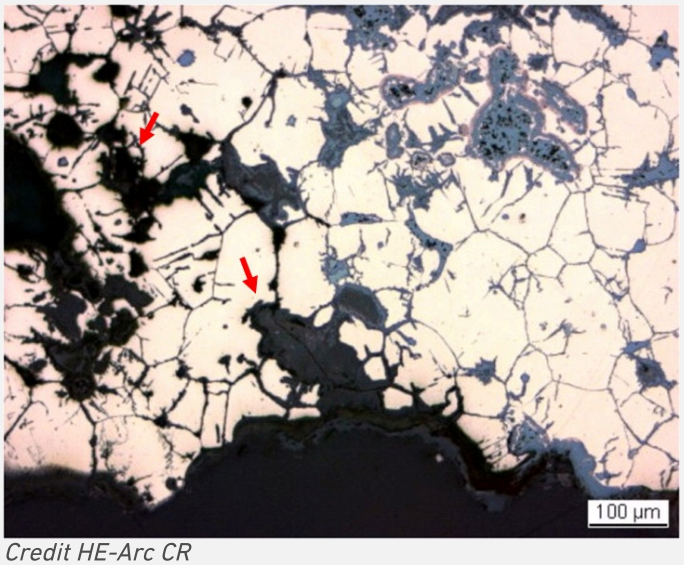
The remaining metal is a porous (red arrows on Fig. 4) tin bronze (Table 1). Five analyses were carried out. S was detected in the non-corroded part of the metal (2 measurements) while P was present only in the corroded metal (3 measurements). As no major difference in the composition was observed (comparison of relative standard deviation,

RSD) all analyses were used to calculate the median value. Inter- and transgranular corrosion has developed so extensively that all grain boundaries and twin lines are outlined (Fig. 4). After etching, the metal shows annealed polygonal grains with a few twins and slip lines below the surface (Fig. 5). The slip lines are restricted to the right side of the sample where the metal is best preserved (Fig. 4). The grain size varies between 50 and 170µm, due to an excessively long or hot annealing procedure leading to a grain coarsening. Small copper sulphide inclusions appear in blue (Fig. 4). The average hardness of the metal is HV1 90.

Fig. 4: Micrograph of the metal sample from Fig. 3 (detail), unetched, bright field. Extensive inter- and transgranular corrosion has developed within the metal. Possible large pores are visible (arrows) inside the remaining metal,

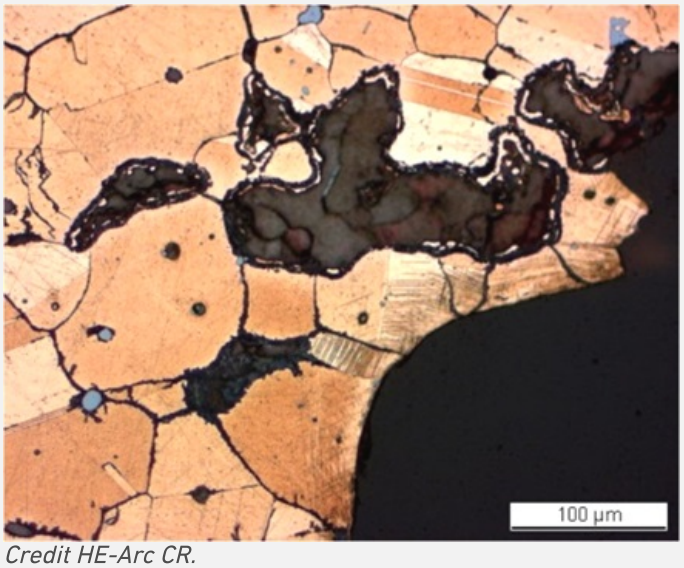
Fig. 5: Micrograph of the metal sample from Fig. 3 (detail), etched, bright field. We observe pink-orange polygonal grains with twins and slip lines as well as copper sulphide inclusions (in blue),

Microstructure	Large polygonal grains with few twins + strain lines
First metal element	Cu

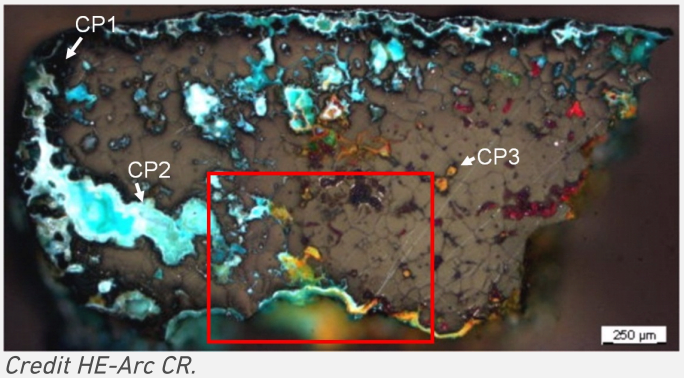
The corrosion crust varies in thickness between 60 and 150µm (Fig. 3). In bright field, it appears dark-grey (Fig. 4) and consists of two layers (CP1 and CP2). The inner layer is dark-grey and dense while the thin outer layer is slightly lighter coloured. Within the metal, the corrosion products are light-grey (CP3, Fig. 4). Under polarized light, the corrosion layer turns blue-green with dark-blue areas (Figs. 6 and 7) whereas corrosion products inside the metal are either light-blue or red-orange (Figs. 6 and 7). The red corrosion products (CP3) have the composition of cuprite/Cu2O while the orange compounds (also CP3) are enriched in Sn (Table 2). The blue-green corrosion products (CP2) both within the remaining metal and on the surface are even richer in Sn and O, and contain some P (Table 2 and Fig. 8). The thin, irregular dark-grey surface layer (CP1) is enriched in P, Fe, Si and Al (Table 2 and Fig. 8). XRD analyses of powdery particles sampled from the thin, dark surface corrosion layer (CP1) indicate the presence of tenorite/CuO and cassiterite/SnO2 (Museum report 1992). The Raman spectra of this layer (Fig. 9) confirmed the presence of tenorite.

Fig. 6: Micrograph of the cross-section of the metal sample (same as Fig. 3) and corresponding to the stratigraphy of Fig. 10, polarised light, showing the location of Fig. 7,

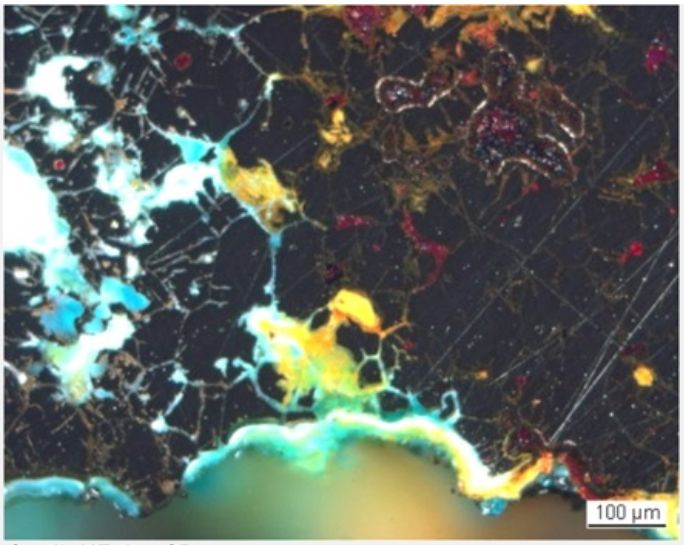
Fig. 7: Micrograph of the metal sample (same as Fig. 4), polarised light. In black the metal. Blue-green, orange and red corrosion products are found in the porous metal and along the grain boundaries,

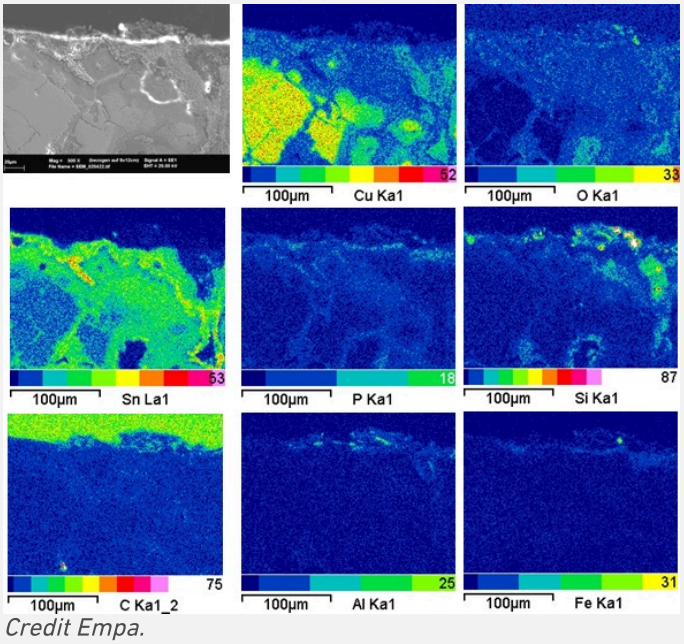
Fig. 8: SEM image, SE-mode, and elemental chemical distribution of the selected area from Fig. 3. Method of examination: SEM/EDS, Laboratory of Analytical Chemistry, Empa,

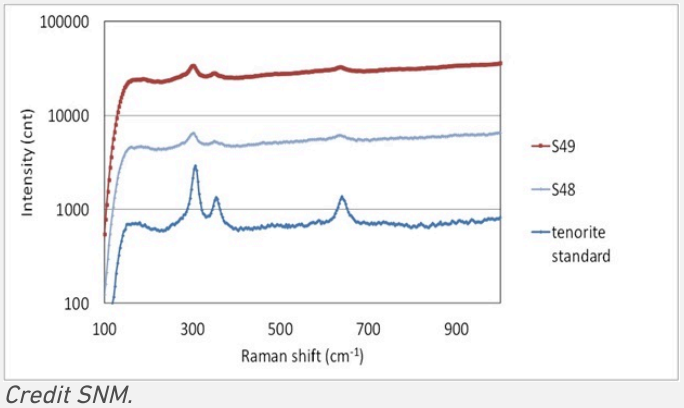
Fig. 9: Raman spectra of the outer dark corrosion layer (S48 and S49) compared to a tenorite standard spectrum. Settings: laser wavelength 532nm, acquisition time 20s for S48 and 100s for S49, one accumulation, filter D1 (7.5-8mW), hole 500, slit 80, grating 600. Method of analysis: Raman spectroscopy, Lab of Swiss National Museum, Affoltern a. Albis ZH,

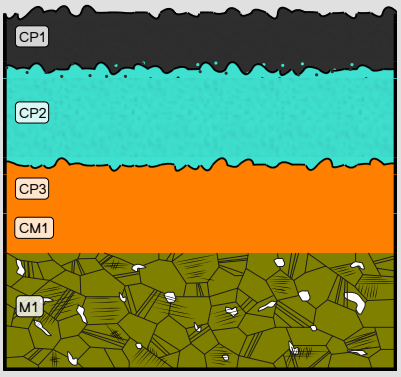
Corrosion form	Uniform - intergranular
Corrosion type	Mostly type II with locally type I (Robbiola)

Fig. 10: Stratigraphic representation of the sample taken from the deformed fragment of metal sheet with dark green / grey patina in cross-section (dark field) using the MiCorr application. The characteristics of the strata are only accessible by clicking on the drawing that redirects you to the search tool by stratigraphy representation. This representation can be compared to Fig. 6, Credit HE-Arc CR.
