HEADREST OR HORSE BIT VFIG 2003.7 - LEADED BRONZE - MODERN TIMES

Artefact name Headrest or horse bit VFig 2003.7

Authors Barbezat. Nadège (HE-Arc CR, Neuchâtel, Neuchâtel, Switzerland) & Christian. Degrigny (HE-Arc CR, Neuchâtel, Neuchâtel, Switzerland) & Valentin. Boissonnas (HE-Arc CR, Neuchâtel, Neuchâtel, Switzerland)

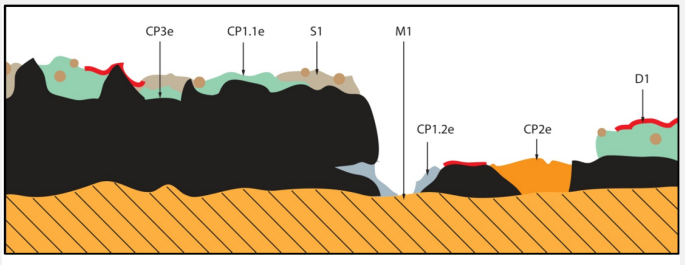
Fig. 3: Stratigraphic representation of the artefact by macroscopic observation,

S1: soil (sand and limestone)
D1: red deposit
CP1.1e: outer light green-blue corrosion layer
CP1.2e: outer white-blue-grey corrosion layer
CP2e: outer orange corrosion layer
CP3e/i: outer/inner black brown corrosion layer
M1: metal

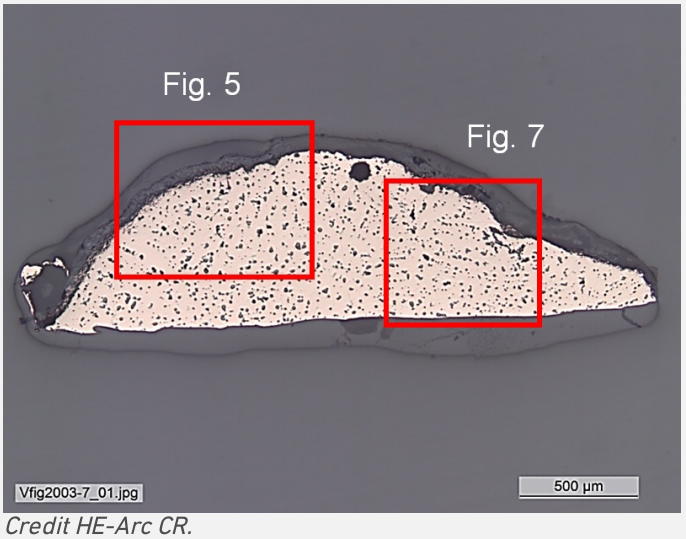
Fig. 4: Micrograph of the cross-section of sample from Fig. 2 of the headrest (or horse bit) showing the location of Figs. 5 and 7,

Description of sample	The sample was cut on the bottom of one of the plates (Fig. 2). On Fig. 4, the top and round shape of the sample is the outer part of the metal. It is covered with corrosion layers. The lower part of the sample corresponds to the cut metal with no corrosion products.
Alloy	Leaded Bronze
Technology	Cast and cold worked (with final annealing?)
Lab number of sample	None
Sample location	HE-Arc CR, Neuchâtel, Neuchâtel
Responsible institution	Bible & Orient Museum, Fribourg, Fribourg
Date and aim of sampling	2014, metallography and chemical analyses

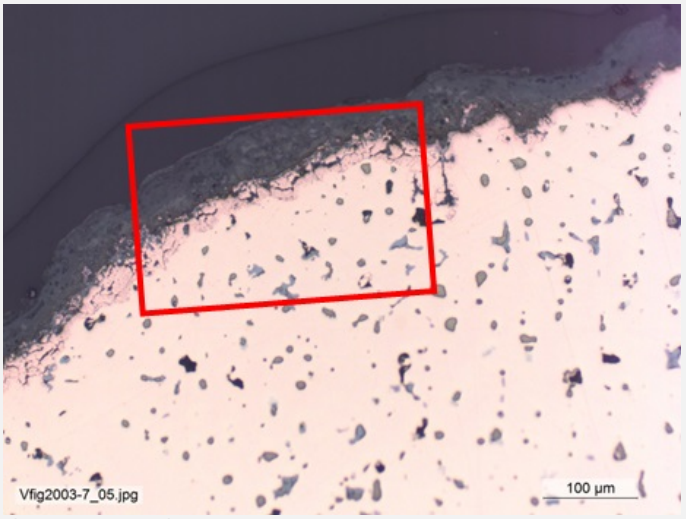
The remaining metal is a leaded bronze (Table 1) containing numerous copper sulphide and lead (Pb) inclusions (Figs. 5 and 6). The porosity is difficult to distinguish since the pores seem to have similar dimensions as the inclusions that could have been removed during the polishing of the sample (Fig. 5). After etching, the structure of the metal appears to be made up mostly of dendrites, but a grain structure seems to have developed on the right side of the sample, with occasional twin lines (Figs. 7 and 8). The twinned grain structure could be the result of cold work and annealing after casting, possibly through the application of an artificial patina under heat.

Fig. 5: Micrograph of the cross-section of sample from Fig. 2 of the headrest (or horse bit) (detail of Fig. 4), unetched, bright field. Light grey copper sulphide and tiny round Pb inclusions as well as "porosities" can be observed. Area of Fig. 9 is marked by a red rectangle,

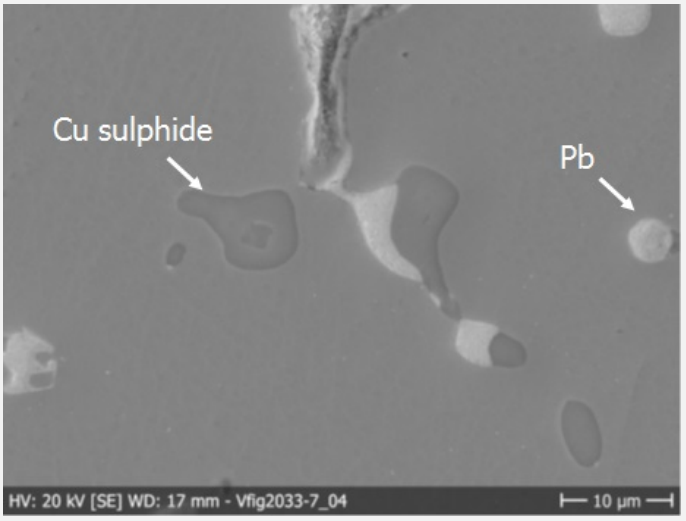
Fig. 6: SEM image (detail of Fig. 5), SE-mode, showing copper sulphide and lead inclusions,

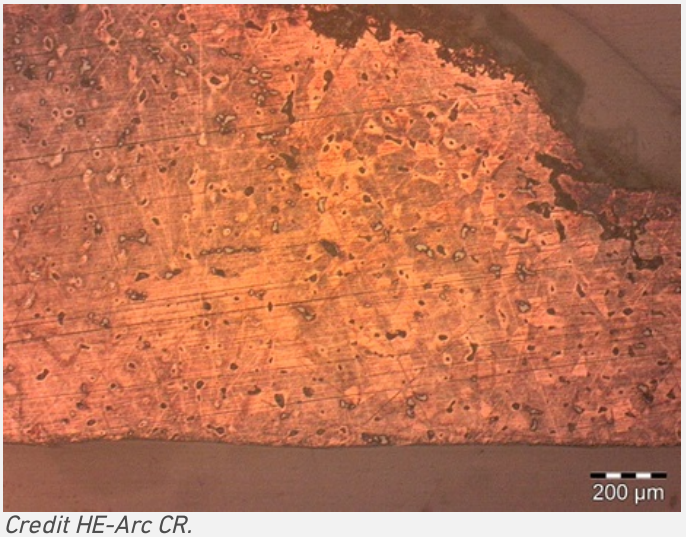
Fig. 7: Micrograph of the metal sample from Fig. 4 showing a dendritic structure and grains,

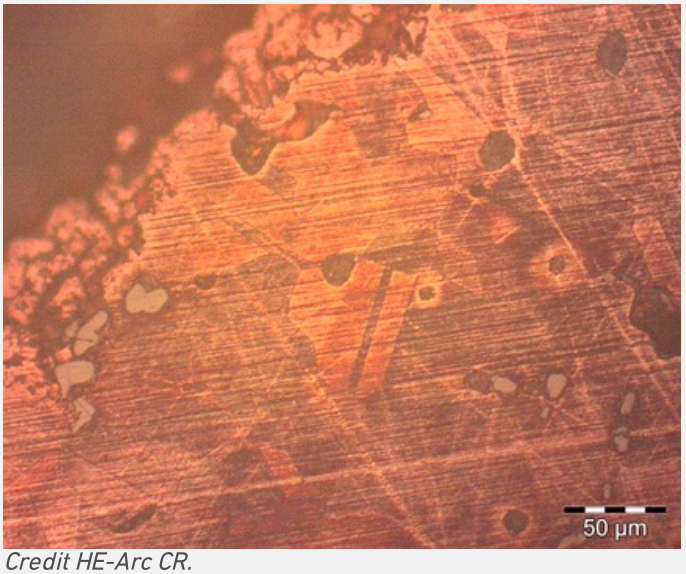
Fig. 8: Micrograph of a selected area of the metal sample showing grains and twin lines,

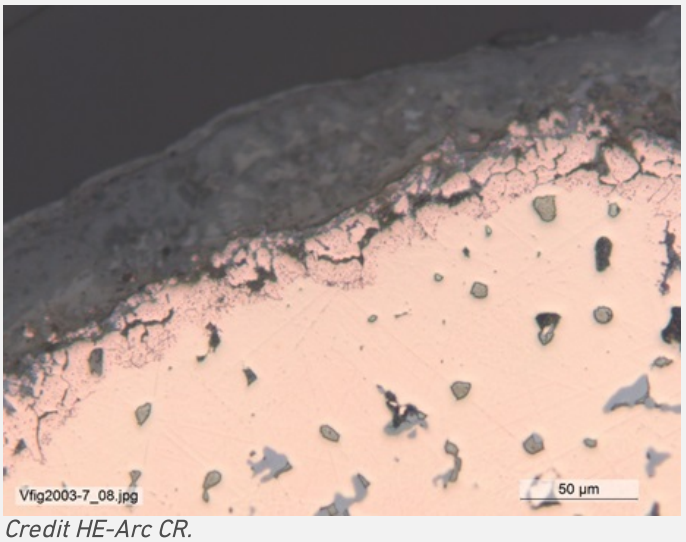
Fig. 9: Micrograph of the metal sample from Fig. 5, unetched, bright field,

The remaining metal seems to have developed intergranular corrosion at the interface metal / corrosion layer (Fig. 9) slightly enriched in Sn (Fig. 11). The outer green corrosion product (CP2) is matte, powdery and mixed with sediments. It looks regular on Figs. 9 and 10 (around 50µm). This corrosion layer is mainly composed of lead (and/or sulphur), oxygen, silicon, chlorine and is depleted in Cu (Fig. 11 and table 2) except in its top part (CP1) where it is Cl, Cu and O-rich (Fig. 11 and table 2). FTIR seems to indicate that it is constituted of atacamite ($Cu_2Cl(OH)_3$, Fig. 12). This is confirmed on the EDS spectra of figure 13 where Pb is clearly detected. The inner corrosion product (CP3) is a dark

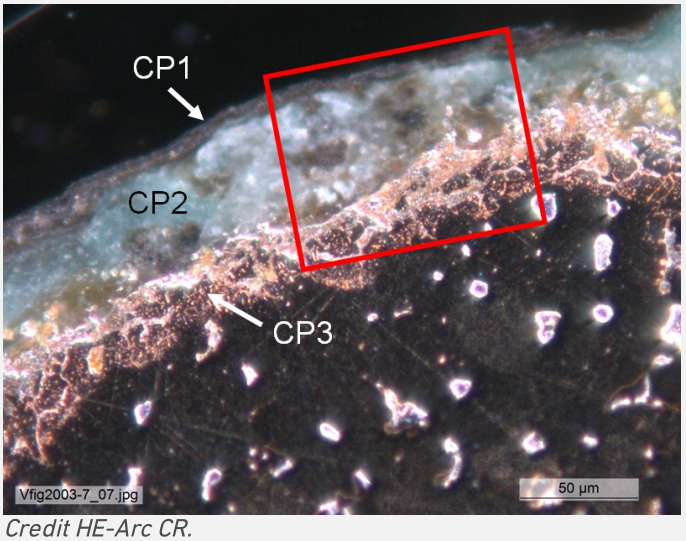
brown, matte layer (Figs. 2 and 10). It covers all the surface of the object, and forms a very thin layer. It is sulphur and oxygen-rich (Fig. 14). FTIR analysis could not reveal the presence of a specific corrosion product.

Fig. 10: Micrograph similar to Fig. 9 and corresponding to the stratigraphy of Fig. 15, polarised light. The area selected for elemental chemical distribution (Fig. 11) is marked by a red rectangle,

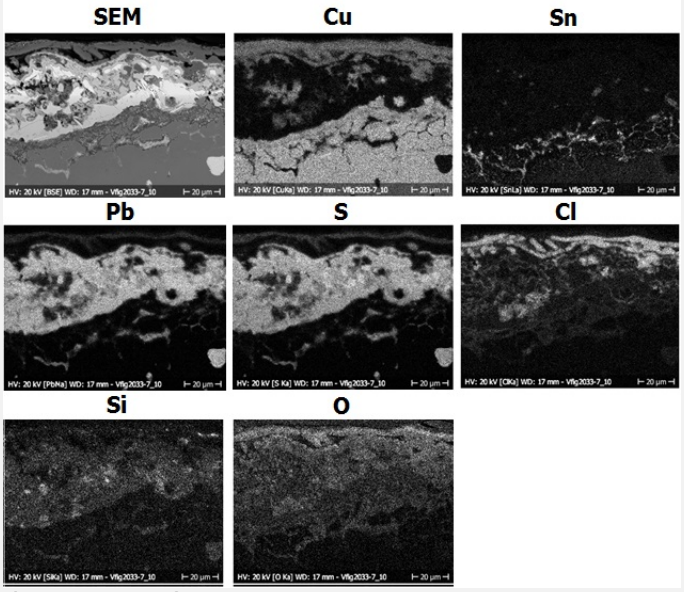
Fig. 11: SEM image, SE-mode, and elemental chemical distribution of the selected area of Fig. 10. Method of examination: SEM-EDS, Lab of Electronic Microscopy and Microanalysis, IMA (Néode), HEI Arc,

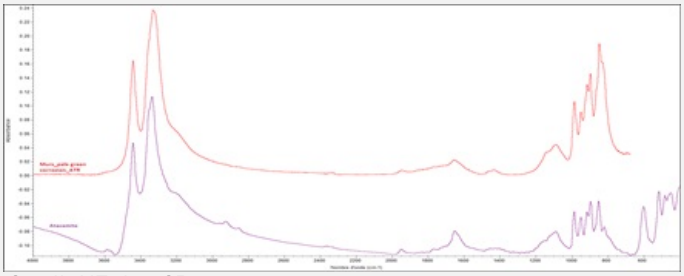
Fig. 12: FTIR spectrum (ATR mode) of the green corrosion powder and comparison to atacamite (purple) spectrum. Method of analysis: FTIR spectroscopy, HE- Arc CR,

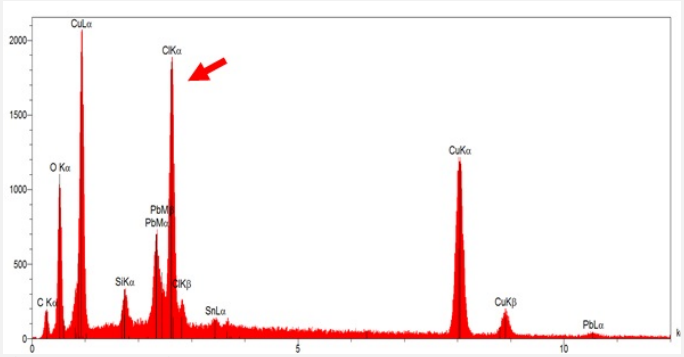
Fig. 13: EDS analysis of the green corrosion powder (Fig. 2). Method of analysis: SEM-EDS, Lab of Electronic Microscopy and Microanalysis, IMA (Néode), HEI Arc,

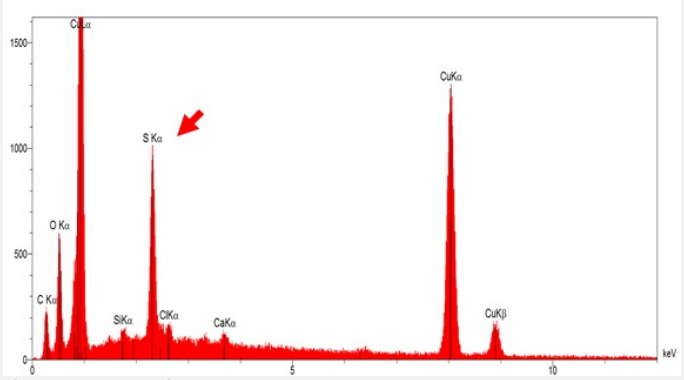
Fig. 14: EDS analysis of the black corrosion powder (Fig. 2). Method of analysis: SEM-EDS, Lab of Electronic Microscopy and Microanalysis, IMA (Néode), HEI Arc,

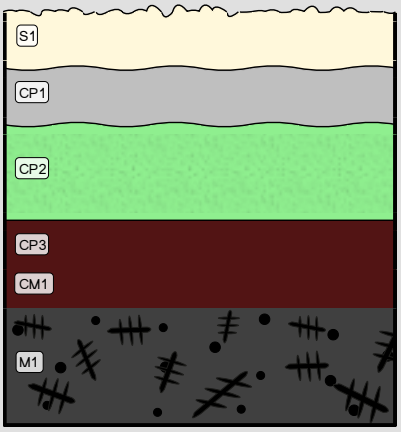
Fig. 15: Stratigraphic representation of sample from Fig. 2 of the headrest (or horse bit) in cross-section (dark field) using the MiCorr application. The characteristics of the strata are only accessible by clicking on the drawing that redirects you to the search tool by stratigraphy representation. This representation can be compared to Fig 10, Credit HE-Arc CR.

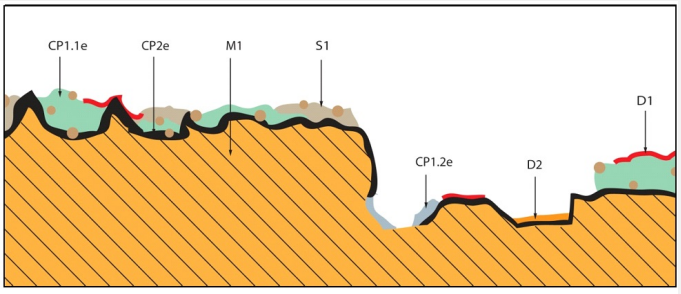
Fig. 16: Improved stratigraphic representation of the headrest from visual observations and analyses (additional mention e or i within the coding correspond to strata in contact with the environment (e) and internal strata (i),

The schematic representation of corrosion layers of Fig. 3 integrating additional information based on the analyses carried out is given in Fig. 16. A thin, black sulphur-rich layer covers the metal surface. A thick green layer has developed on top and seems to be constituted mainly of atacamite enriched in lead with sediments on top.

Strata	Composition
Sediments (**S1**)	Si, O
Deposits (**D1 & D2**)	?
Outer green corrosion product (CP1e) – **CP2**	Atacamite + Pb or S?
Inner black corrosion product (CP2i) – **CP3**	S ou Pb, Cu, O, a bit of Sn
Remnant metal phase (**M1**)	Bronze (85%Cu, 7%Sn, 5%Pb)
