HEADREST OR HORSE BIT VFIG 2003.7 - LEADED BRONZE - MODERN TIMES

Artefact name Headrest or horse bit VFig 2003.7

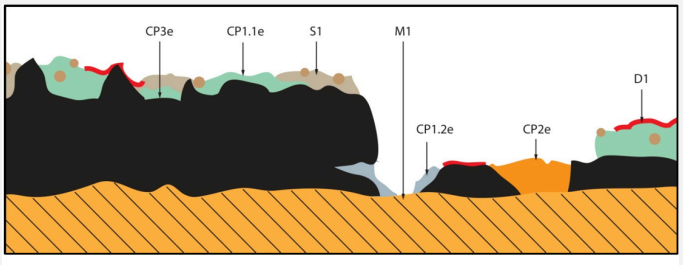
Fig. 3: Stratigraphic representation of the artefact by macroscopic observation,

S1: soil (sand and limestone)
D1: red deposit
CP1.1e: outer light green-blue corrosion layer
CP1.2e: outer white-blue-grey corrosion layer
CP2e: outer orange corrosion layer
CP3e/i: outer/inner black brown corrosion layer
M1: metal

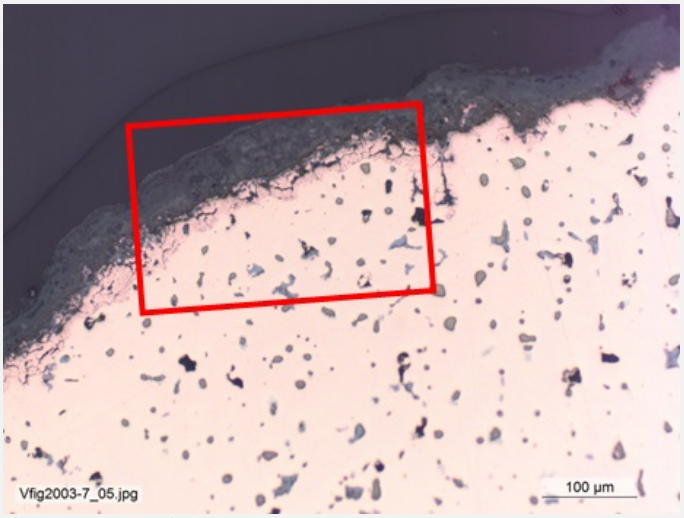
The remaining metal is a leaded bronze (Table 1) containing numerous copper sulphide and lead (Pb) inclusions (Figs. 5 and 6). The porosity is difficult to distinguish since the pores seem to have similar dimensions as the inclusions that could have been removed during the polishing of the sample (Fig. 5). After etching, the structure of the metal appears to be made up mostly of dendrites, but a grain structure seems to have developed on the right side of the sample, with occasional twin lines (Figs. 7 and 8). The twinned grain structure could be the result of cold work and annealing after casting, possibly through the application of an artificial patina under heat.

Fig. 5: Micrograph of the cross-section of sample from Fig. 2 of the headrest (or horse bit) (detail of Fig. 4), unetched, bright field. Light grey copper sulphide and tiny round Pb inclusions as well as “porosities” can be observed. Area of Fig. 9 is marked by a red rectangle,

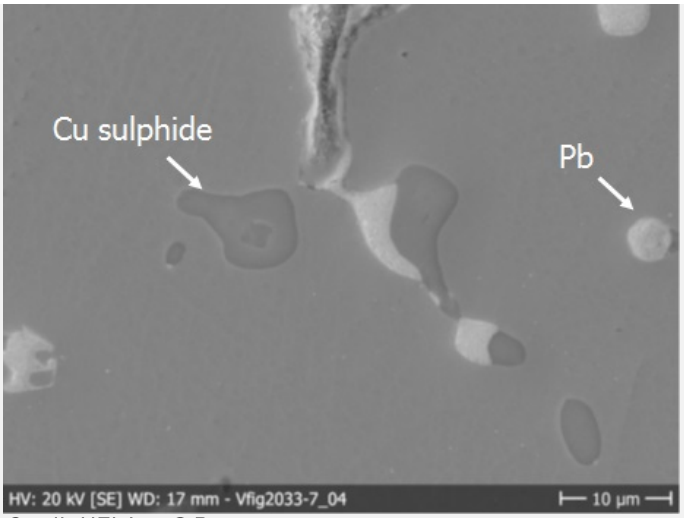
Fig. 6: SEM image (detail of Fig. 5), SE-mode, showing copper sulphide and lead inclusions,

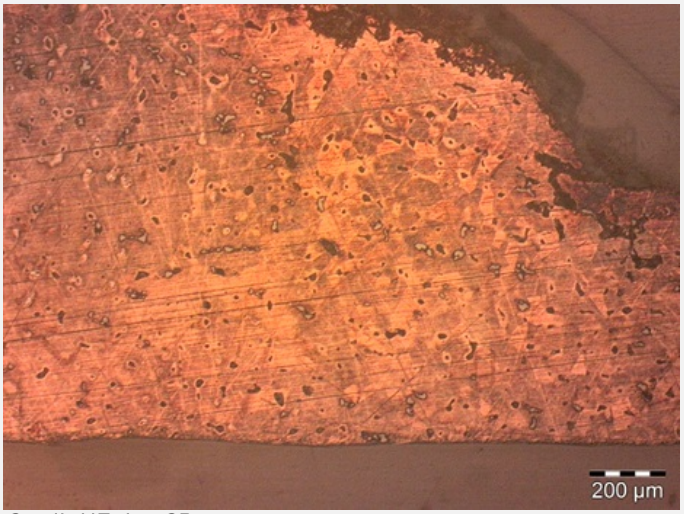
Fig. 7: Micrograph of the metal sample from Fig. 4 showing a dendritic structure and grains,

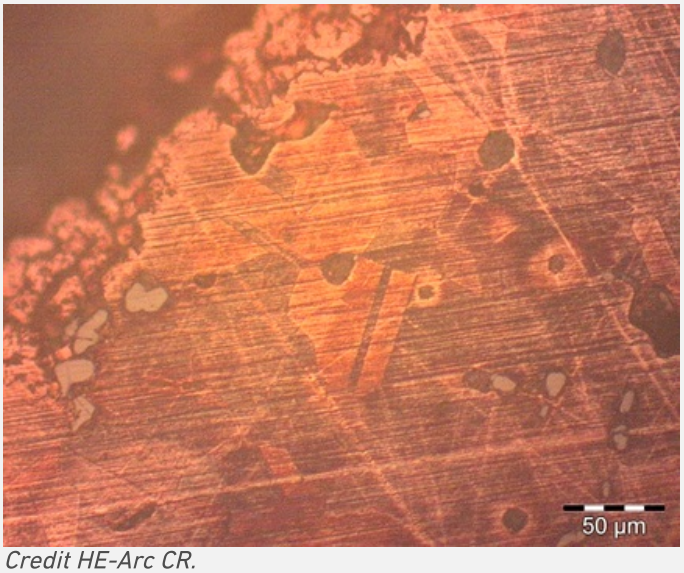
Fig. 8: Micrograph of a selected area of the metal sample showing grains and twin lines,

Microstructure	Dendritic structure & limited grain structure (with twin lines)
First metal element	Cu
Other metal elements	Sn, Pb

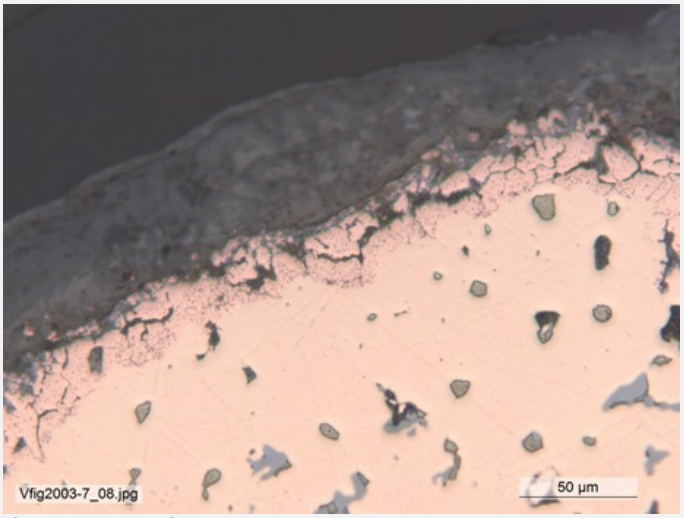
The remaining metal seems to have developed intergranular corrosion at the interface metal / corrosion layer (Fig. 9) slightly enriched in Sn (Fig. 11). The outer green corrosion product (CP2) is matte, powdery and mixed with sediments. It looks regular on Figs. 9 and 10 (around 50µm). This corrosion layer is mainly composed of lead (and/or sulphur), oxygen, silicon, chlorine and is depleted in Cu (Fig. 11 and table 2) except in its top part (CP1) where it is Cl, Cu and O-rich (Fig. 11 and table 2). FTIR seems to indicate that it is constituted of atacamite ($Cu_2Cl(OH)_3$, Fig. 12). This is confirmed on the EDS spectra of figure 13 where Pb is clearly detected. The inner corrosion product (CP3) is a dark brown, matte layer (Figs. 2 and 10). It covers all the surface of the object, and forms a very thin layer. It is sulphur and oxygen-rich (Fig. 14). FTIR analysis could not reveal the presence of a specific corrosion product.

Elements proportions	O	Si	Cl	Pb/S	Cu	Sn
Blue corrosion product (CP1)	++	(+)	+	++	+	nd
Green corrosion product (CP2)	+	++	(+)	++	(+)	nd
Remnant metal phase	nd	nd	nd	+	++	++

Table 2: Chemical composition of the corrosion crust from Fig. 10. Method of analysis: SEM-EDS, Lab of Electronic Microscopy and Microanalysis, IMA (Néode), HEI Arc (+++: high concentration, ++ medium concentration, + low concentration, nd: not-detected).

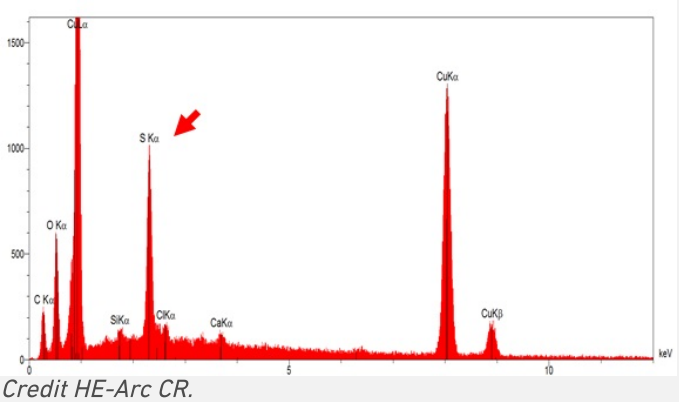
Fig. 13: EDS analysis of the green corrosion powder (Fig. 2). Method of analysis: SEM-EDS, Lab of Electronic Microscopy and Microanalysis, IMA (Néode), HEI Arc,

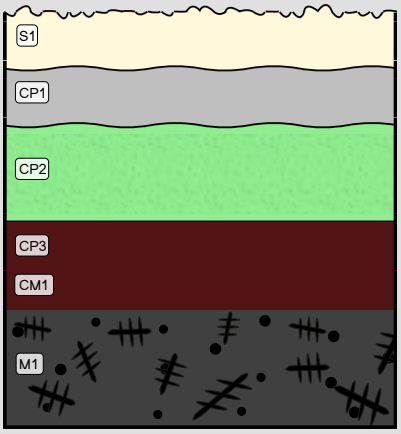
Fig. 15: Stratigraphic representation of sample from Fig. 2 of the headrest (or horse bit) in cross-section (dark field) using the MiCorr application. The characteristics of the strata are only accessible by clicking on the drawing that redirects you to the search tool by stratigraphy representation. This representation can be compared to Fig 10, Credit HE-Arc CR.

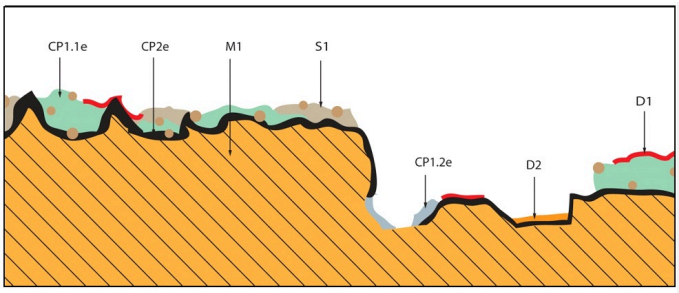
Fig. 16: Improved stratigraphic representation of the headrest from visual observations and analyses (additional mention e or i within the coding correspond to strata in contact with the environment (e) and internal strata (i),

The schematic representation of corrosion layers of Fig. 3 integrating additional information based on the analyses carried out is given in Fig. 16. A thin, black sulphur-rich layer covers the metal surface. A thick green layer has developed on top and seems to be constituted mainly of atacamite enriched in lead with sediments on top.

Strata	Composition
Sediments (**S1**)	Si, O
Deposits (**D1 & D2**)	?
Outer green corrosion product (CP1e) – **CP2**	Atacamite + Pb or S?
Inner black corrosion product (CP2i) – **CP3**	S ou Pb, Cu, O, a bit of Sn
Remnant metal phase (**M1**)	Bronze (85%Cu, 7%Sn, 5%Pb)
