MOIL CHISEL DEV 995 762 PR – STEEL – EARLY MEDIEVAL TIMES – SWITZERLAND

Artefact name Moil chisel DEV 995 762 PR

Authors Marianne. Senn (Empa, Dübendorf, Zurich, Switzerland) & Christian. Degrigny (HE-Arc CR, Neuchâtel, Neuchâtel, Switzerland)

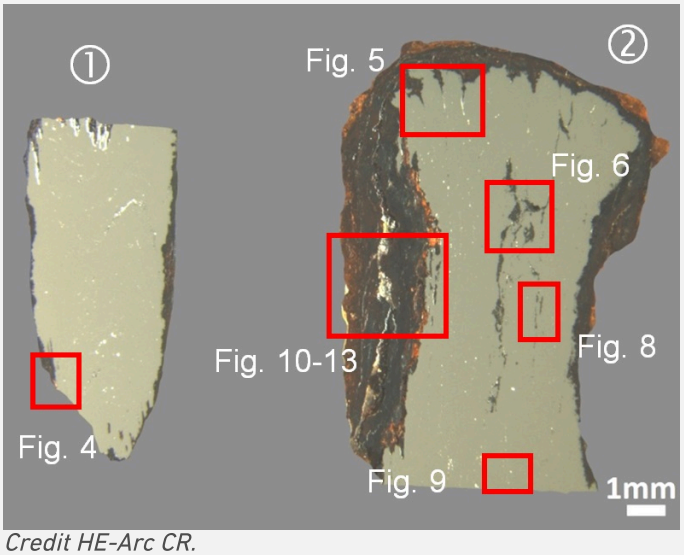
Fig. 3: Micrograph of the cross-sections of samples 1 and 2 taken from the moil chisen showing the location of Figs. 4 to 6 and 8 to 13,

Description of sample	Two samples were taken on both extremities of the chisel (Fig. 2). They show the remaining metal covered by thick and cracked corrosion crusts (Fig. 3).
Alloy	Steel
Technology	Welded
Lab number of sample	DEV 762
Sample location	HE-Arc CR, Neuchâtel, Neuchâtel
Responsible institution	Office de la Culture, Porrentruy, Jura
Date and aim of sampling	2000, metallography and chemical composition of the metal

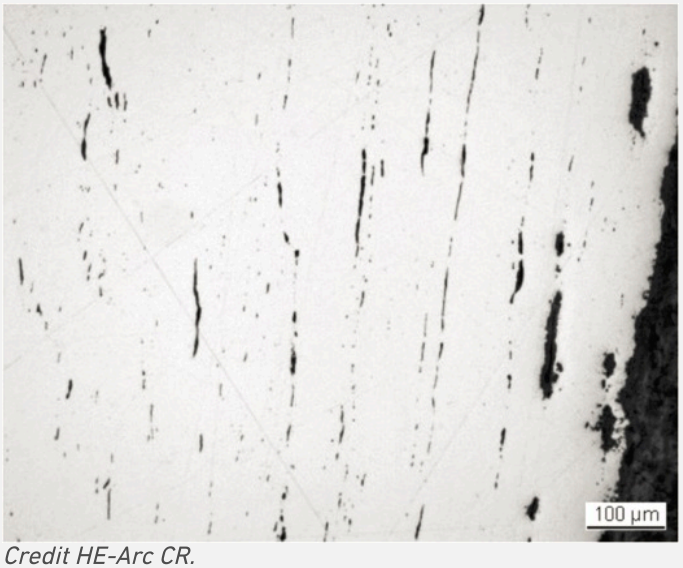
Fig. 4: Micrograph of metal sample 1 from Fig. 3 (reversed picture, detail), unetched, bright field. Slag inclusions organized in rows mark the welding seams,

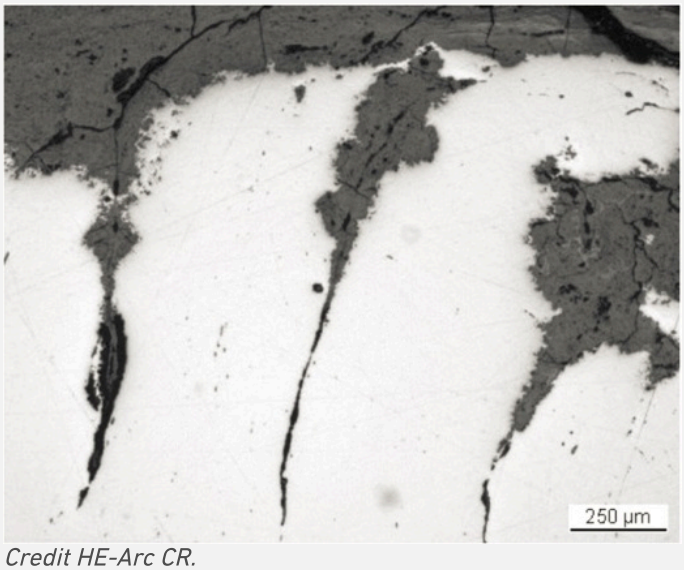
Fig. 5: Micrograph of metal sample 2 from Fig. 3 (reversed picture, detail), unetched, bright field. Corrosion has penetrated along the welding seams,

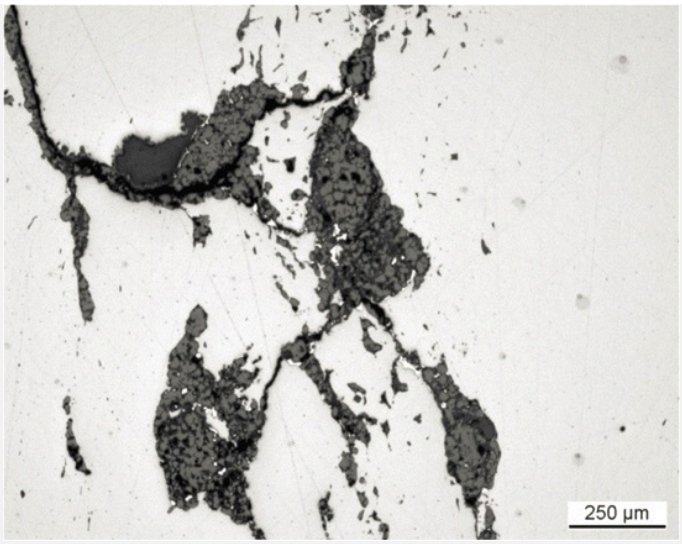
Fig. 6: Micrograph of metal sample 2 from Fig. 3 (reversed picture, detail), unetched, bright field. We observe large slag inclusions with a structure of coarse wüstite dendrites in a glassy matrix,

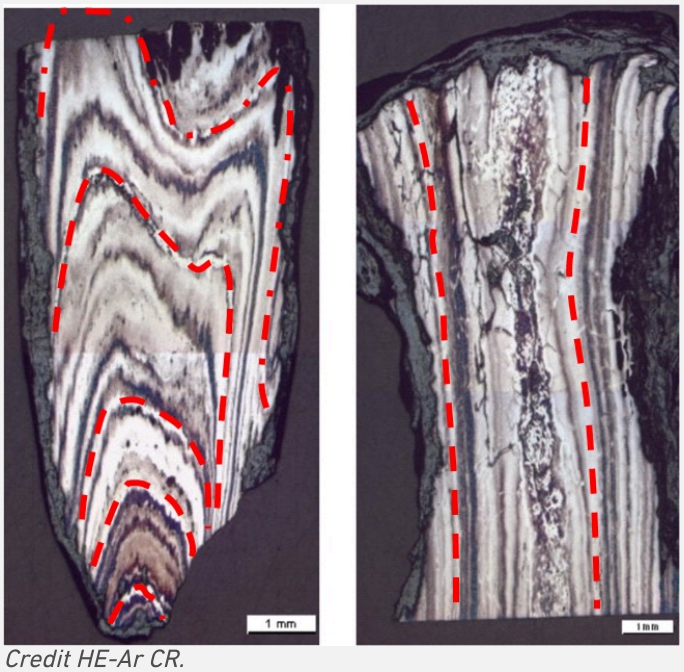
Fig. 7: Micrograph of metal samples 1 and 2, etched with Oberhoffer's reagent, bright field. The P segregation along the welding seams is outlined. The main welding seams are marked by red dotted lines,

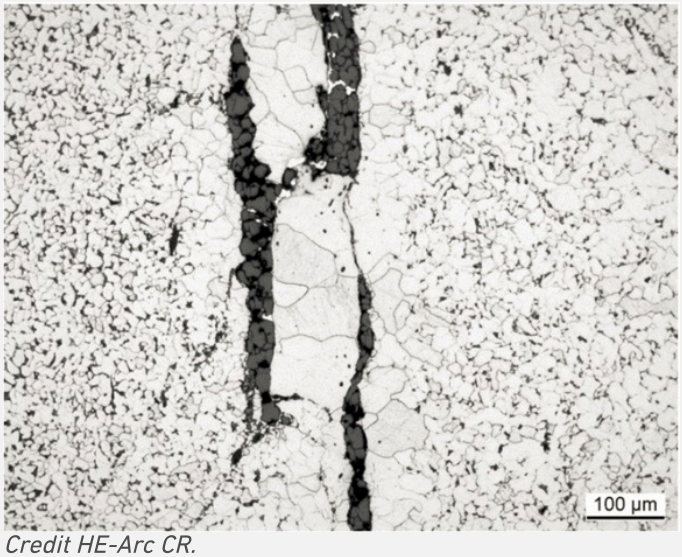
Fig. 8: Micrograph of metal sample 2 from Fig. 3 (detail), nital etched, bright field. We observe a hypoeutectoid steel including a ferritic zone surrounded by slag inclusions,

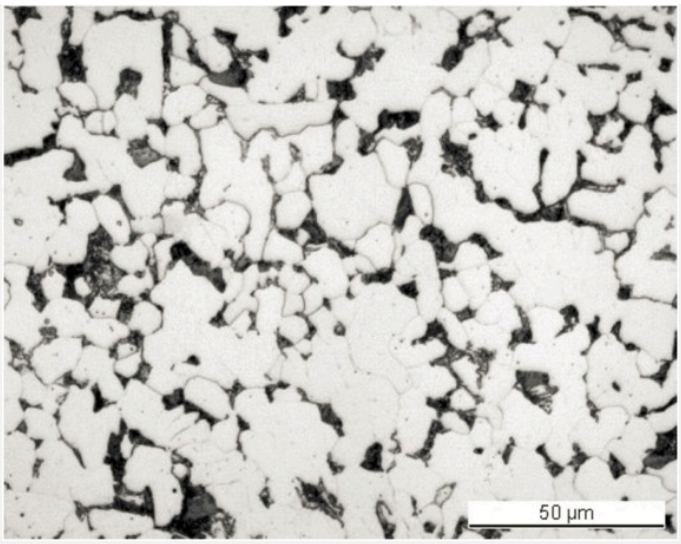
Fig. 9: Micrograph of metal sample 2 from Fig. 3 (detail), nital etched, bright field. We observe a hypoeutectoid steel with a structure of ferrite in white and pearlite in black,

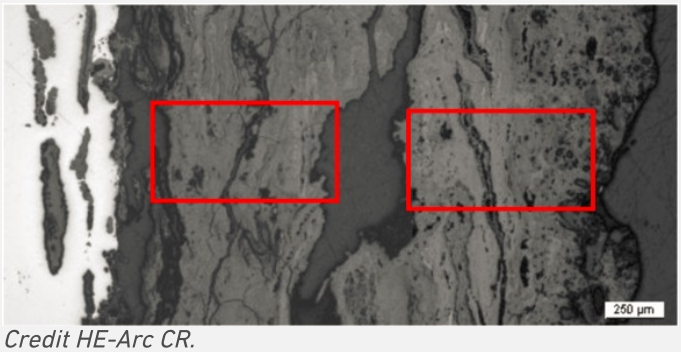
The metal - corrosion products interface is irregular (Fig. 3) and the average thickness of the corrosion crust is about 0.6mm. However, on the left side of the sample taken from the head of the chisel (Fig. 3) the corrosion crust is thicker with an average thickness of about 2mm. This area is further detailed below (Figs. 10 and 11). The corrosion crust can be divided into several layers (CP1-CP4). In bright field, and in the BSE-mode of the SEM image, darker and lighter regions are visible (Figs. 10, 12 and 13). In this area the corrosion layer contains typical trace elements of the metal (As and P, Table 3). In polarised light we see a dark-red zone in which different grey zones are included (Fig. 12). The element mapping and the analyses show that at the metal - corrosion crust interface iron chlorides occur (Figs. 12 and Table 3, CP4 in Fig. 14). Only the outer zone, which has reacted with the soil, has a different colour (orange) and incorporates many rock inclusions (Si, Al and Ca) (Fig. 13 and Table 3, CP1 in Fig. 14).

Fig. 10: Micrograph showing the metal - corrosion crust interface from Fig. 3 (reversed picture, detail), unetched, bright field. The areas selected for elemental chemical distributions (Fig. 12 (left) and Fig. 13 (right)) are marked by red rectangles,

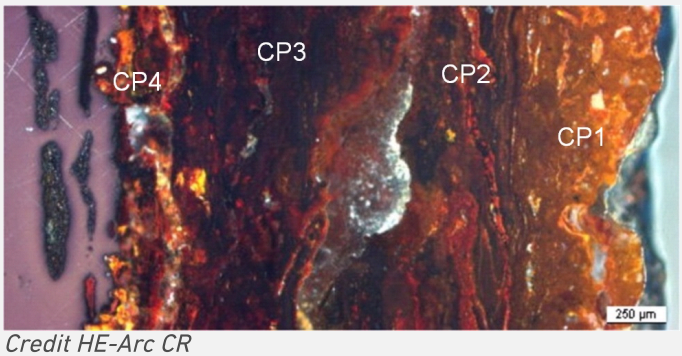
Fig. 11: Micrograph (same as Fig. 10) corresponding to the stratigraphy of Fig. 14, unetched, polarised light. From left to right: the metal in violet, the successive corrosion layers having a yellow (CP4), grey (CP3) to dark-red colour (CP2). The outer layer is orange-brown with quartz inclusions in white (CP1),

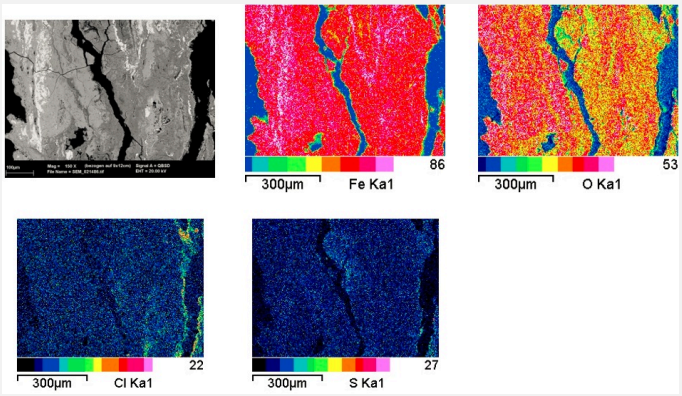
Fig. 12: SEM image, BSE-mode, and elemental chemical distribution of the selected area from Fig. 10 (reversed picture). Method of examination: SEM/EDS, Laboratory of Analytical Chemistry, Empa,

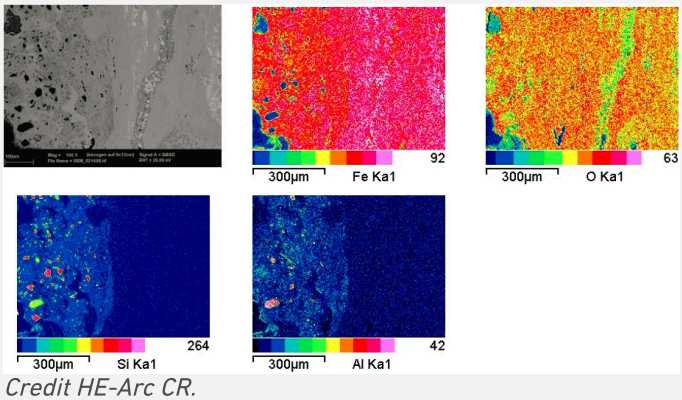
Fig. 13: SEM image, BSE-mode, and elemental chemical distribution of the selected area from Fig. 10 (reversed picture). Method of examination: SEM/EDS, Laboratory of Analytical Chemistry, Empa,

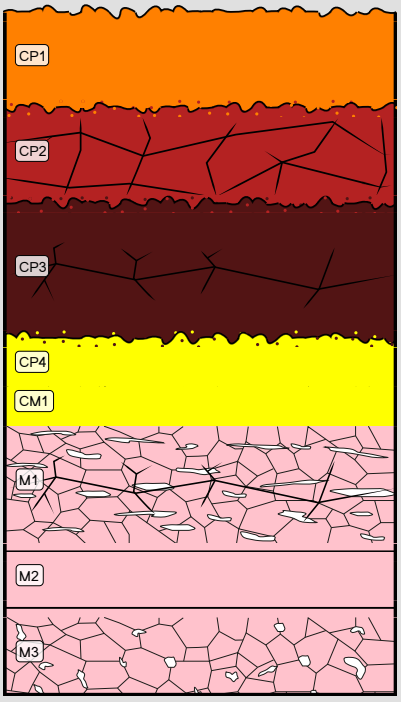
Fig. 14: Stratigraphic representation of sample 2 from the moil chisel in cross-section (dark field) using the MiCorr application. The characteristics of the strata are only accessible by clicking on the drawing that redirects you to the search tool by stratigraphy representation. This representation can be compared to Fig. 11, Credit HE-Arc CR.
