# FRAGMENT OF THE SUPPORT STRUCTURE OF AN ENGINE VHS-404 - GREY CAST IRON - MODERN TIMES

| **Artefact name** | Fragment of the support structure of an engine VHS-404 |
| **Authors** | Marianne. Senn (EMPA, Dübendorf, Zurich, Switzerland) & Christian. Degrigny (HE-Arc CR, Neuchâtel, Neuchâtel, Switzerland) |

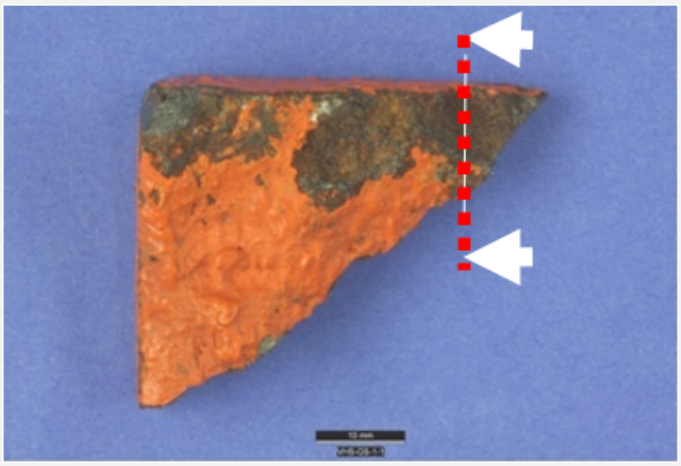
Fig. 1: Fragment (left) of the painted support structure of the engine from the SS Rigi steamer (right) (after www.verkehrshaus.ch, consulted on December 5, 2011),

| **Description of the artefact** | Corroded fragment (Fig. 1) of the painted support structure of the engine from the SS Rigi steamer. |

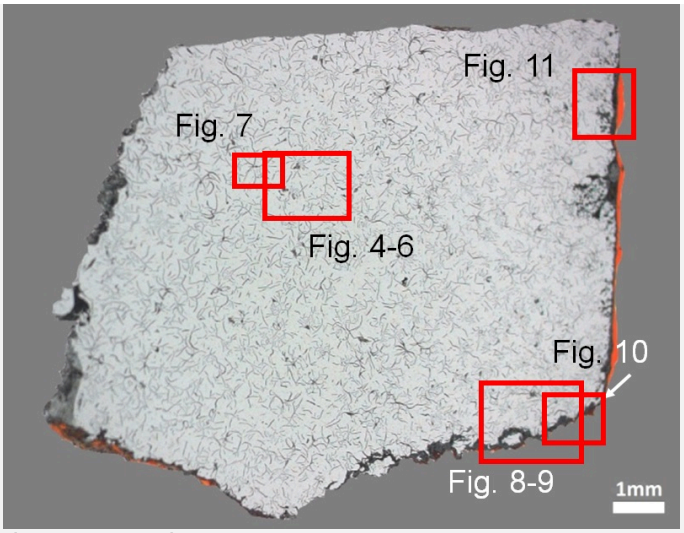
Fig. 3: Micrograph of the cross-section of the fragment showing the location of Figs. 4 to 11,

| **Description of sample** | The sample is a cross-section through the fragment of the support structure of the engine (Fig. 3). Dimensions: Lmax = 10mm; Wmax = 10mm. |

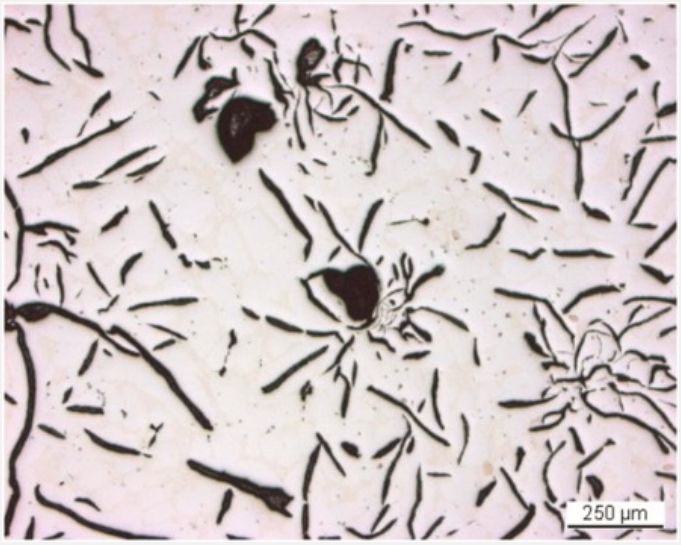
The remaining metal is a high P and Si grey cast iron with elevated Mn and V contents (Tables 1 and 2). The structure contains black graphite flakes and graphite nodules (Fig. 4) as well as angular grey manganese sulphide inclusions which can contain a dark alumina-rich centre (Fig. 4 and Table 1). The graphite flakes are irregular and vary in size. At low magnification the flakes are evenly spread over the entire surface with a tendency to form clusters. Some porosity is noticeable. Under SEM, in the BSD-mode, an additional eutectic phase is visible (Fig. 5). After etching one can see how the graphite is surrounded by alpha-iron in a pearlite matrix (Figs. 6 and 7). The lamellar pearlite includes steadite ($Fe_3P$) and manganese sulphide (MnS) inclusions. According to the cast iron diagram after Maurer (Bargel and Schulze 2008, 257), the structure is typical for a hypoeutectic pearlitic grey cast iron (C content <4.3 mass%, Si content ca. 2.0 mass%) including pearlite, steadite and graphite. The slow cooling rate and the higher Si level have favoured the formation of graphite. The high P content favours the growth of interconnected networks of steadite. The average hardness of the metal is HV1 160. This hardness is only approximate. Normally cast iron hardness is determined with a Brinell test, but due to the small size of the sample this could not be carried out. The calculated HB is about 150.

Fig. 4: Micrograph of the metal sample from Fig. 3 (inverted picture, detail), unetched, bright field. We observe graphite flakes and irregular nodules in black and the metal in white. The small grey spots are manganese sulphide inclusions,

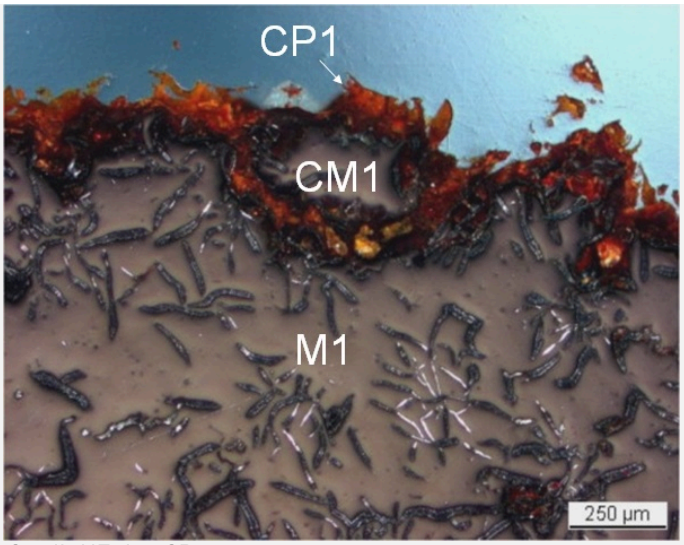
The thin corrosion crust (CP1) is limited to three sides of the sample and some remains of a paint coating (orange) are visible (Fig. 3). In bright field, the corrosion crust appears light-grey (Fig. 8), under polarised orange (Fig. 9). It is mainly composed of iron oxides (Table 3 and Fig. 10). The Pb and Ba-rich paint system has been applied directly onto the oxidized Fe, Si and Mn-rich casting skin (Fig. 11). The paint layer is probably an anodic inhibitor made from minium (red lead) with a barium sulphate filler. Because of the interference of Pb with S in the EDS spectra S is difficult to detect.

Fig. 8: Micrograph showing the metal - corrosion layer interface from Fig. 3 (inverted picture, detail), unetched, bright field. We observe in white the metal, in light-grey the corrosion layer, in black the graphite flakes,

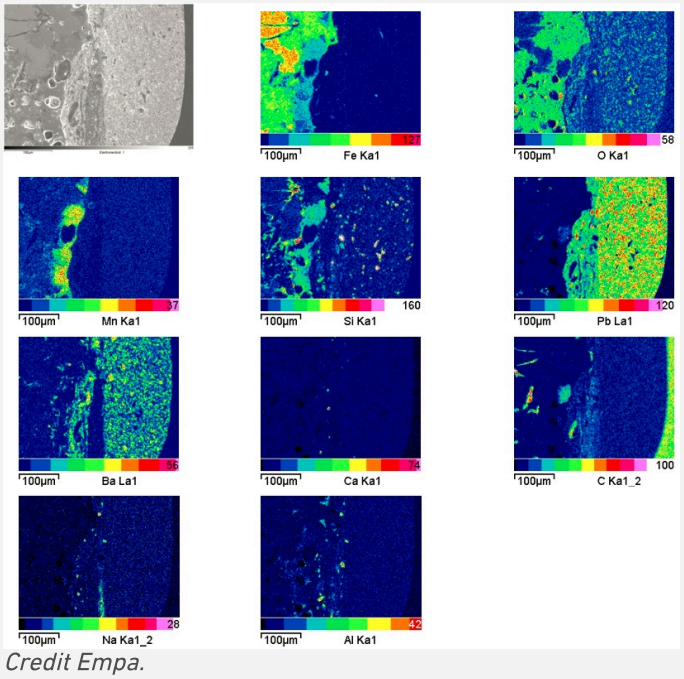
Fig. 10: SEM image, SE-mode, and elemental chemical distribution of the selected area from Fig. 3 (detail). Method of examination: SEM/EDS, Laboratory of Analytical Chemistry, Empa,
