KNIFE WITH A GROOVE ON BOTH SIDES DEV 995 814 PR - FE ALLOY - EARLY MEDIEVAL TIMES - SWITZERLAND

Artefact name	Knife with a groove on both sides DEV 995 814 PR
Authors	Marianne. Senn (EMPA, Dübendorf, Zurich, Switzerland) & Christian. Degrigny (HE-Arc CR, Neuchâtel, Neuchâtel, Switzerland)
Url	/artefacts/965/

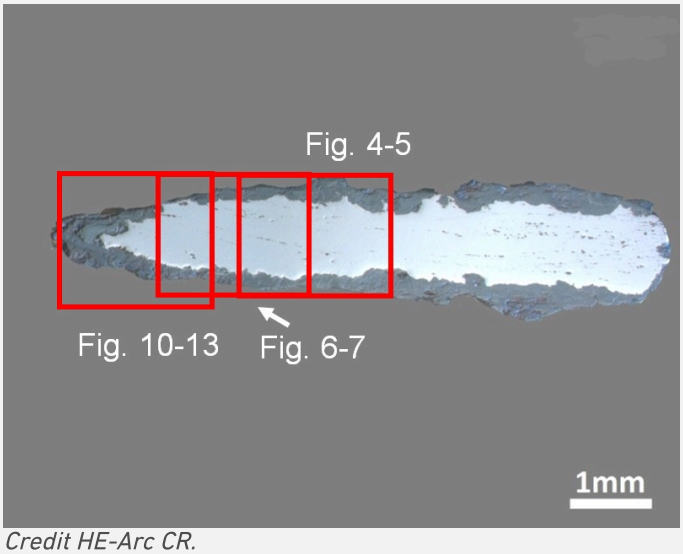
Fig. 3: Micrograph of the cross-section of a cut through the tip of the knife showing the location of Figs. 4 to 7 and 10 to 13,

The cross-section shows a cut through the tip of the knife (Fig. 2). The metal is surrounded by thick corrosion products (Fig. 3). Dimensions: L = 8mm; Wmax. = 2mm.

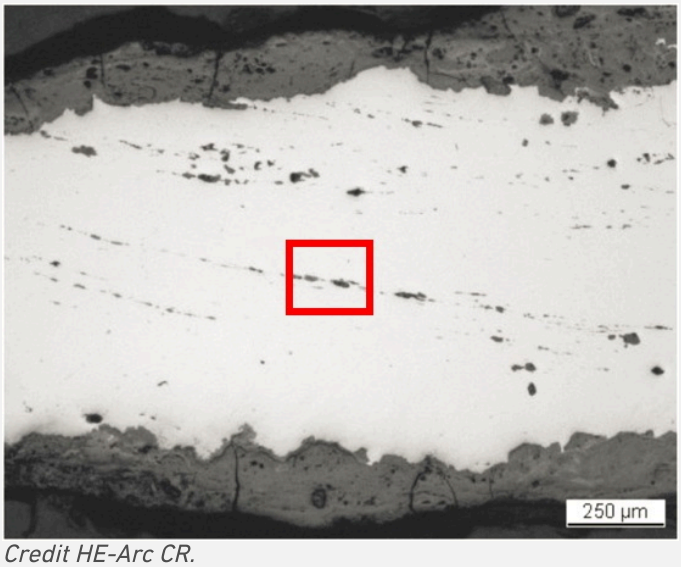
Fig. 4: Micrograph of the metal sample from Fig. 3 (detail), unetched, bright field. In white the metal, in light-grey the slag inclusions and the corrosion layer. The micrograph of Fig. 5 is marked by a rectangle,

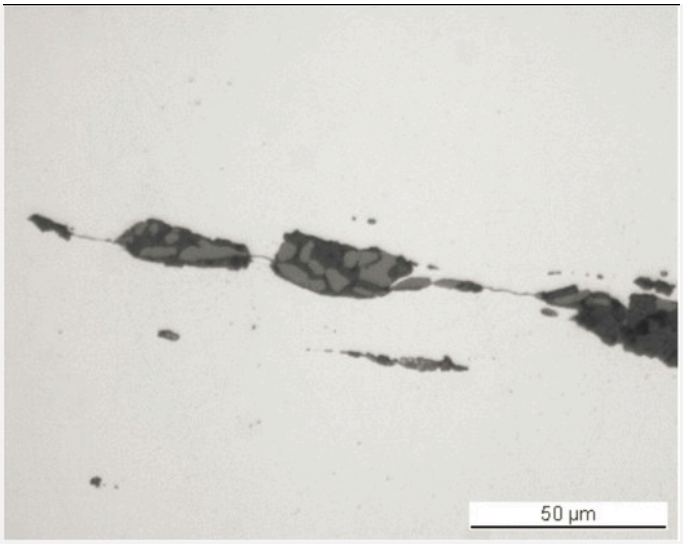
Fig. 5: Micrograph (detail of Fig. 4), unetched, bright field. The slag inclusions have a structure of wüstite dendrites (light-grey) in a glassy matrix (dark-grey),

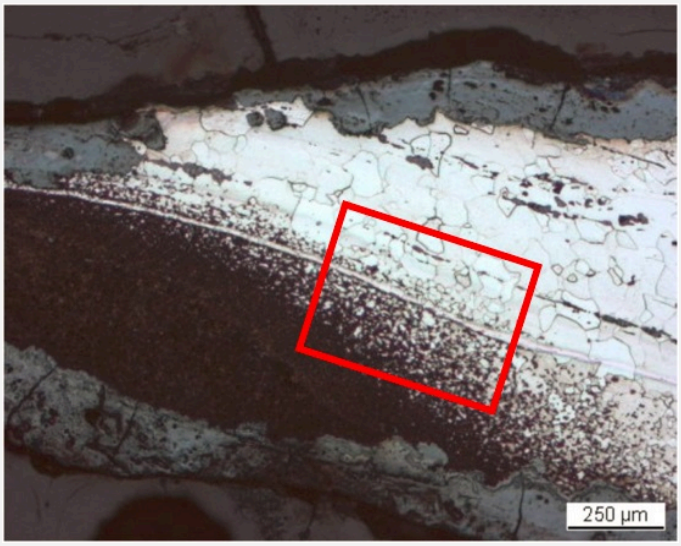
Fig. 6: Micrograph of the metal sample from Fig. 3 (detail), nital etched, bright field. In white we observe the ferrite, in black or dark-grey the pearlite and bainite. The micrograph of Fig. 7 is marked by a rectangle,

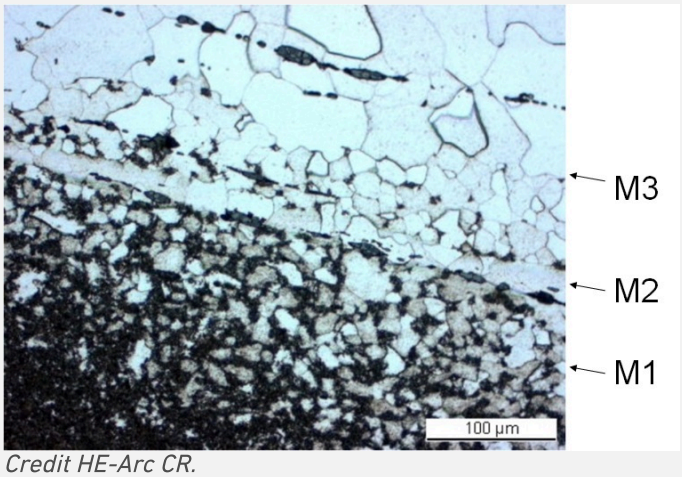
Fig. 7: Micrograph (detail of Fig. 6) corresponding to the stratigraphy of Fig. 14, nital etched, bright field,

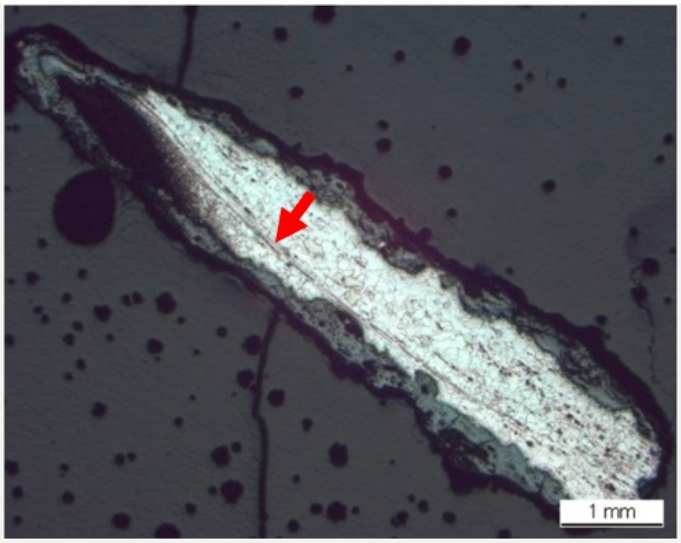
The remaining metal consists of two forged wrought iron bars, one of which includes a carburized tip (M1, Table 1). They are separated by a welding seam (M2, Figs. 8 and 9). The ferritic part (M3) is Cu-rich, whereas the carburized tip has a low and medium content of trace elements (Table 1). The metal contains elongated slag inclusions (Fig. 4) showing a structure of wüstite (FeO) in a glassy matrix (Fig. 5 and Table 2). Most of the slag inclusions are arranged in rows, marking the welding seam (Figs. 4 and 8) and following the forging direction. Their chemical composition differs in the Mn content (Table 2): the latter is higher in the slag inclusions of the carburized tip. The high P content of the slag in the ferritic part must be noted since the metal in general has a medium P content (Tables 1 and 2). Etching with Oberhoffer's reagent solution makes the P distribution visible (Fig. 9). Dark areas are depleted of P whereas P-rich zones, such as those found in the welding seam, appear in white. After nital etching, the very fine steel microstructure of the tip shows the transition from hypoeutectoid to eutectoid steel (ferrite component in white and pearlite component in black, partly bainite, Figs. 6, 7 and 8). The body of the knife is made of wrought iron with an annealed, irregular ferritic structure (Figs. 6 and 7). The average hardness of the wrought iron (HV1 130) is a little higher than expected, whereas the hardness of steel in the hypoeutectoid-eutectoid tip (HV1 360) is an indication of quench-hardening followed by tempering.

Fig. 8: Micrograph of the metal sample from Fig. 3 (rotated by 45°), nital etched, bright field. In white we observe the ferrite, in black or dark-grey the pearlite. The red arrow shows the welding seam,

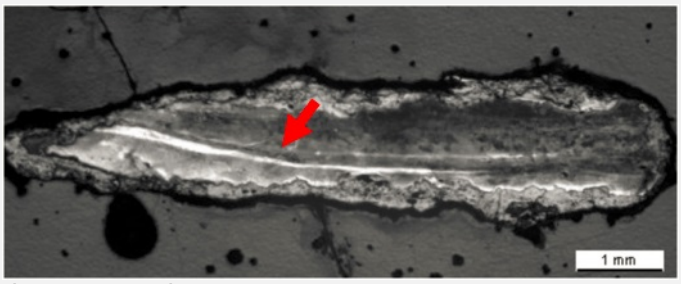
Fig. 9. Micrograph of the metal sample from Fig. 3, etched with Oberhoffer's reagent. The welding seam appears in white (red arrow),

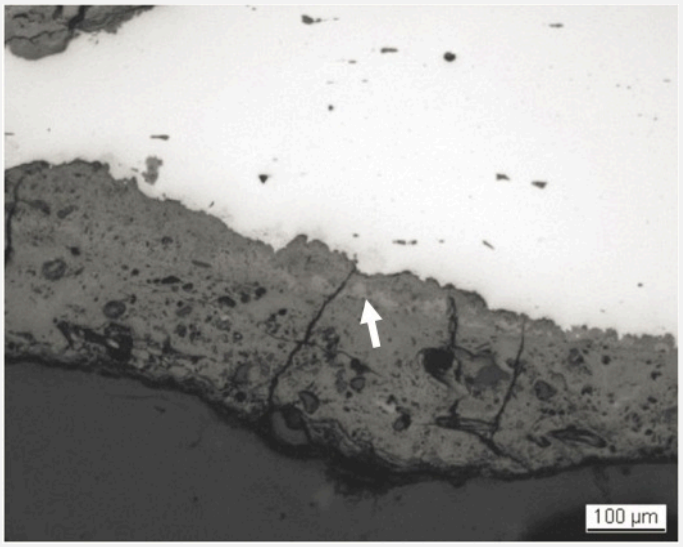
The metal - corrosion products interface is irregular (Figs. 3, 4 and 10) and the average thickness of the corrosion crust is 200µm. In bright field, the corrosion appears grey, rather heterogeneous and heavily cracked. A thin light-grey layer (indicated by an arrow in Fig. 10) can be detected. Under polarised light the corrosion is more clearly stratified, the thin layer mentioned before is black (CP3) and surrounded by dark-brown (CP2) and orange-red (CP1) corrosion layers (Figs. 11 and 12). It contains less O (magnetite or hematite?) than the orange-brown corrosion products (iron hydroxides?) (Table 3 and Fig. 13). The outer corrosion layer (covering the aforementioned thin black layer) contains external markers such as quartz grains and other rock fragments (Ca, Fig. 13). The shape of the blade is preserved in the corrosion crust (Fig. 13, arrows on the SEM image). The absence of P, an external marker, highlights where the limit of the original surface was located (interface CP1 / CP2).

Fig. 10: Micrograph showing the metal - corrosion crust interface from Fig. 3 (detail of Fig. 11), unetched, bright field. The heterogeneous and heavily cracked corrosion layer appears grey enclosing a light-grey layer (indicated by an arrow),

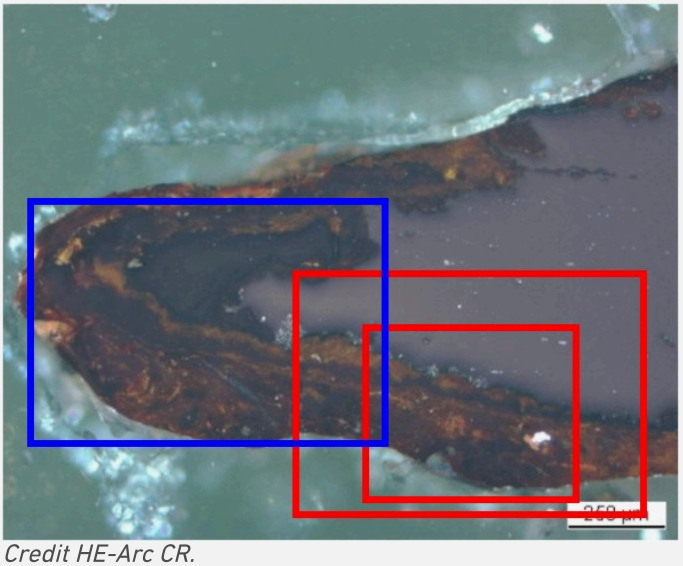
Fig. 11: Micrograph showing the metal - corrosion crust interface from Fig. 3 (detail) unetched, polarised light. The micrographs of Fig. 10 and Fig. 12 are marked by the large and small red rectangles respectively while the area selected for elemental chemical distribution (Fig. 13) is marked by the blue rectangle. The light-grey layer of Fig. 10 (arrow) appears black whereas the rest of the corrosion layer is brown, red and orange,

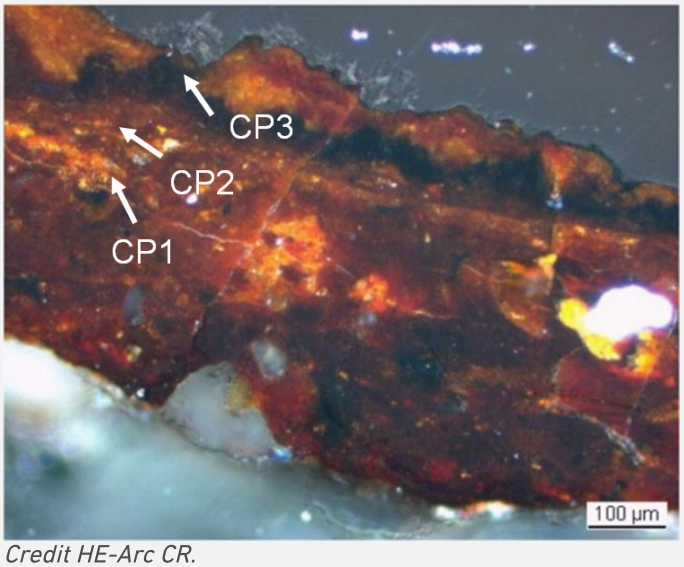
Table 3: Chemical composition (mass %) of the corrosion layer (from Fig. 12). Method of analysis: SEM/EDS, Laboratory of Analytical Chemistry, Empa.

Fig. 12: Micrograph (detail from Fig. 11) corresponding to the stratigraphy of Fig. 14, unetched, polarised light. The black corrosion layer next to the metal surface corresponds to the light-grey layer indicated with an arrow on Fig. 10,

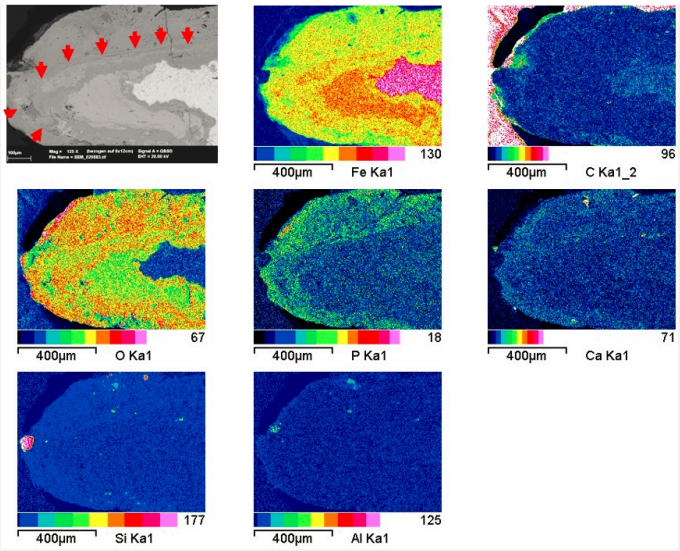
Fig. 13: SEM image, BSE-mode, and elemental chemical distribution of the selected area from Fig. 11 (inversed picture). Method of examination: SEM/EDS, Laboratory of Analytical Chemistry, Empa,

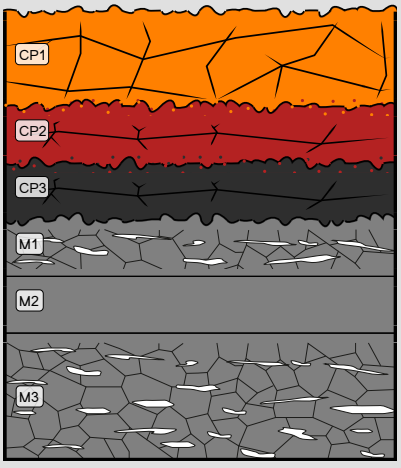
Fig. 14: Stratigraphic representation of the tip of the knife in cross-section (dark field) using the MiCorr application. The characteristics of the strata are only accessible by clicking on the drawing that redirects you to the search tool by stratigraphy representation. This representation can be compared to Fig. 7 and Fig. 12, Credit HE-Arc CR.
