SWORD M-SCH-B2735 - P-RICH IRON - IRON AGE - SWITZERLAND

Artefact name	Sword M-Sch-B2735
Authors	Marianne. Senn (Empa, Dübendorf, Zurich, Switzerland) & Christian. Degrigny (HE-Arc CR, Neuchâtel, Neuchâtel, Switzerland)
Url	/artefacts/967/

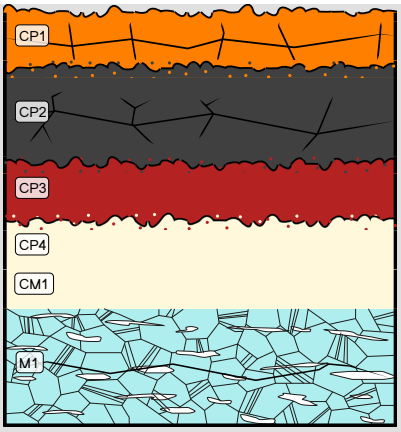
Fig. 10: Stratigraphic representation of the sample taken from the sword in cross-section (dark field) using the MiCorr application. The characteristics of the strata are only accessible by clicking on the drawing that redirects you to the search tool by stratigraphy representation. This representation can be compared to Fig. 8, Credit HE-Arc CR.
