ARMATURE FROM A CLOCK MOVEMENT MIH IV-212 - ZN AL SN CU ALLOY - MODERN TIMES

Artefact name Armature from a clock movement MIH IV-212

Authors Marianne. Senn (Empa, Dübendorf, Zurich, Switzerland) & Christian. Degrigny (HE-Arc CR, Neuchâtel, Neuchâtel, Switzerland)

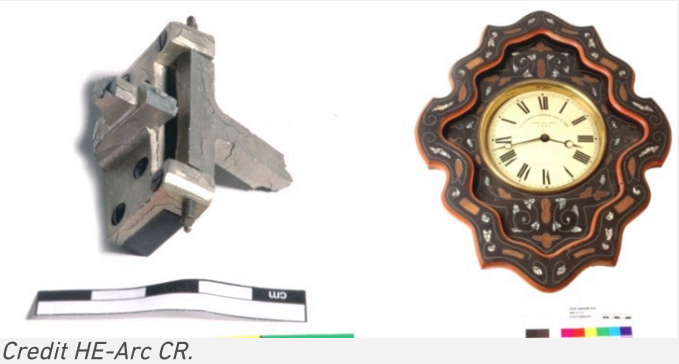
Fig. 1: Broken armature (left) from the clock movement of a wooden wall clock (right) (after Seematter 2009),

Description of the artefact Armature from the clock movement of a wooden wall clock with electric movement, broken in two elements (Fig. 1 and Fig. 2) with a heavily cracked surface.

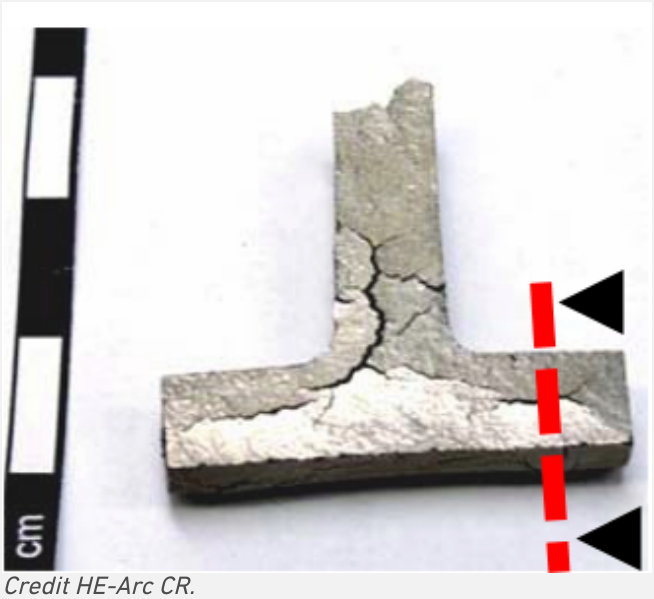
Fig. 2: Location of sampling area on one of the two broken elements of the armature,

Description of sample	This sample is the complete cross-section from one of the two broken elements of the armature (Fig. 2). The metal has large cracks radiating from the centre to the outside which have deformed the armature (Fig. 3).
Alloy	Zn Al Sn Cu Alloy
Technology	As-cast
Lab number of sample	MIH-VI-212
Sample location	HE-Arc CR, Neuchâtel, Neuchâtel
Responsible institution	International museum of horology (IMH), La Chaux-de-Fonds, Neuchâtel
Date and aim of sampling	2009, metal analysis

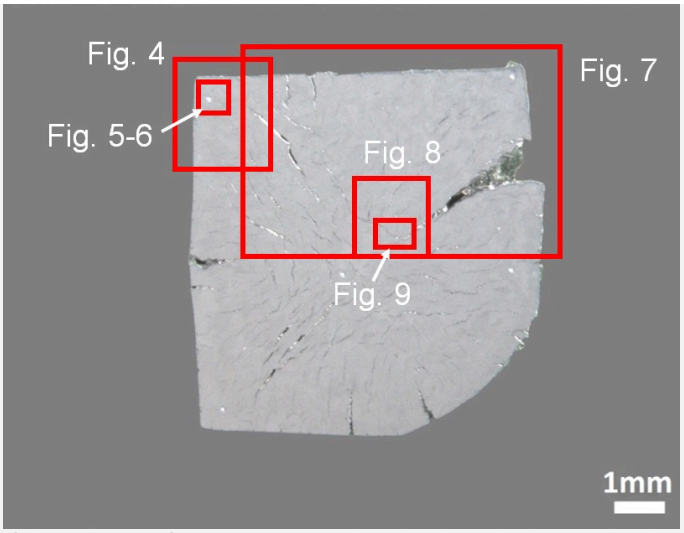
Fig. 3: Micrograph of the cross-section of the fragment sampled from the armature showing the location of Figs. 4 to 9,

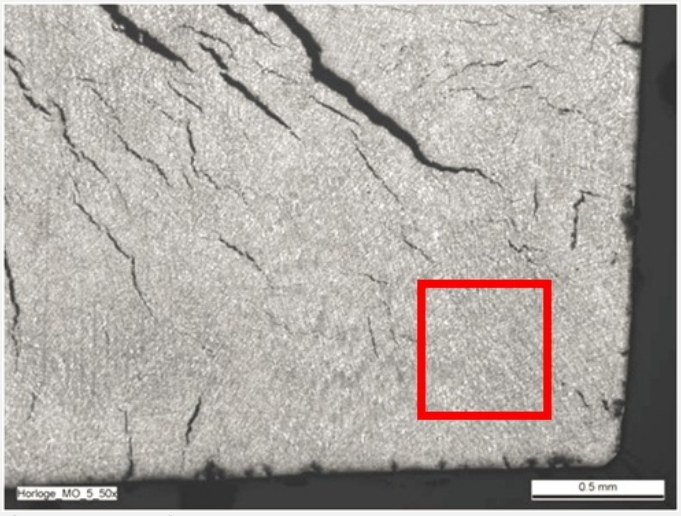
Table 1: Chemical composition (mass %) of the metal (oxygen not shown). Method of analysis: SEM/EDS, Lab of Electronic Microscopy and microanalysis, IMA (Néode), HEI Arc.

The metal is a Zn-Al-Sn-Cu alloy (Table 1) with an average hardness of HV1 105. A fine dendritic structure is observed (Fig. 4) which consists of clearly separated Zn, Al-Cu and Sn-rich phases (Figs. 5 and 6). Pb is associated with Sn but also forms tiny nodules.

Elements	Zn	Al	Sn	Cu	Pb	Total
Metal	67	17	11	4	<1	99

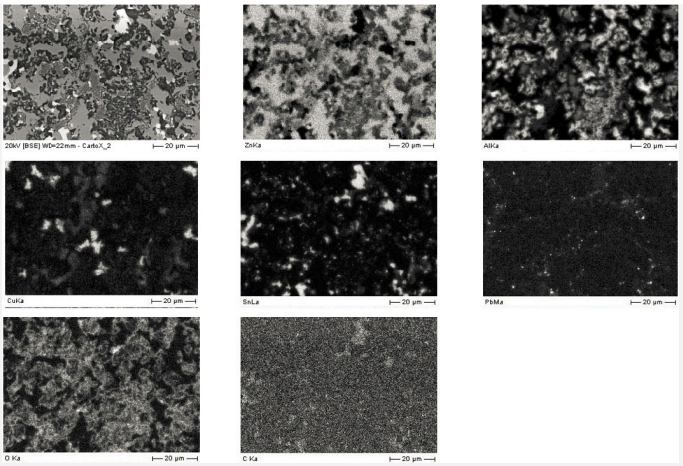
Fig. 5: SEM image, BSE-mode, detail from Fig. 4 (detail), unetched, bright field. Three phases appear: in light-grey the Zn-rich phase, in dark-grey the Al and Cu-rich phase and in white the Sn-rich phase,

Fig. 6: SEM image, BSE-mode, and elemental chemical distribution of the selected area from Fig. 5. Method of examination: SEM/EDS, Lab of Electronic Microscopy and microanalysis, IMA (Néode), HEI Arc,

The Zn-rich phase is heavily oxidised internally (Fig. 6). The corrosion has developed throughout the entire metal body, generating cracks (Figs. 7 and 8). The cracks are Zn, O and C-rich (Fig. 9) and could be composed of zinc carbonate.

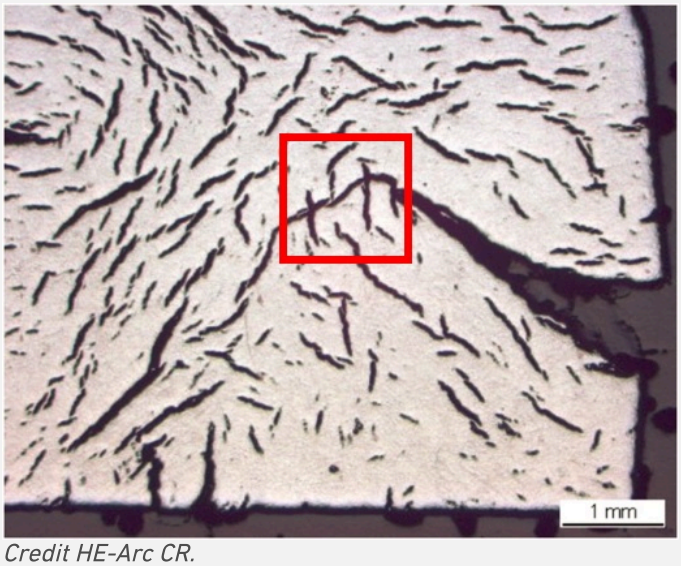
Fig. 7: Micrograph showing the metal - “corrosion products” interface from Fig. 3 (reversed picture, detail), unetched, bright field,

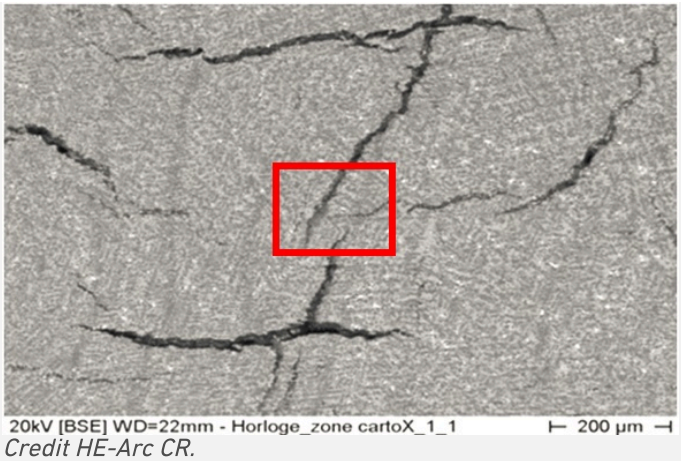
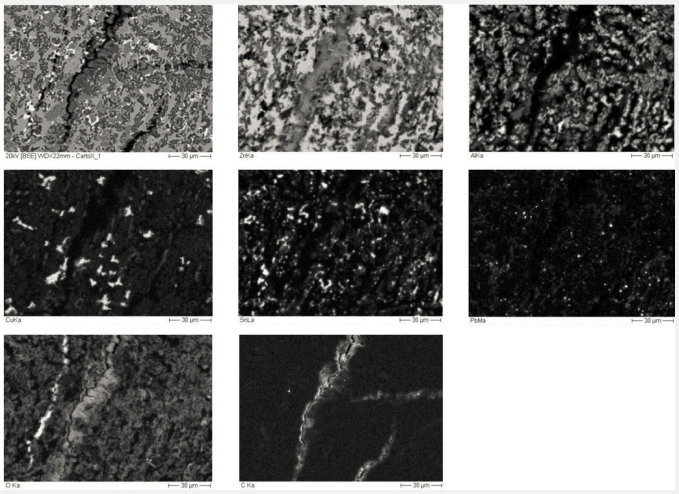
Fig. 8: Micrograph of the metal sample, detail from Fig. 7 (reversed and rotated by 90°), unetched, bright field. A dendritic structure is visible. The area selected for elementary mapping (Fig. 9) is marked by a rectangle. Can be compared to the stratigraphy representation of Fig. 10,

Fig. 9: SEM image, BSE-mode, and elemental chemical distribution of the selected area from Fig. 8 (detail). Method of examination: SEM/EDX, Lab of Electronic Microscopy and microanalysis, IMA (Néode), HEI Arc,

Corrosion form	Internal cracking
Corrosion type	zinc pest

The armature of the clock mechanism is constituted of a ZnAlSnCu alloy. The absence of cohesion between the different phases has led to the penetration of O during the manufacturing of the alloy. Small original cracks have developed further eventually causing the armature to break. This phenomenon is called zinc pest. It develops mainly on cast objects, starting with localised modifications (blisters and pits, Cramer and Covino 2005).
