# BLADE FRAGMENT OF A WINGED AXE FK43 – TIN BRONZE – MIDDLE BRONZE AGE – SWITZERLAND

| **Artefact name** | Blade fragment of a winged axe FK43 |
| **Authors** | Marianne. Senn (Empa, Dübendorf, Zurich, Switzerland) & Christian. Degrigny (HE-Arc CR, Neuchâtel, Neuchâtel, Switzerland) |

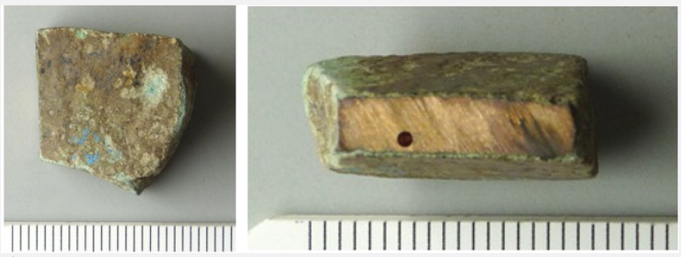
Fig. 1: Blade fragment of winged axe. The drilling on the right picture was carried out at a later stage and does not form part of the original object,

| **Description of the artefact** | Blade fragment of a semi-finished median-winged axe. Its surface is covered with a thick dark green corrosion crust (Fig. 1). Dimensions: L = 20mm; Tmax. = 8.5mm; WT = 15g. |

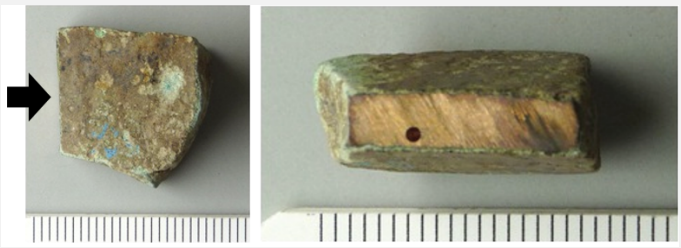
Fig. 2: Location of sampling area (arrow, left picture) and side view (right picture),

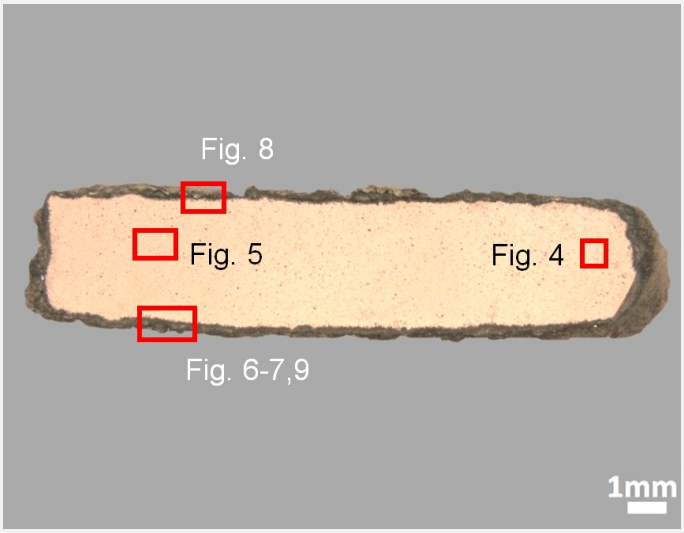
Fig. 3: Micrograph of the cross-section of the sample taken from the blade fragment of the winged axe showing the location of Figs. 4 to 9,

| **Description of sample** | The sample was cut from the fragment shown in Fig. 2. The cross-section is rectangular in shape (L = 17mm, W= 4mm) and has a thick corrosion crust (Figs. 2 and 3). |

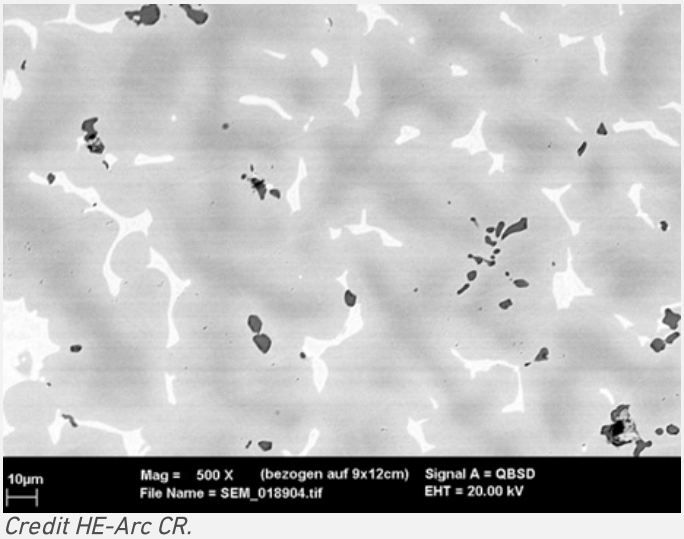
The remaining metal is a tin bronze containing some As (Table 1) with high porosity and grey copper sulphide inclusions (Figs. 4 and 5, Table 2). The etched metal has the typical dendritic structure of a cast tin bronze with an average hardness of HV1 135 (Fig. 6). The cored dendritic structure is surrounded by an alpha-delta eutectoid. The core of the dendrites is rich in Cu whereas the outer layers are rich in Sn.

Table 2: Chemical composition (mass %) of the dark-grey inclusions seen in Fig. 4. Method of analysis: SEM/EDS, Laboratory of Analytical Chemistry, Empa.

Fig. 4: SEM image of the metal sample from Fig. 3 (detail), BSE-mode. The cored alpha phase of the dendrites appears in grey, becoming lighter towards the periphery (more Sn). The alpha-delta eutectoid appears in white and the copper sulphide inclusions in dark-grey,

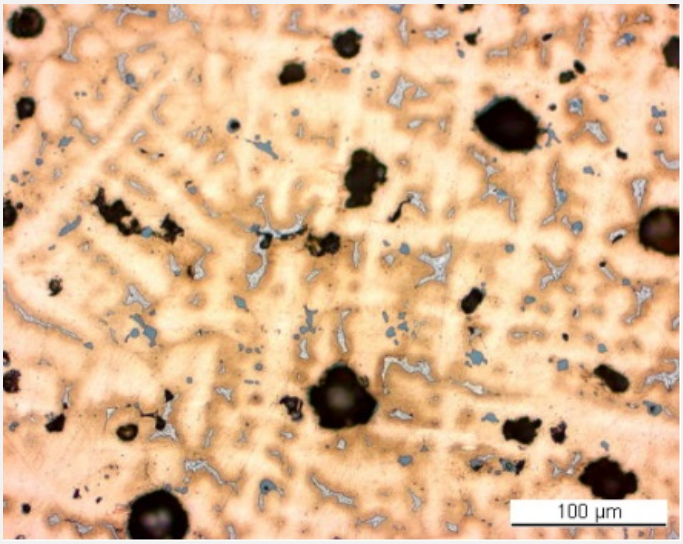
Fig. 5: Micrograph of the metal sample from Fig. 3, etched, bright field. We observe the eutectoid phase in light grey and copper sulphide inclusions in dark-grey,

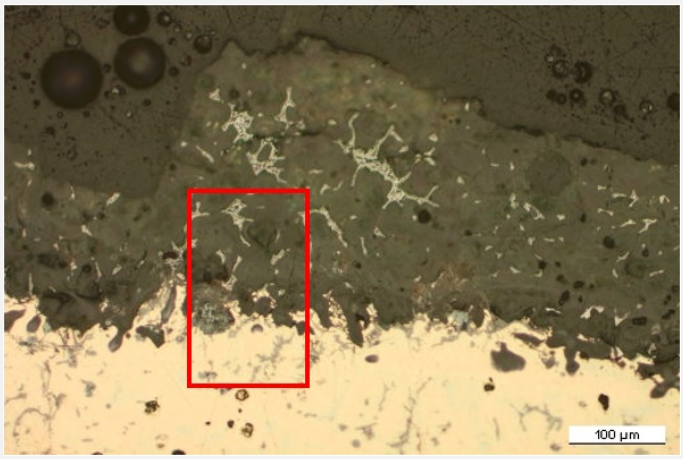
A dark green corrosion crust with a thickness between 100 and 320µm covers the entire surface of the blade fragment (Fig. 6). It retains a metallic ghost structure (Sn-rich eutectoid alpha + delta phase). Under polarized light localized orange and red corrosion products can be seen at the metal - corrosion crust interface (Fig. 7). Interdendritic corrosion and corroded slip lines can be seen in the metal structure and near fissures (Fig. 8). Elemental mapping (Fig. 9) shows that the green layer is Sn-rich (CP1, probably cassiterite, $SnO_2$) and depleted of Cu,

Fig. 6: Micrograph of the metal sample from Fig. 3 (rotated 180°), unetched, bright field. A metallic ghost structure is preserved in the corrosion crust. The area selected for elemental chemical distribution (Fig. 9) is marked by a red rectangle,

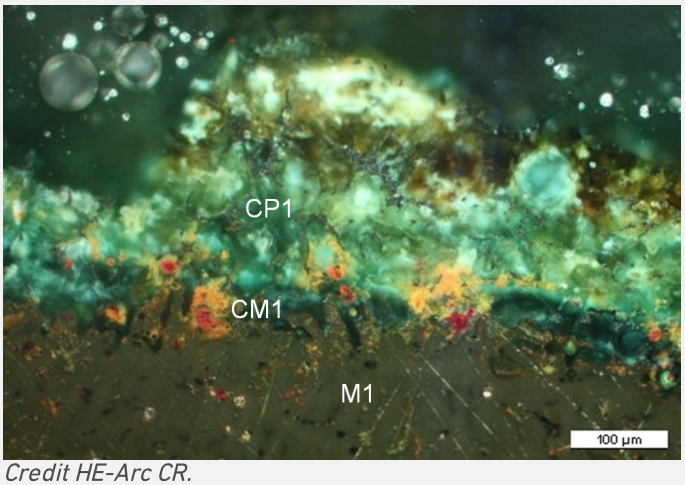
Fig. 7: Micrograph similar to Fig. 6 and corresponding to the stratigraphy of Fig. 11, polarised light. At the metal - green corrosion crust interface red and orange corrosion products can be seen,

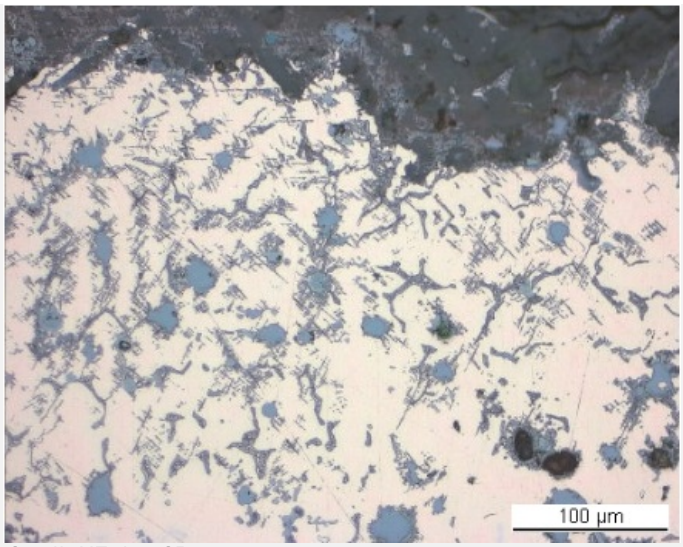
Fig. 8: Micrograph of the metal sample from Fig. 3 (detail), unetched, bright field. Metal with slip lines outlined by the corrosion,

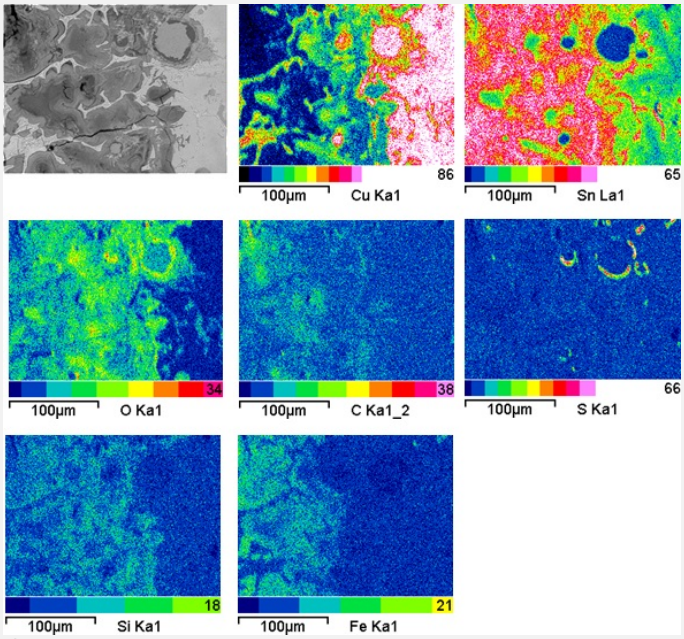
whereas the orange and red corrosion aggregates are depleted of Sn and rich in Cu (Fig. 9, Table 3). Their Raman spectra indicate that they are mainly composed of cuprite (Fig. 10). The overall corrosion crust contains O, Si, C and Fe from the environment, while S is concentrated around the cuprite particles (Fig. 9).

Table 3: Chemical composition (mass %) of the corrosion crust from Fig. 9. Method of analysis: SEM/EDS, Laboratory of Analytical Chemistry, Empa.

Fig. 9: SEM image, SE-mode, and elemental chemical distribution of the selected area of Fig. 6 (reversed picture rotated by 270°). Method of examination: SEM/EDS, Laboratory of Analytical Chemistry, Empa,

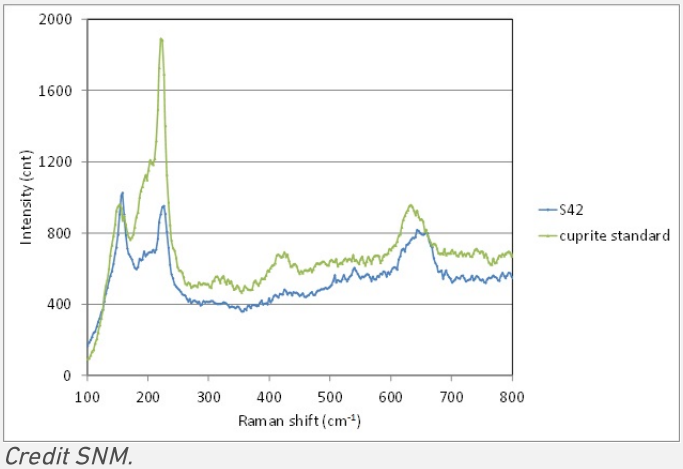
Fig. 10: Raman spectrum of a red-orange corrosion particle (S42) of Fig. 7 compared to the cuprite standard spectrum. Settings: laser wavelength 532nm, acquisition time 10s, one accumulation, filter D2 (0.75-0.8mW), hole 500, slit 80, grating 600. Method of analysis: Raman spectroscopy, Lab of Swiss National Museum, Affoltern a. Albis ZH,

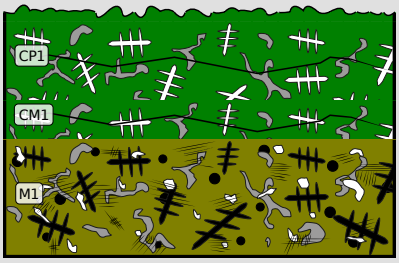
Fig. 11: Stratigraphic representation of the sample taken from the blade fragment of the winged axe in cross-section (dark field) using the MiCorr application. The characteristics of the strata are only accessible by clicking on the drawing that redirects you to the search tool by stratigraphy representation. This representation can be compared to Fig. 7, Credit HE-Arc CR.
