BLADE FRAGMENT OF A WINGED AXE FK43 – TIN BRONZE – MIDDLE BRONZE AGE – SWITZERLAND

Artefact name	Blade fragment of a winged axe FK43
Authors	Marianne. Senn (Empa, Dübendorf, Zurich, Switzerland) & Christian. Degrigny (HE-Arc CR, Neuchâtel, Neuchâtel, Switzerland)
Url	/artefacts/981/

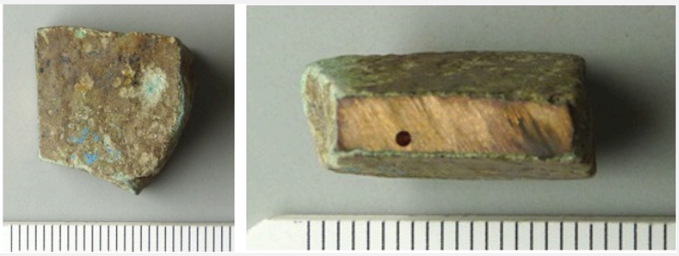
Fig. 1: Blade fragment of winged axe. The drilling on the right picture was carried out at a later stage and does not form part of the original object,

Description of the artefact	Blade fragment of a semi-finished median-winged axe. Its surface is covered with a thick dark green corrosion crust (Fig. 1). Dimensions: L = 20mm; Tmax. = 8.5mm; WT = 15g.
Type of artefact	Tool
Origin	Obstgartenstrasse, Erlenbach, Zurich, Switzerland
Recovering date	Excavation 1980.002
Chronology category	Middle Bronze Age
chronology tpq	1550 B.C.
chronology taq	1350 B.C.
Chronology comment	
Burial conditions / environment	Soil
Artefact location	Kantonsarchäologie, Dübendorf, Zurich

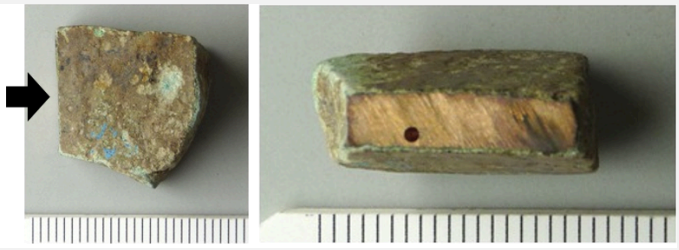
Fig. 2: Location of sampling area (arrow, left picture) and side view (right picture),

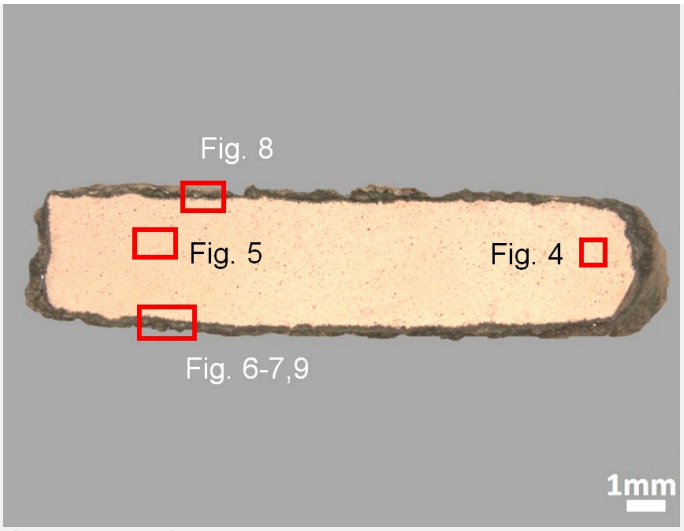
Fig. 3: Micrograph of the cross-section of the sample taken from the blade fragment of the winged axe showing the location of Figs. 4 to 9,

Description of sample	The sample was cut from the fragment shown in Fig. 2. The cross-section is rectangular in shape (L = 17mm, W= 4mm) and has a thick corrosion crust (Figs. 2 and 3).
Alloy	Tin Bronze
Technology	As-cast
Lab number of sample	ERL-43
Sample location	Begbroke Science Park (Peter Northover), Yarnton, England
Responsible institution	Kantonsarchäologie, Dübendorf, Zurich
Date and aim of sampling	Date unknown, metallography and chemical analyses

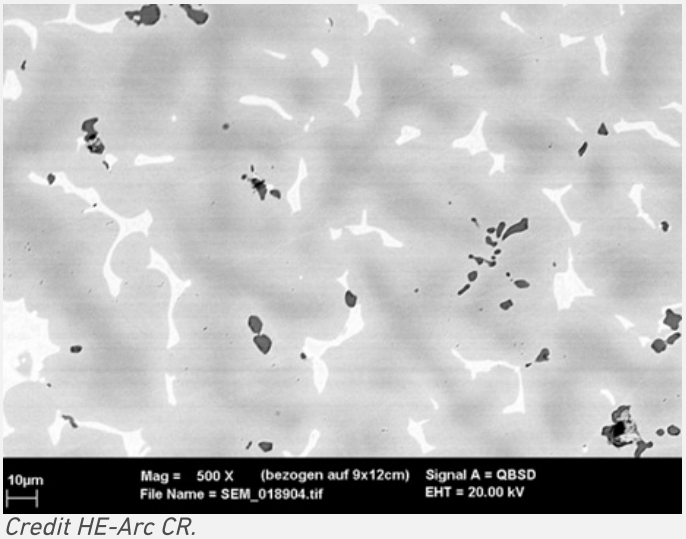
The remaining metal is a tin bronze containing some As (Table 1) with high porosity and grey copper sulphide inclusions (Figs. 4 and 5, Table 2). The etched metal has the typical dendritic structure of a cast tin bronze with an average hardness of HV1 135 (Fig. 6). The cored dendritic structure is surrounded by an alpha-delta eutectoid. The core of the dendrites is rich in Cu whereas the outer layers are rich in Sn.

Table 2: Chemical composition (mass %) of the dark-grey inclusions seen in Fig. 4. Method of analysis: SEM/EDS, Laboratory of Analytical Chemistry, Empa.

Fig. 4: SEM image of the metal sample from Fig. 3 (detail), BSE-mode. The cored alpha phase of the dendrites appears in grey, becoming lighter towards the periphery (more Sn). The alpha-delta eutectoid appears in white and the copper sulphide inclusions in dark-grey,

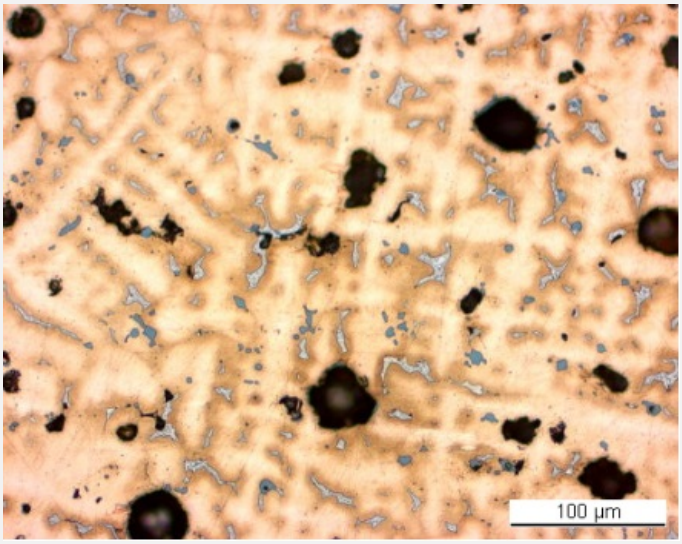
Fig. 5: Micrograph of the metal sample from Fig. 3, etched, bright field. We observe the eutectoid phase in light grey and copper sulphide inclusions in dark-grey,

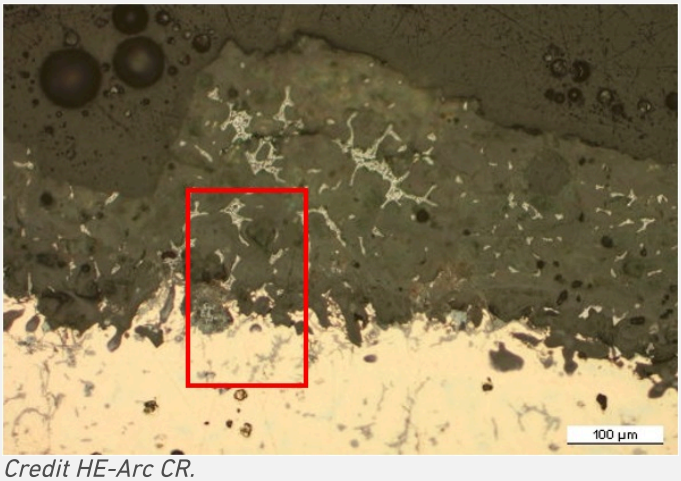
A dark green corrosion crust with a thickness between 100 and 320µm covers the entire surface of the blade fragment (Fig. 6). It retains a metallic ghost structure (Sn-rich eutectoid alpha + delta phase). Under polarized light localized orange and red corrosion products can be seen at the metal - corrosion crust interface (Fig. 7). Interdendritic corrosion and corroded slip lines can be seen in the metal structure and near fissures (Fig. 8). Elemental mapping (Fig. 9) shows that the green layer is Sn-rich (CP1, probably cassiterite, SnO_2) and depleted of Cu, whereas the orange and red corrosion aggregates are depleted of Sn and rich in Cu (Fig. 9, Table 3). Their Raman spectra indicate that they are mainly composed of cuprite (Fig. 10). The overall corrosion crust contains O, Si, C and Fe from the environment, while S is concentrated around the cuprite particles (Fig. 9).

Fig. 6: Micrograph of the metal sample from Fig. 3 (rotated 180°), unetched, bright field. A metallic ghost structure is preserved in the corrosion crust. The area selected for elemental chemical distribution (Fig. 9) is marked by a red rectangle,

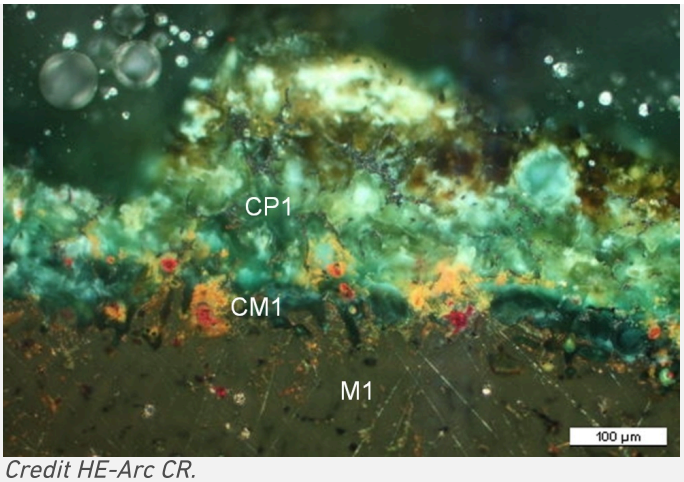
Fig. 7: Micrograph similar to Fig. 6 and corresponding to the stratigraphy of Fig. 11, polarised light. At the metal - green corrosion crust interface red and orange corrosion products can be seen,

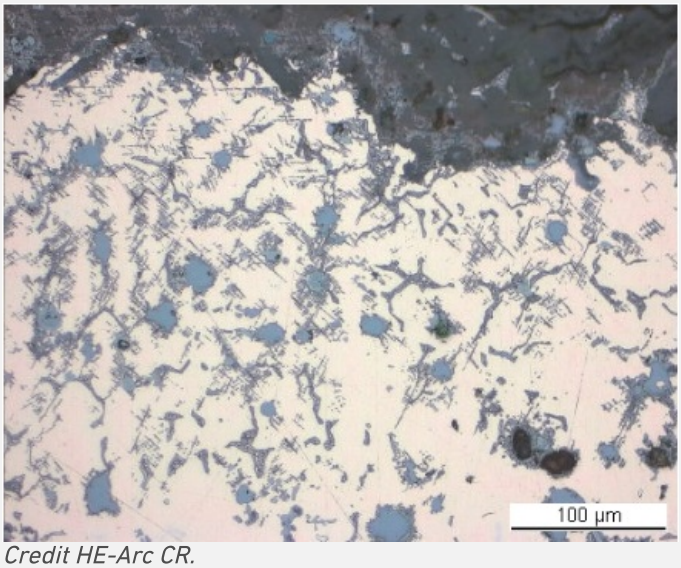
Fig. 8: Micrograph of the metal sample from Fig. 3 (detail), unetched, bright field. Metal with slip lines outlined by the corrosion,

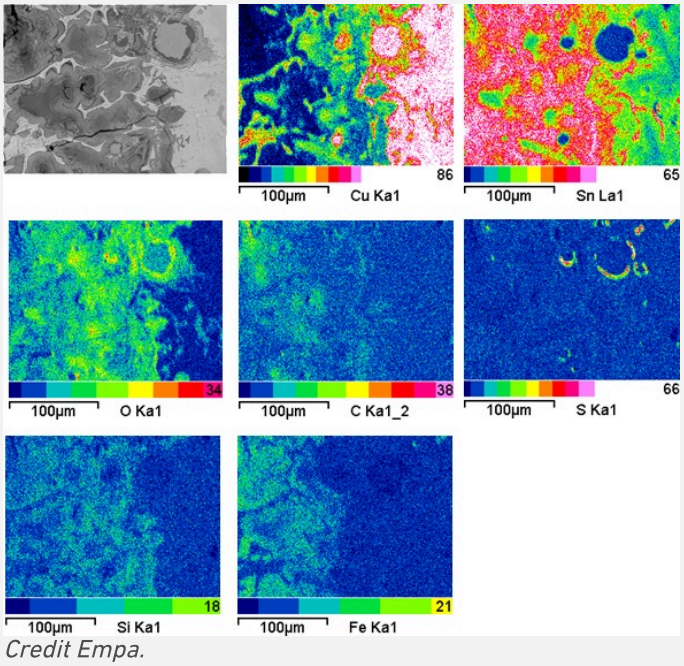
Table 3: Chemical composition (mass %) of the corrosion crust from Fig. 9. Method of analysis: SEM/EDS, Laboratory of Analytical Chemistry, Empa.

Fig. 9: SEM image, SE-mode, and elemental chemical distribution of the selected area of Fig. 6 (reversed picture rotated by 270°). Method of examination: SEM/EDS, Laboratory of Analytical Chemistry, Empa,

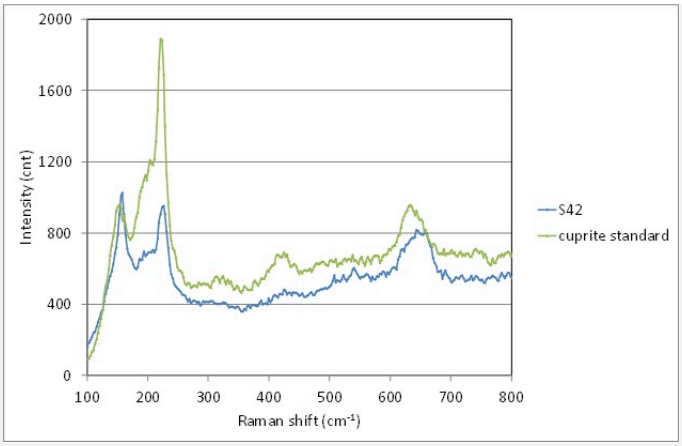
Fig. 10: Raman spectrum of a red-orange corrosion particle (S42) of Fig. 7 compared to the cuprite standard spectrum. Settings: laser wavelength 532nm, acquisition time 10s, one accumulation, filter D2 (0.75-0.8mW), hole 500, slit 80, grating 600. Method of analysis: Raman spectroscopy, Lab of Swiss National Museum, Affoltern a. Albis ZH,

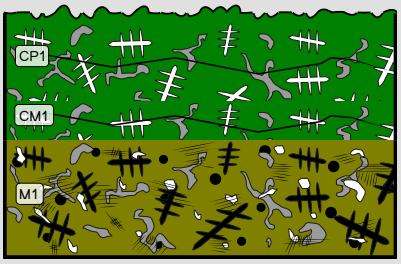
Fig. 11: Stratigraphic representation of the sample taken from the blade fragment of the winged axe in cross-section (dark field) using the MiCorr application. The characteristics of the strata are only accessible by clicking on the drawing that redirects you to the search tool by stratigraphy representation. This representation can be compared to Fig. 7, Credit HE-Arc CR.
