OVAL BRACELET WITH SURFACE DECORATIONS OF LINES AND INDENTATIONS MAH ANC. 2662 - LEADED BRONZE - LATE BRONZE AGE - SWITZERLAND

Artefact name	Oval bracelet with surface decorations of lines and indentations MAH anc. 2662
Authors	Marianne. Senn (Empa, Dübendorf, Zurich, Switzerland) & Christian. Degrigny (HE-Arc CR, Neuchâtel, Neuchâtel, Switzerland)
Url	/artefacts/982/

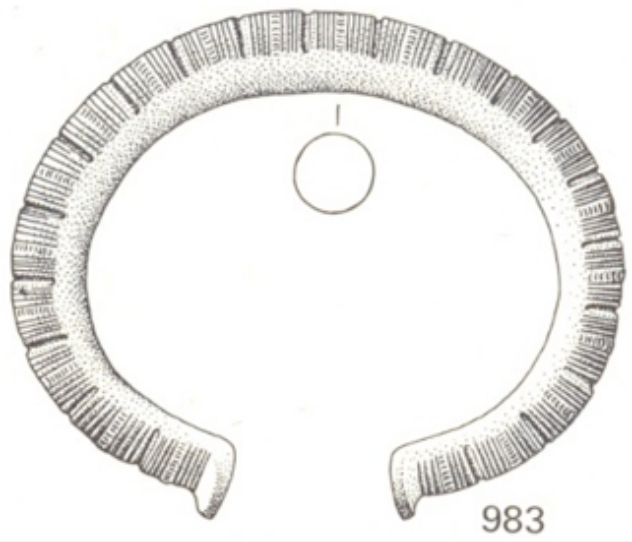
Fig. 1: Oval bracelet with surface decorations of lines and indentations (after Paszthory 1985, Tafel 82),

Description of the artefact	Bracelet decorated on the outside with surface decorations of lines and indentations (Paszthory 1985, 164 - Fig.1). It presents a dense, black patina. Dimensions: Ø = around 6.1cm; WT = 98g.
Type of artefact	Jewellery
Origin	Les Eaux-Vives, Genève, Geneva, Switzerland
Recovering date	Unknown
Chronology category	Late Bronze Age

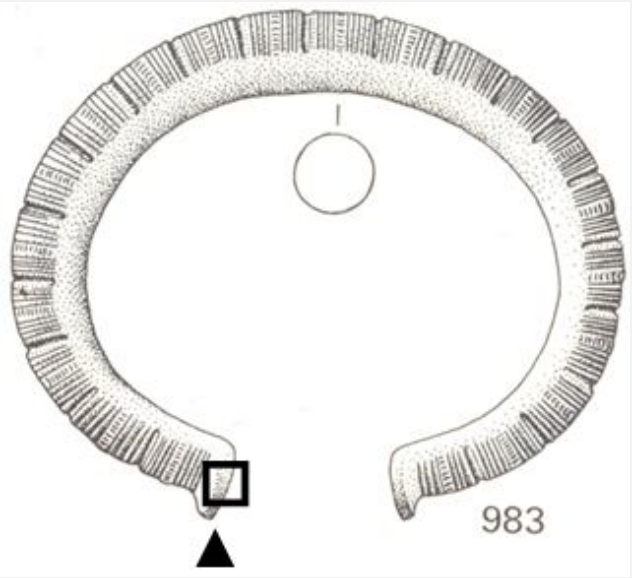
Fig. 2: Location of sampling area,

Description of sample	Two samples were taken from this object – only one is presented here. The sample is a section from one end of the bracelet (Fig. 2). Its dimensions are: L = 1.3mm and W = 0.3mm. The corrosion layer is relatively thick (Fig. 3).
Alloy	Leaded Bronze
Technology	As-cast
Lab number of sample	MAH 77-110-1a
Sample location	Musées d'art et d'histoire, Genève, Geneva
Responsible institution	Musées d'art et d'histoire, Genève, Geneva
Date and aim of sampling	1977, study of black and iron rich surface deposit on the object

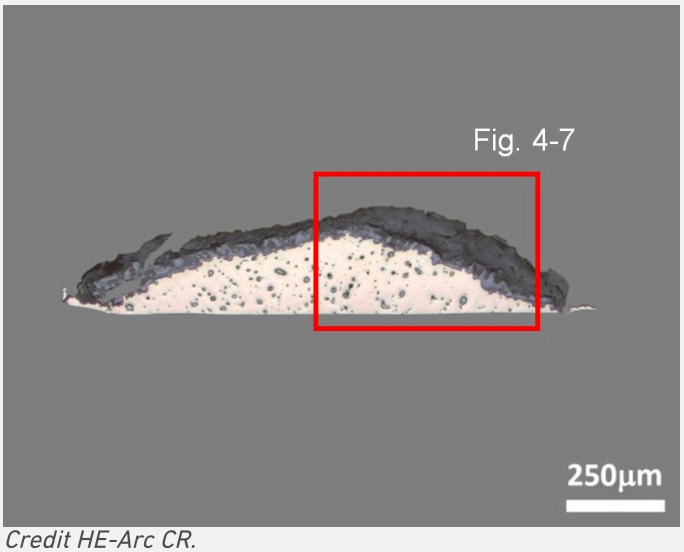
Fig. 3: Micrograph of the cross-section of the sample taken from the bracelet with surface decorations of lines and indentations showing the location of Figs. 4 to 7,

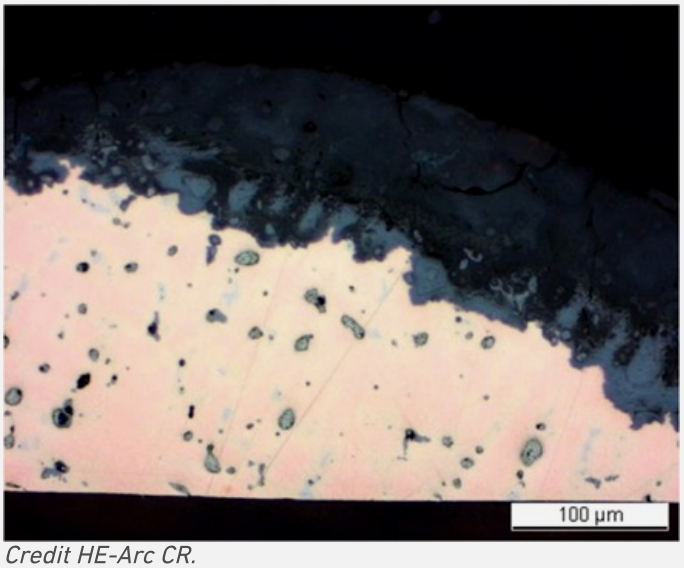
The remaining metal is a leaded bronze (Table 1) with low porosity, light and dark-grey inclusions (Fig. 4). In bright field the unetched alpha-delta eutectoid appears light-blue (Fig. 4). Etching reveals the dendritic structure of an as-cast metal (Fig. 5) with an average hardness of HV1 100. The inclusions appear as dark-grey (Pb-rich) and light-grey (copper sulphide) (Fig. 5 and Table 2) while the alpha-delta eutectoid is white (Fig. 5). The pink alpha phase is cored.

Table 2: Chemical composition (mass %) of the inclusions on Fig. 4. Method of analysis: SEM/EDS, Laboratory of Analytical Chemistry, Empa.

Fig. 4: Micrograph of the metal sample from Fig. 3 (detail), unetched, bright field. The metal is in pink, the Pb-rich inclusions in light-grey, the copper sulphide inclusions in dark-grey and the alpha-delta eutectoid in light-blue,

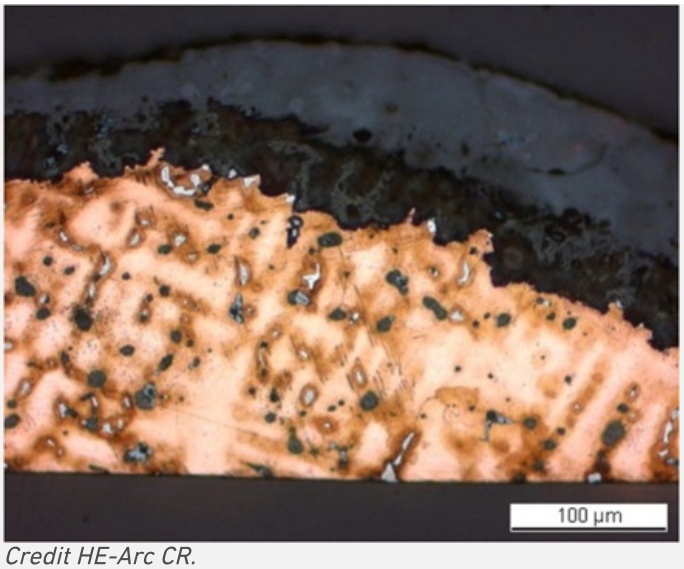
Fig. 5: Micrograph similar to Fig. 5, etched, bright field. The dendritic structure of the leaded bronze is revealed with the alpha-delta eutectoid in white and the alpha phase in pink. The colour difference of the alpha phase is due to coring,

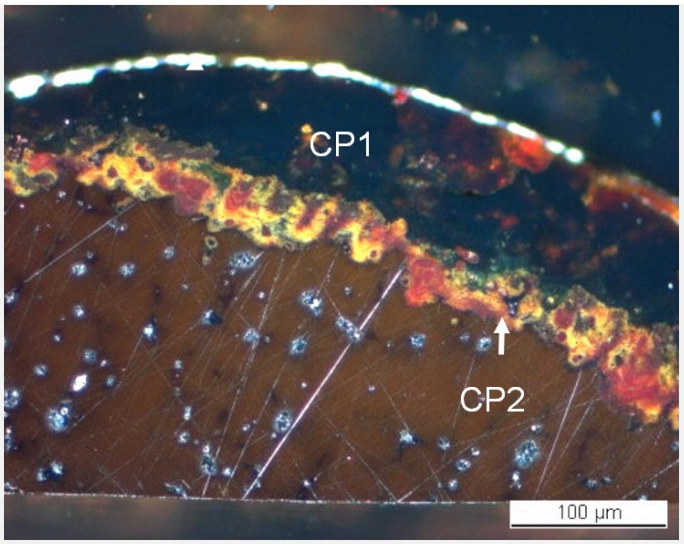
The corrosion crust has an average thickness of 80µm. It is composed of two layers (Fig. 6). The inner layer (CP2), which appears grey in bright field (Fig. 4), retains a Sn-rich dendritic ghost structure (Table 3 and Fig. 5). In polarized light, this layer is a mixture of reddish and yellow-brown corrosion products with some green areas (Fig. 6). The reddish parts have a composition similar to cuprite/Cu2O (Table 3). The adjacent dense, cracked layer, which appears dark-grey in bright field (CP1), is mainly composed of Fe,O and Sn with Sn,O and Fe-rich and Fe and O-rich zones contaminated with Si while being depleted of Cu (Fig. 8). In polarised light, it is dark, almost black with some red areas. In areas it contains Ag, Fe and Sn-rich inclusions with traces of Pb and Cu (Fig. 7 and Table 3).

Fig. 6: Micrograph similar to Fig. 4 and corresponding to the stratigraphy of Fig. 8, polarised light. From bottom left to top right: the metal in brown, the dendritic ghost structure in red, yellow-brown and green and the outer corrosion layer in black with some red areas. The thin white line is a crack,

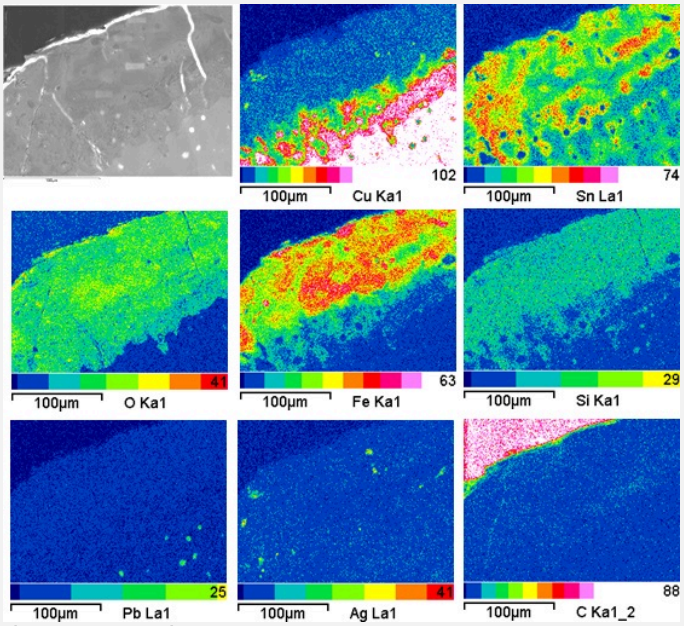
Table 3: Chemical composition (mass %) of the corrosion layers from Figs. 6 and 7. Method of analysis: SEM/EDS, Laboratory of Analytical Chemistry, Empa.

Fig. 7: EDS elemental chemical distribution in an SEM image (detail of Fig. 4, reversed picture). Method of examination: SEM/EDS, Laboratory of Analytical Chemistry, Empa,

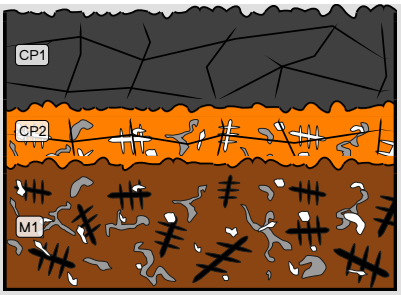
Fig. 8: Stratigraphic representation of the sample taken from the bracelet with a dense, black lake patina in cross-section (dark field) using the MiCorr application. The characteristics of the strata are only accessible by clicking on the drawing that redirects you to the search tool by stratigraphy representation. This representation can be compared to Fig. 6, Credit HE-Arc CR.

The surface of the cast leaded bronze has been replaced by a Fe/Sn-rich corrosion that retains a dendritic ghost structure. It is composed of a mixture of copper oxides (cuprite?) and a Sn-rich corrosion product (cassiterite?). The outer corrosion layer is composed of Fe-O and Sn-O-Fe areas depleted of Cu, but contaminated with Si. The enrichment in Fe seems to be the same as for the formation of patinas from lake contexts. However the outer corrosion layer was not formed in anaerobic conditions. Since the original surface is absent (destroyed) we refer to type corrosion 2 after Robbiola et al. 1998.
