OVAL BRACELET WITH SURFACE DECORATIONS OF LINES AND INDENTATIONS MAH ANC. 2662 - LEADED BRONZE - LATE BRONZE AGE - SWITZERLAND

Artefact name	Oval bracelet with surface decorations of lines and indentations MAH anc. 2662
Authors	Marianne. Senn (Empa, Dübendorf, Zurich, Switzerland) & Christian. Degrigny (HE-Arc CR, Neuchâtel, Neuchâtel, Switzerland)
Url	/artefacts/982/

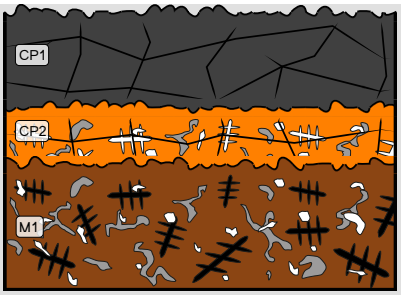
Fig. 8: Stratigraphic representation of the sample taken from the bracelet with a dense, black lake patina in cross-section (dark field) using the MiCorr application. The characteristics of the strata are only accessible by clicking on the drawing that redirects you to the search tool by stratigraphy representation. This representation can be compared to Fig. 6, Credit HE-Arc CR.

The surface of the cast leaded bronze has been replaced by a Fe/Sn-rich corrosion that retains a dendritic ghost structure. It is composed of a mixture of copper oxides (cuprite?) and a Sn-rich corrosion product (cassiterite?). The outer corrosion layer is composed of Fe-O and Sn-O-Fe areas depleted of Cu, but contaminated with Si. The enrichment in Fe seems to be the same as for the formation of patinas from lake contexts. However the outer corrosion layer was not formed in anaerobic conditions. Since the original surface is absent (destroyed) we refer to type corrosion 2 after Robbiola et al. 1998.
