MILITARY ID TAG 5668-MXX-1008-1 - ZN PB ALLOY - MODERN TIMES - FRANCE

Artefact name Military ID tag 5668-MXX-1008-1

Authors Christian. Degrigny (HE-Arc CR, Neuchâtel, Neuchâtel, Switzerland) & Marie-Jeanne. Scholl (HE-Arc CR, Neuchâtel, Neuchâtel, Switzerland) & Valentin. Boissonnas (HE-Arc CR, Neuchâtel, Neuchâtel, Switzerland)

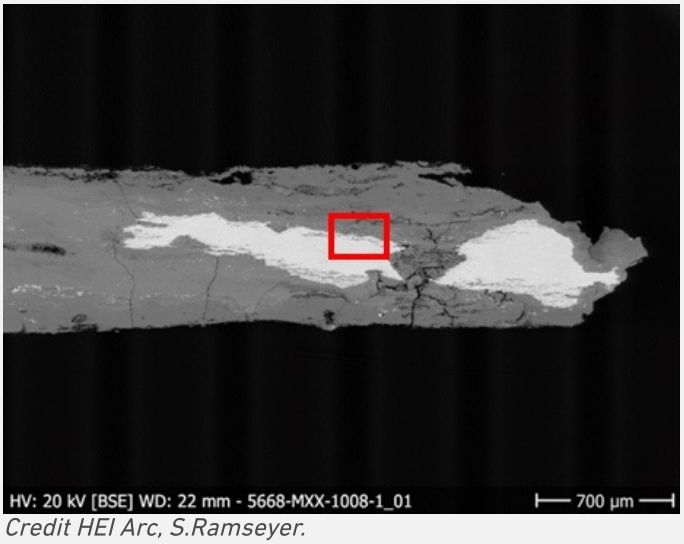
Table 1: Chemical composition of the metal. Method of analysis: SEM-EDS, Lab of Electronic Microscopy and Microanalysis, IMA (Néode), HEI Arc.

The remaining metal is a zinc alloy (Table 1) containing 1.8% in weight lead. Lead appears in the metal in the form of small flattened white Pb inclusions (Fig. 6), confirming the manufacturing technique, namely lamination. The etched metal does not show any specific microstructure (Fig. 7).

Elements	Zn	Pb
mass%	98.2	1.8

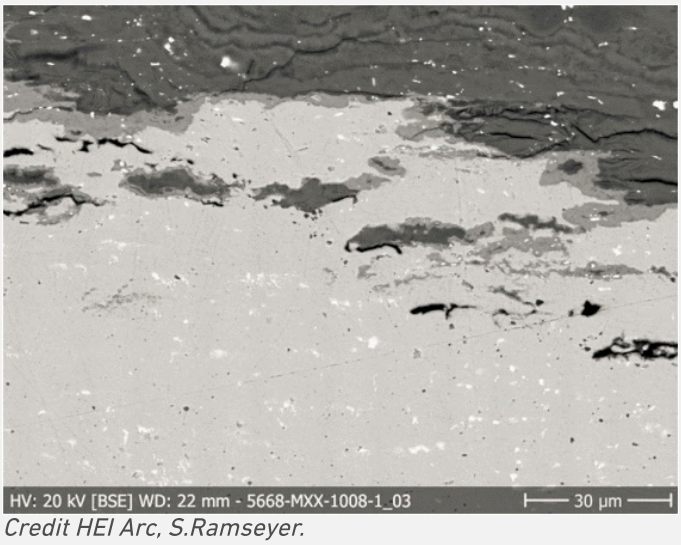
Fig. 5: SEM image of the cross-section, from Fig. 4 (detail), BSE-mode. Note the presence of Pb inclusions all through the thickness of the heavily cracked corrosion layers. The SEM image of Fig. 6 is marked by a rectangle,

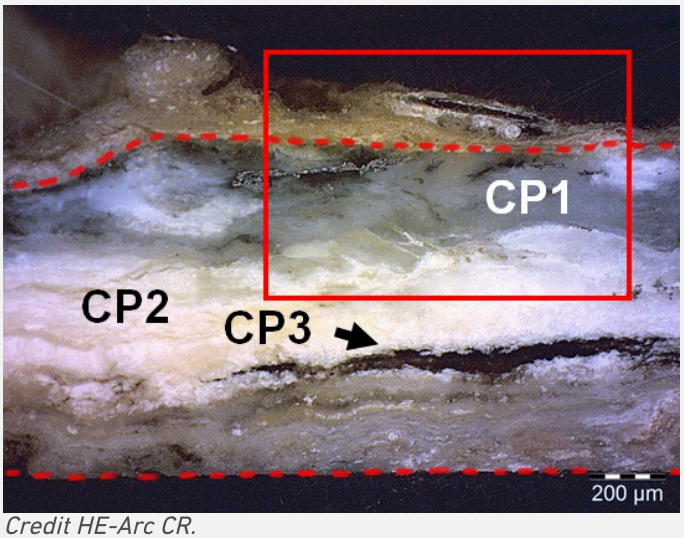
Table 2: Chemical composition of the different corrosion layers from Fig. 10. Method of analysis: SEM-EDS, Lab of Electronic Microscopy and Microanalysis, IMA (Néode) (+++: high concentration, ++ medium concentration, + low concentration, nd: not-detected).

The corrosion structure is multi-layered: several corrosion products overlap. However they are not all continuous layers, since some of them are isolated. Most of the corrosion products layers show structural voids (up to 100 µm thick) and some cracks inside. Three layers can be distinguished (Fig 8 and Figs. 16 or 17 - only Fig. 16 is detailed below) which have the same elements but in different proportions (Figs. 9, 10 and table 2):

Elements	O	Zn	Pb	S
Inner grey layer (CP1)	++	+++	+	
Black inclusions		+	+++	
Inner white layer (CP2)	++	+++	+	
Inner black layer (CP3)	++	+++	+	
Inner grey-orange layer	+	++		++
Remnant metal phase		+++	+

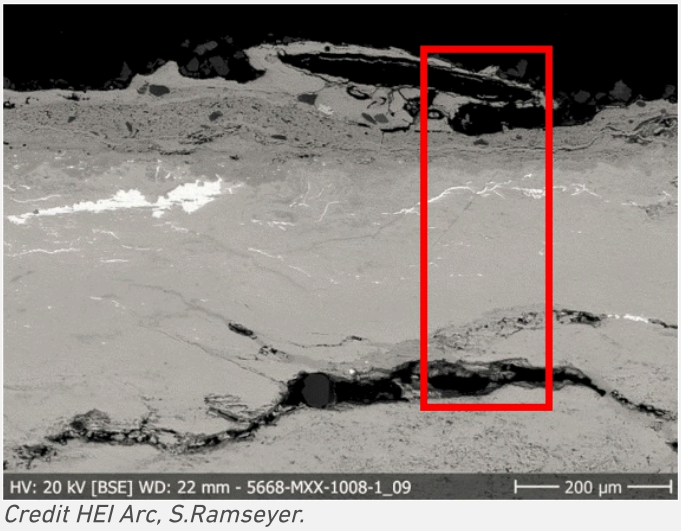
The inner grey layer (CP1, Figs. 8 and 16) has been identified by FTIR as a zinc carbonate (smithsonite), mixed with other unidentified corrosion products. Raman spectra seems to confirm it (Fig. 13). The exact composition of the inner white layer (CP2) is unknown. It shows a bluish fluorescence under UV light and has been identified by FTIR as a mixture of zinc oxides and carbonates, that could be zinc hydroxycarbonates (hydrozincite). Raman spectroscopy shows also a mixture of carbonates and other corrosion products (Fig. 14). The inner black layer (CP3) is a zinc carbonate as well, identified by FTIR and Raman spectroscopy (Fig. 15) appearing as a vein between layers of grey and white (Fig. 8).

Fig. 8: Micrograph of the cross-section, from Fig. 4 (detail) and corresponding to the stratigraphy of Fig. 5, unetched, dark field, 50x. View of the inner layers and the limit of the original surface (red line). We can see that the interfaces between the different layers are not well defined: some of the white corrosion product is found inside the inner grey layer. The micrograph of Fig. 9 is marked by a rectangle,

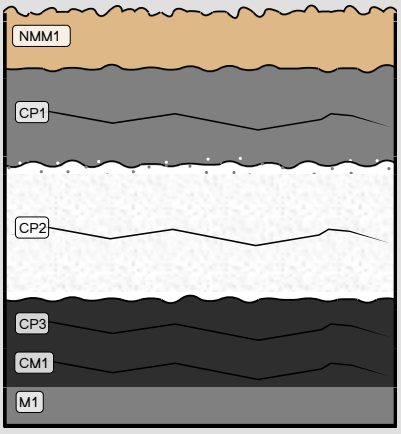
Fig. 16: Stratigraphic representation of fragment b of the military tag in cross-section (dark field) using the MiCorr application. The characteristics of the strata are only accessible by clicking on the drawing that redirects you to the search tool by stratigraphy representation. This representation can be compared to Fig. 10, Credit HE-Arc CR, M-J.Scholl.

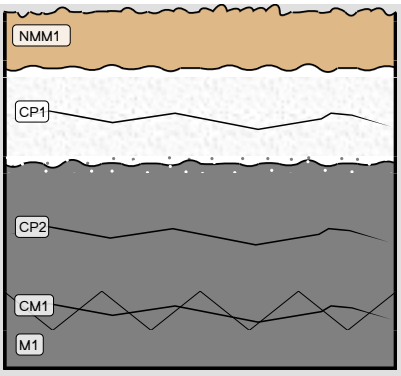
Fig. 17: Stratigraphic representation of fragment b of the military tag in cross-section (dark field) using the MiCorr application. The characteristics of the strata are only accessible by clicking on the drawing that redirects you to the search tool by stratigraphy representation. This representation is different from Fig. 10 due to the inversion of CP1 and CP2. Furthermore, CP3 is not represented, Credit HE-Arc CR, M-J.Scholl.
