FRAGMENT OF A BED STRUCTURE 03 12751-20.2.5 - TIN BRONZE - ROMAN TIMES - SWITZERLAND

Artefact name Fragment of a bed structure 03 12751-20.2.5

Authors Marianne. Senn (Empa, Dübendorf, Zurich, Switzerland) & Christian. Degrigny (HE-Arc CR, Neuchâtel, Neuchâtel, Switzerland)

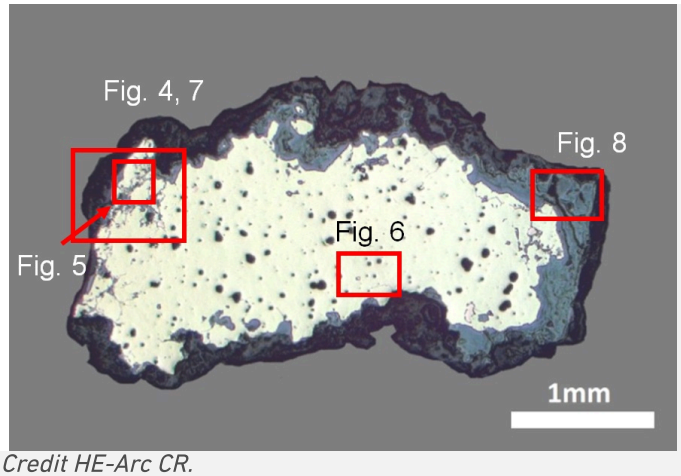
Fig. 3: Micrograph, in bright field, of the cross-section of the sample taken from the bed structure showing the location of Figs. 4 to 8,

Description of sample	The sample is a section from the fragment represented on Fig. 2. The remaining metal is surrounded by a thick corrosion crust (Fig. 3). Its dimensions are: L = 3.5mm and W = 1.5mm.
Alloy	Tin Bronze
Technology	Partly annealed after cold working
Lab number of sample	HECR-MK5
Sample location	HE-Arc CR, La Chaux-de-Fonds, Neuchâtel
Responsible institution	HE-Arc CR, La Chaux-de-Fonds, Neuchâtel
Date and aim of sampling	2008-2009, analyses of the corrosion products

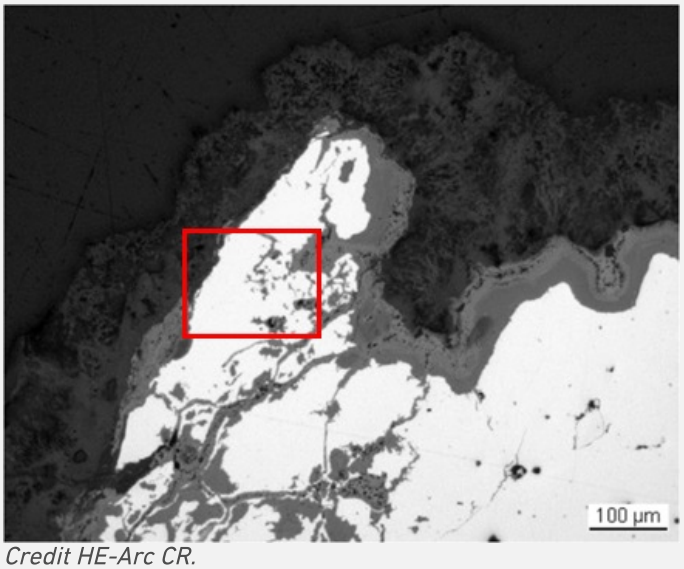
The remaining metal is a porous tin bronze (Table 1) with tiny iron oxides inclusions (Table 2) and secondary re-deposited copper. Intergranular corrosion has developed locally inside the metal (Figs. 4 and 5). The etched alloy shows a structure principally consisting of large polygonal grains, some of which include strain lines (Fig. 6). Locally an isolated alpha + delta eutectoid can be seen. Much smaller twinned grains can be found on the left side of the sample (Fig. 5). The average hardness of the metal is HV1 100. However on the left side of the sample, where the grains are smaller and twinned, the hardness is much higher (more cold work followed by annealing).

Fig. 4: Micrograph of the metal sample from Fig. 3 (detail), unetched, bright field. From bottom right to top left we observe: the metal (in white) with porosity (in black) and the corrosion layer (in light and dark-grey). The micrograph of Fig. 5 is marked by a rectangle,

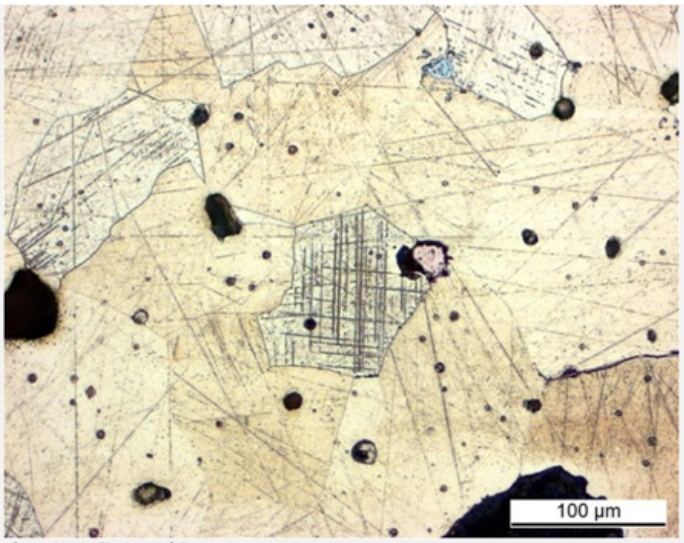
Fig. 6: Micrograph of the metal sample from Fig. 3, etched, bright field. The metal shows a structure consisting of large polygonal grains including strain lines. Pores are in black, remnants of the Sn-rich eutectoid phase in grey and secondary deposited copper in pink,

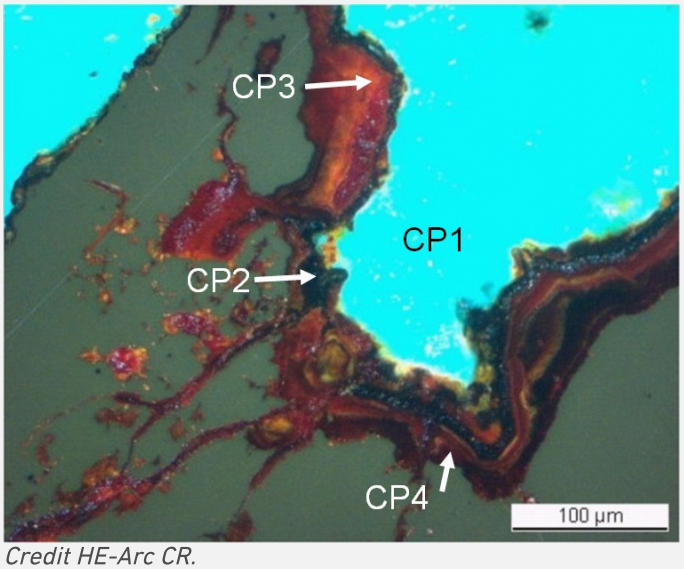
The metal - corrosion products interface is irregular (Fig. 3) and the average thickness of the corrosion crust is 300µm. The latter can be divided into four layers (Fig. 4). In bright field, the inner layer (CP4) is medium grey and dense. In polarised light it is dark-red/orange (Fig. 7). It is Sn-rich, contains O and Cl but is Cu depleted (Table 3 and Fig. 8). The next layer (CP3) is as well medium grey in bright field and light-red in polarised light. It has a composition similar to cuprite/Cu2O (Table 3). This was confirmed by Raman spectroscopy (Fig. 9). The third layer (CP2) is thin, is light grey in bright field and contains black pores. Under polarised light it looks brilliant black (Fig. 7) and is rich in Cu with Sn and O (Fig. 8). Using XRD, it was identified as a mixture of tenorite/CuO, cuprite/Cu2O and cassiterite/SnO2 (Krieg 2009). Raman spectroscopy could only detect tenorite in this layer (Fig. 10). In bright field the thick outer layer (CP1) is marbled in dark-grey and black, in polarised light it appears blue-green (Fig. 7). XRD analysis gave a composition close to malachite/Cu2CO3(OH)2 (Krieg 2009). In the present study no C was detected (Fig. 8), but Raman spectroscopy confirmed its presence (Fig. 11). The spectrum obtained shows a good match with published spectra (Bouchard and Smith 2003). Peaks are similar to those expected for malachite but most of them have a Raman shift: 3322, 1503, 1108, 1073, 759, 731, 603, 540, 442, 357, 276, 225, 186, 163 cm^{-1}. The underlined Raman shifts correspond to the peaks of greatest intensity. Environmental elements such as Si are concentrated on the top surface (Fig. 8).

Table 3: Chemical composition (mass %) of the corrosion crust from Fig. 7. Method of analysis: SEM/EDS, Laboratory of Analytical Chemistry, Empa.

Fig. 7: Micrograph showing the metal - corrosion crust interface from Fig. 3 (detail of Fig. 4) and corresponding to the stratigraphy of Fig. 12, polarised light. From bottom left to to right: In grey the metal, in dark-red/orange CP4, in light red CP3, in black (with pores) CP2 and in green-blue CP1,

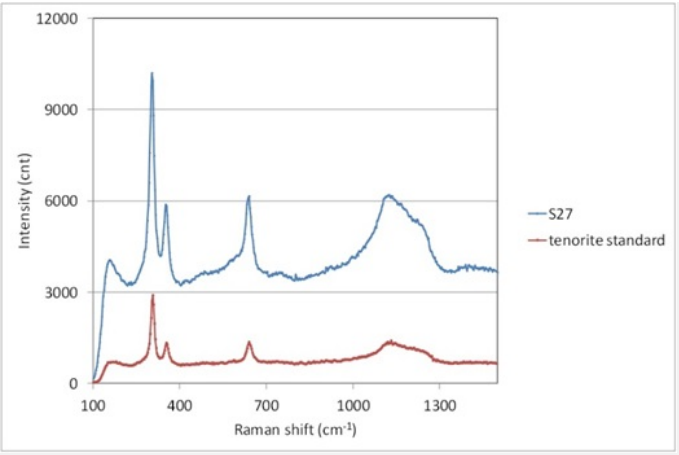
Fig. 10: Raman spectrum of the black layer (CP2) with pores (S27) from Fig. 7 compared to a tenorite standard spectrum. Settings: laser wavelength 532nm, acquisition time 100s, one accumulation, filter D1 (7.5-8mW), hole 500, slit 80, grating 600. Method of analysis: Raman spectroscopy, Lab of Swiss National Museum, Affoltern a. Albis ZH,

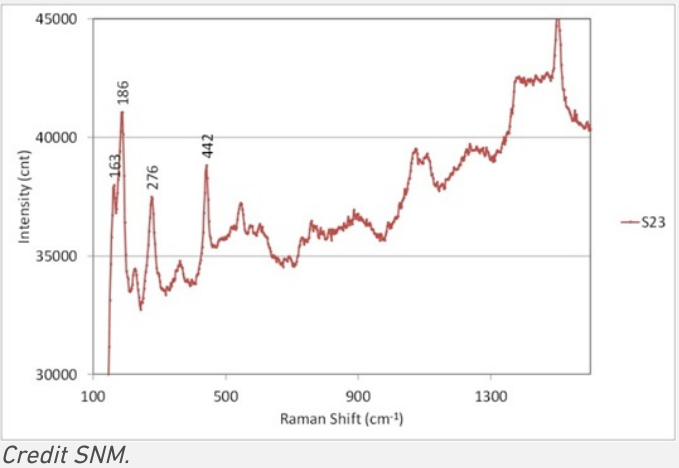
Fig. 11: Raman spectrum of the green outer corrosion layer (CP1) from Fig. 7. Settings: laser wavelength 532nm, acquisition time 80s, one accumulation, filter D2 (0.75-0.8mW), hole 500, slit 80, grating 600. Method of analysis: Raman spectroscopy, Lab of Swiss National Museum, Affoltern a. Albis ZH,

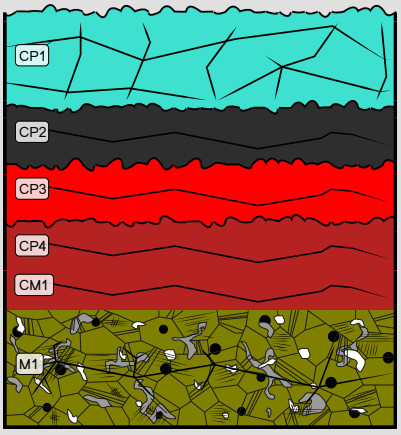
Fig. 12: Stratigraphic representation of the sample taken from the bed structure in cross-section (dark field) using the MiCorr application. The characteristics of the strata are only accessible by clicking on the drawing that redirects you to the search tool by stratigraphy representation. This representation can be compared to Fig. 7, Credit HE-Arc CR.
