BUST OF AN APPLIQUE 2005.054.F00265.1 - QUARTERNARY BRONZE ALLOY - ROMAN TIMES - SWITZERLAND

Artefact name	Bust of an applique 2005.054.F00265.1
Authors	Christian. Degrigny (HE-Arc CR, Neuchâtel, Neuchâtel, Switzerland) & Marie. Arnautou (HE-Arc CR, Neuchâtel, Neuchâtel, Switzerland) & Valentin. Boissonnas (HE-Arc CR, Neuchâtel, Neuchâtel, Switzerland)
Url	/artefacts/985/

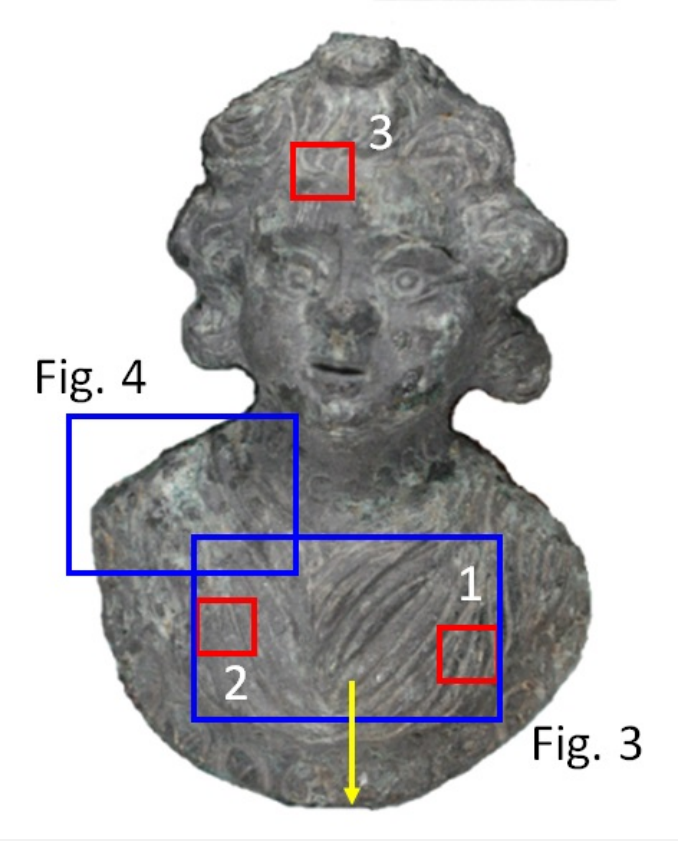
Fig.2: Location of areas of visual observation in blue, of sampling in yellow and of analyses (XRF) in red,

Description of sample	The sample is a scale (1 x 1 mm) of the dark-grey patina taken from the bottom part of the bust (Fig.2).
Alloy	Quarternary bronze alloy
Technology	Hollow cast, chiselled
Lab number of sample	None
Sample location	None
Responsible institution	Museum Augusta Raurica, Avenches
Date and aim of sampling	2013, study of the corrosion layer

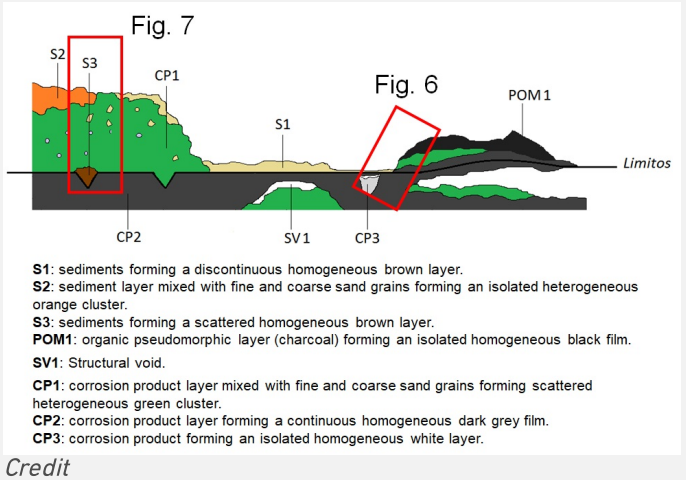
S1: sediments forming a discontinuous homogeneous brown layer.
S2: sediment layer mixed with fine and coarse sand grains forming an isolated heterogeneous orange cluster.
S3: sediments forming a scattered homogeneous brown layer.
POM1: organic pseudomorphic layer (charcoal) forming an isolated homogeneous black film.
SV1: Structural void.
CP1: corrosion product layer mixed with fine and coarse sand grains forming scattered heterogeneous green cluster.
CP2: corrosion product layer forming a continuous homogeneous dark grey film.
CP3: corrosion product forming an isolated homogeneous white layer.

Fig. 5: Stratigraphic representation based on visual observation and visualization of the stratigraphies of Figs. 6 and 7.

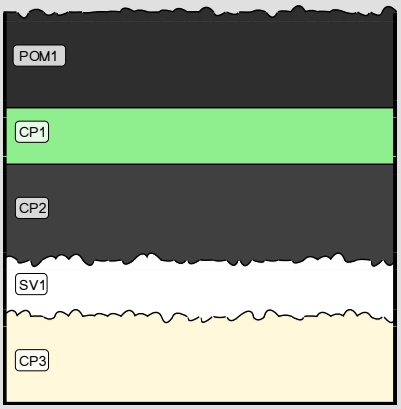
Fig. 6: Stratigraphic representation of the corrosion structure of the bust observed macroscopically under binocular microscope using the MiCorr application. The characteristics of the strata are only accessible by clicking on the drawing that redirects you to the search tool by stratigraphy representation. This representation can be compared to Fig. 5, Credit HE-Arc CR, C.Degrigny.

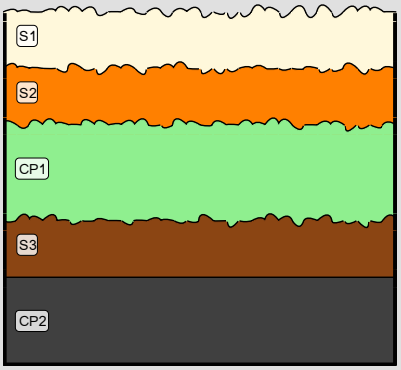
Fig. 7: Stratigraphic representation of the corrosion structure of the bust observed macroscopically under binocular microscope using the MiCorr application. The characteristics of the strata are only accessible by clicking on the drawing that redirects you to the search tool by stratigraphy representation. This representation can be compared to Fig. 5, Credit HE-Arc CR, C.Degrigny.

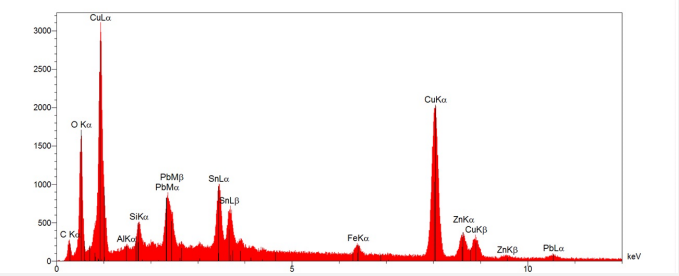
The qualitative analysis carried out on the dark patina by SEM/EDS (Fig. 8) confirms the XRF results (Table 1), showing the same elements and the presence of O, which probably correspond to copper oxide (cuprite Cu2O or tenorite CuO). The dark patina is covered by an adherent green corrosion layer (CP1) which has developed in scattered clusters (probably copper carbonate). The clusters have a surface area of 2 mm2 to 2 cm2, and have a thickness of 0.5 to 5 millimeters. In some places, the green corrosion layer has formed in the porous blisters of the dark layer (Fig. 5). Charcoal might be found locally (POM1) as well as different sediments: S1 (discontinuous and brown), S2 (mixed with fine and coarse sand grains) and S3 (scattered homogeneous brown layer).

Fig. 8: EDS spectrum of the scale of the dark-grey patina taken from the bottom part of the bust (yellow arrow of Fig. 2),
