PIN OR NEEDLE FRAGMENT HR-3031 - TIN BRONZE - LATE BRONZE AGE - SWITZERLAND

Artefact name	Pin or needle fragment HR-3031
Authors	Marianne. Senn (EMPA, Dübendorf, Zurich, Switzerland) & Christian. Degrigny (HE-Arc CR, Neuchâtel, Neuchâtel, Switzerland)
Url	/artefacts/986/

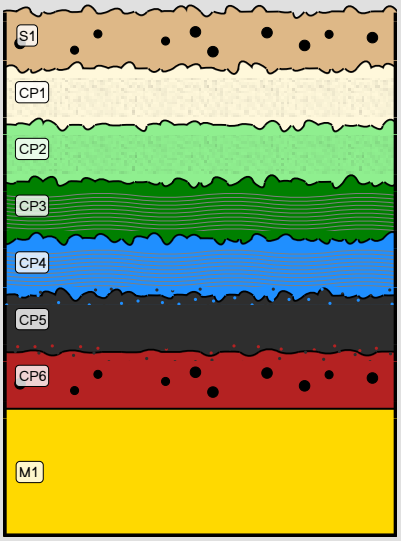
Fig. 3: Stratigraphic representation of the pin or needle fragment with green-blue patina under binocular using the MiCorr application. The characteristics of the strata are only accessible by clicking on the drawing that redirects you to the search tool by stratigraphy representation, Credit HE-Arc CR.

The two corrosion structures observed under binocular and on cross-sections look rather different. It might be due to some disruption during the cutting process.

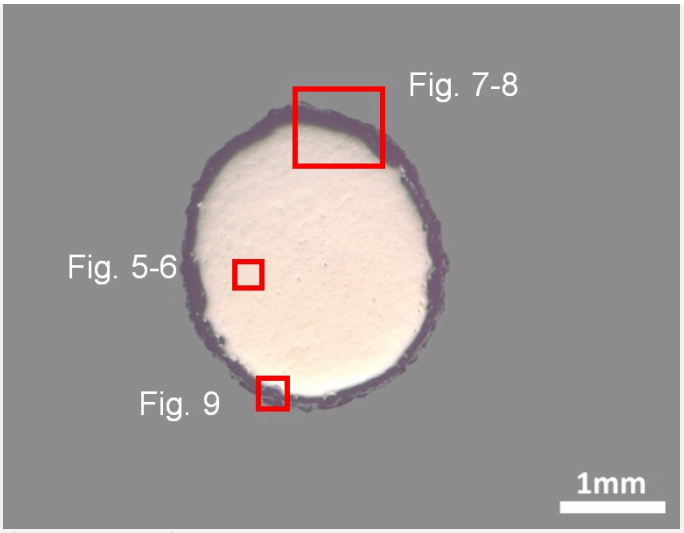
Fig. 4: Micrograph of the cross-section of the sample taken from the pin or needle fragment with green-blue patina showing the location of Figs. 5 to 9,

Description of sample	The cross-section is circular and is a complete section through the pin (Fig. 2). The surface is completely covered with a rather thin corrosion crust of irregular thickness (Fig. 4).
Alloy	Tin Bronze
Technology	Cold worked after annealing
Lab number of sample	MAH 87-195
Sample location	Musées d'art et d'histoire, Genève, Geneva
Responsible institution	Musées d'art et d'histoire, Genève, Geneva
Date and aim of sampling	1987, metallography and corrosion characterisation

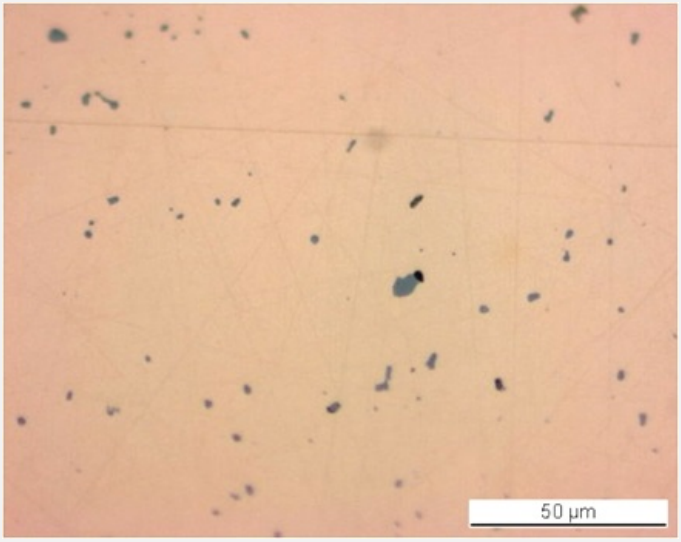
The remaining metal is a tin bronze and contains small copper sulphide and Pb-rich inclusions evenly distributed throughout the metal (Fig. 5, Tables 1 and 2). The Pb-rich inclusions are only visible with SEM appearing as white particles. The etched structure of the tin bronze shows re-crystallised and angular grains, some of them with twins (Fig. 6). Strain or slip lines are visible, especially near the metal surface. They indicate a final cold working. Copper sulphide inclusions are found both at the grain boundaries and inside the grains (Fig. 6). The average hardness of the metal is about HV1 120.

Fig. 5: Micrograph of the metal sample from Fig. 4 (detail), unetched, bright field. Grey copper sulphide inclusions are clearly visible,

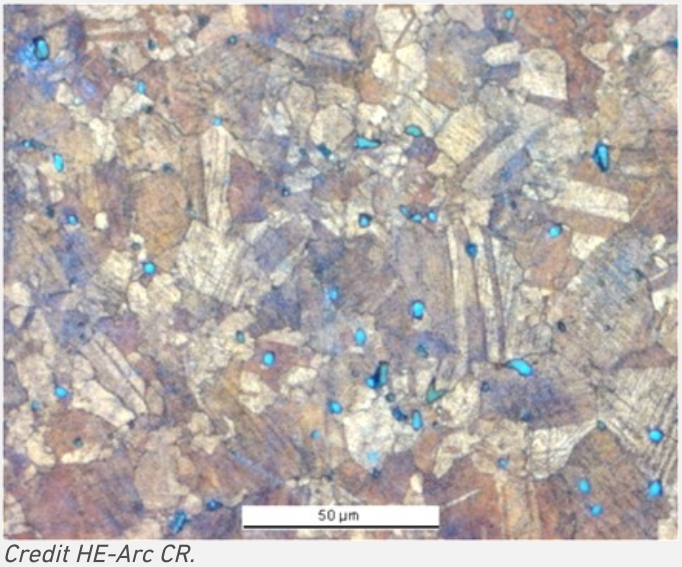
Fig. 6: Micrograph of the metal sample from Fig. 4 (detail), etched, bright field. Small angular re-crystallised grains (some with twins) with slip lines are observed. Copper sulphide inclusions appear in blue,

The pin is made from a tin bronze and has been repeatedly cold worked and annealed. After the last annealing there has been some cold work, as can be seen from the strain lines visible after etching the metal. Due to the presence in the corrosion crust of an outer malachite layer, the corrosion was described as terrestrial by Schweizer (Schweizer 1994). The elemental chemical distribution of the corrosion crust shows a more complex situation: as expected for an object buried in a terrestrial site, a typical enrichment of Sn is observed in the inner and intermediate layers covering the remaining metal surface. However it is combined with Fe and S which are often present in lake patinas. According to Schweizer, these layers were formed in anaerobic conditions and developed later on into malachite in an aerated soil through partial dehydration (Schweizer 1994, Schwartz 1934). Since the original surface is absent (destroyed), we refer to type 2 corrosion after Robbiola et al. 1998.

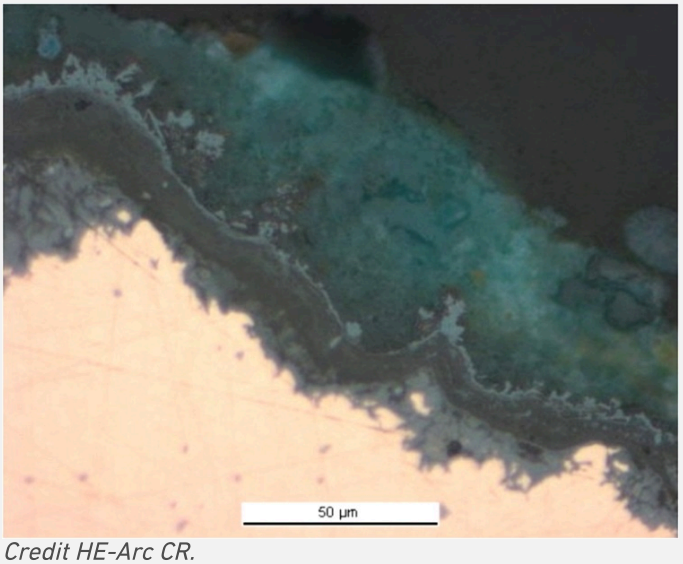
The corrosion crust has an average thickness of about 50µm (Fig. 7). In polarised light (Fig. 8), the corrosion stratigraphy is more clearly visible: it is composed of an inner dark red-green-yellow corrosion layer (CP6 to CP8, an agglomerate of nanoscale stannic oxides with cuprite) directly on the metal core (Table 3 and Fig. 9, already studied by Piccardo et al. 2007), an intermediate multi-layered black-grey bands (CP3 to CP5) and an outer turquoise-green layer (CP1-CP2) analysed with XRD by Schweizer and identified as malachite/CuCO3Cu(OH)2 (Schweizer 1994). In some areas the dark-red layers (CP8) can also be found in between the black-grey bands (CP3 to CP5) and the malachite (CP1-CP2). Elemental chemical distribution of the SEM image of Fig. 9 shows that the black-grey layers are enriched in Sn but also contain Fe. Superior markers such as contextual Al and Si are present in the outer malachite layers. S is present both on the rim of the outer black-grey layers and in the malachite (Fig. 9, Table 3).

Fig. 7: Micrograph of the metal sample from Fig. 4 (detail) and corresponding to the stratigraphy of Fig. 10, unetched, bright field. Stratigraphy of the corrosion crust: inner light grey layer (CP3), intermediate dark grey layer with a light-grey rim (CP2) and outer grey-green layer (CP1),

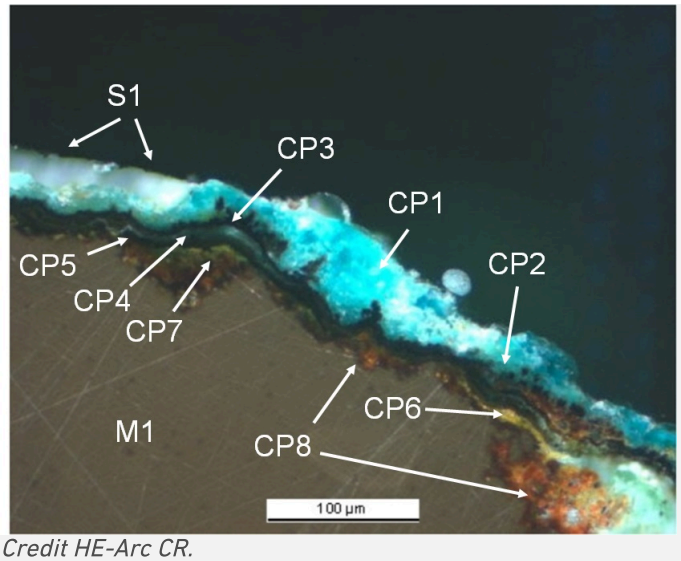
Fig. 8: Micrograph of the metal sample from Fig. 4 and corresponding to the stratigraphy of Fig. 10, polarised light. The metal appears in brown; the inner layer appears as red-orange, the intermediate layer as black and the outer layer as turquoise,

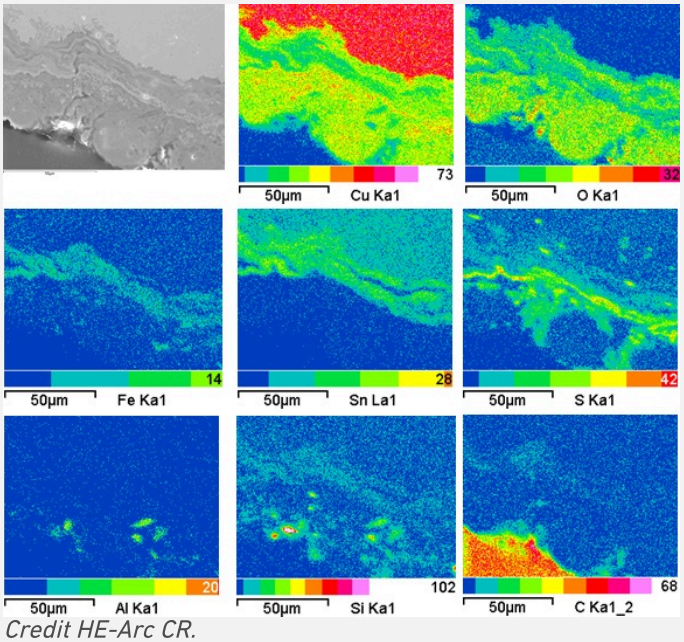
Fig. 9: SEM image, SE-mode, and elemental chemical distribution of a selected area of Fig. 4. Method of examination: SEM/EDS, Laboratory of Analytical Chemistry, Empa,

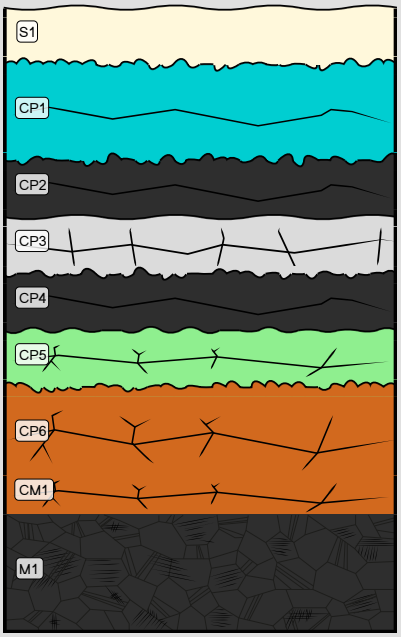
Corrosion form	Multiform - pitting
Corrosion type	Type II (Robbiola)

Fig. 10: Stratigraphic representation of the sample taken from the pin or needle fragment with green-blue patina in cross-section (dark field) using the MiCorr application. The characteristics of the strata are only accessible by clicking on the drawing that redirects you to the search tool by stratigraphy representation. This representation can be compared to Figs. 7 and 8, Credit HE-Arc CR.
