SACRIFICIAL KNIFE (TUMI) IVC 24745 - CU ALLOY - UNKNOWN - PERU

Artefact name	Sacrificial knife (tumi) IVc 24745
Authors	Christian. Degrigny (HE-Arc CR, Neuchâtel, Neuchâtel, Switzerland) & Marion. Billot (HE-Arc CR, Neuchâtel, Neuchâtel, Switzerland) & Valentin. Boissonnas (HE-Arc CR, Neuchâtel, Neuchâtel, Switzerland)
Url	/artefacts/988/

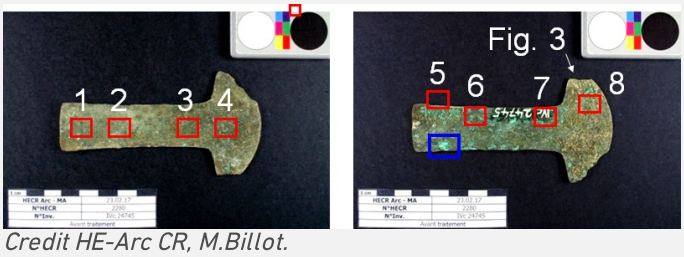
Fig. 2: Location of Fig. 3, XRF analyses (red squares) and the sampling area (blue square),

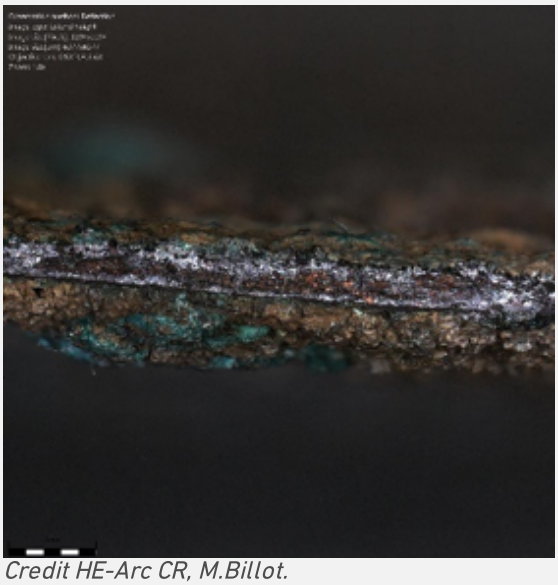
Fig. 3: Detail of the corrosion structure of the fractured cutting edge of the knife. To be related to the schematic stratigraphy of Fig. 6,

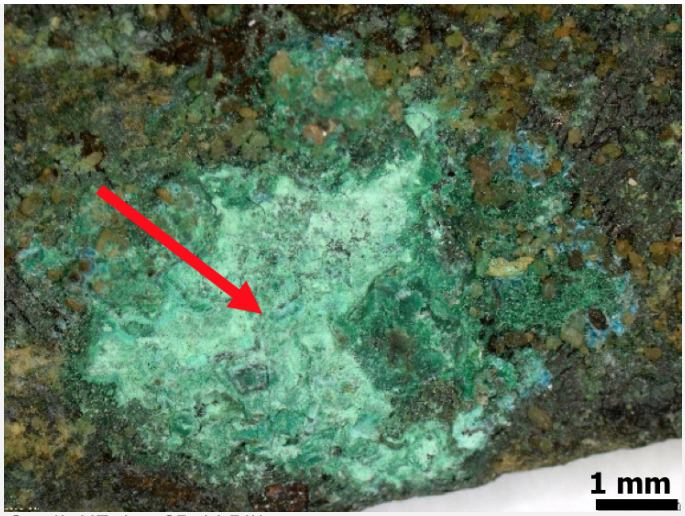
Fig. 4: Detail from Fig. 2 of the sampling area for XRF and XRD analysis,
