COOKING POT HANDLE FRAGMENT V.008.2/2948.1. - LEADED BRONZE - ROMAN TIMES - SWITZERLAND

Artefact name Cooking pot handle fragment V.008.2/2948.1.

Authors Christian. Degrigny (HE-Arc CR, Neuchâtel, Neuchâtel, Switzerland) & Lucile. Ruynat (HE-Arc CR, None) & Valentin. Boissonnas (HE-Arc CR, Neuchâtel, Neuchâtel, Switzerland)

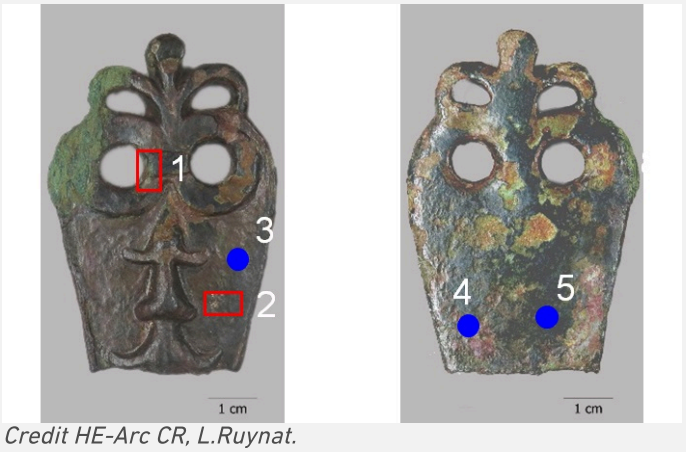
Fig. 1: Cooking pot handle before and after treatment, front (a and c) and back (b and d),

Description of the artefact The object is the tip of a cooking pot handle representative of the Augustan age (100 AD), recognisable by the axial symmetry and the two orifices surrounded by prominent edging and flared shape. The upper part is composed of an openwork flower with three petals, comparable to the representation of the fleur-de-lis. A curved pattern frieze can be seen in the centre of the object. No decoration was found on the back. Before treatment, the object was covered with green corrosion products and organic remains, most of which were mineralised (Figs. 1a and b). Dimensions : L = 73 mm ; W = 48 ; T = 9 mm ; WT = 80.8 g.

Burial conditions / environment	Soil
Artefact location	Archaeological Service of the Aargau canton, Brugg, Aargau
Owner	Archaeological Service of the Aargau canton, Brugg, Aargau
Inv. number	V.008.2/2948.1. (Inv. Number at HE-Arc: 2001)
Recorded conservation data	2008: Probably a first sediment clearing by archaeologists during the excavation. 2016-17: Lucile Ruynat, mechanical removal of the corrosion products over the limitos with ultrasonic scalpel. Conservation of wooden remains at the top right of the front of the object. Protective layer (varnish) with acrylic resin Paraloid B72®.

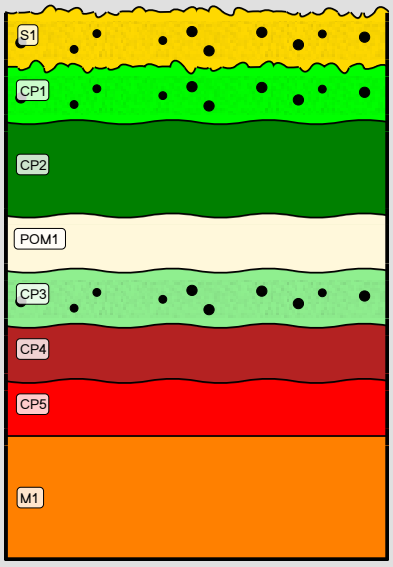
The stratigraphy below gives an overview of the corrosion layers encountered on the object from visual macroscopic observation. The stratigraphy was created before treatment by observation under a binocular microscope and modified during the mechanical removal of corrosion products.

S1	Sediments with sand forming isolated and highly porous ochre-colored clusters
CP1	Scattered clusters of highly porous medium green corrosion product
CP2	Continuous layer of compact dark green corrosion product
SV1	Structural voids within CP2
POM1	Pseudomorphs of organic remains
POM2	Pseudomorphs of wood remains
CP3	Scattered clusters of highly porous light green corrosion product
CP4	Discontinuous layer of compact dark-red corrosion products
CP5	Discontinuous layer of compact red corrosion product
M1	Continuous and compact metal

Fig. 3: Stratigraphic representation of the cooking pot handle fragment in cross-section based on macroscopic global observation and indication of Fig. 4,

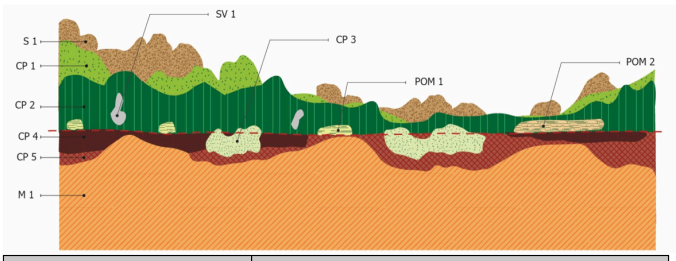
The schematic representation of corrosion layers of Fig.3 integrating additional information based on the analyses carried out is given in Fig. 7.

S1: Sediments	Soil and sand
CP1: Outer light green corrosion clusters	Malachite?
CP2: Outer dark green corrosion layer	Malachite?
SV1	Structural voids within CP2
POM1: Pseudomorphs of organic remains	Stems, grass within CP2
POM2: Pseudomorphs of organic remains	Wood within CP2
CP3: Outer/inner isolated light green corrosion product	No Nantokite, No Malachite
CP4: Inner black-dark red corrosion layer	Main phase: Cuprite Tin enrichment
CP5: Inner red corrosion layer	Main phase: Cuprite
M1: Orange Metal	Bronze with high lead content, probably with dendrites (as-cast)

Fig. 7: Improved stratigraphic representation of the cooking pot handle fragment from visual observations and analyses,

The object is a leaded bronze with a well-preserved metal core. Covering the metal are two strata (CP4 and CP5) composed of cuprite, the darker (CP4) appears enriched in tin. The superior interface of these layers represents the limitos. In areas the limitos, CP4 and CP5 have been replaced by a light green porous corrosion product (CP3). The following layers CP2 and CP1 are probably malachite.
The powdery green corrosion layer CP3 has frequently been observed on bronzes of Vindonissa where it can be located within cuprite or malachite layers. It is typically developed below the limitos and renders the latter extremely fragile. The nature of this corrosion product has not yet been determined. However, the absence of chlorine indicates that it is not a chlorinated corrosion product such as atacamite or paratacamite. The aggressive urban soil could be a reason for the transformation of these naturally grown and stable corrosion layers.
