FRAGMENT OF AN AEGIS OF NEÏTH 1886.305.0096 - LEADED BRONZE

Artefact name Fragment of an Aegis of Neïth 1886.305.0096

Authors Line. Pedersen (HE-Arc, Neuchâtel, Neuchâtel, Switzerland) & Christian. Degrigny (HE-Arc CR, Neuchâtel, Neuchâtel, Switzerland) & Valentin. Boissonnas (HE-Arc CR, Neuchâtel, Neuchâtel, Switzerland)

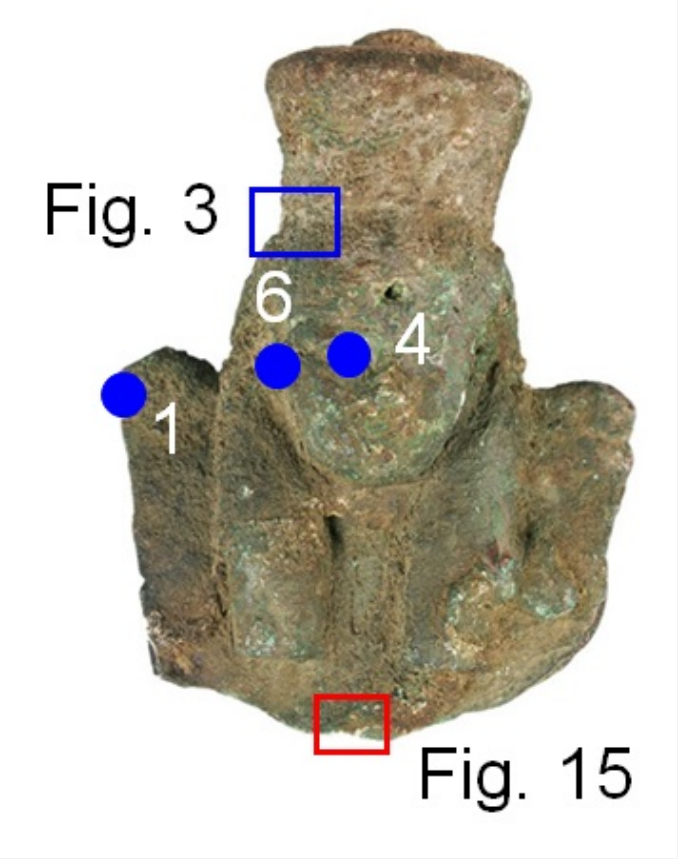
Description of the artefact Fragment of an aegis surmounted by the head of Neith, the Egyptian goddess of war (Fig. 1). Traces of leaf gilding is still present in certain areas (Fig. 3). The lower part of the collar and the upper part of the crown are broken (Fig. 2 and 4). The surface is covered with a thick and hard, green-brown corrosion crust (Fig. 2, 3 and 4). A cross-section was studied on the lower edge that was broken after excavation. Dimensions: L = 96mm; W = 72mm; T = 40mm; WT = 216g.

Fig. 2: Front face of the aegis with location of XRF measurements (blue spots), powder sample (red square) and gilding remains on the surface (blue square),

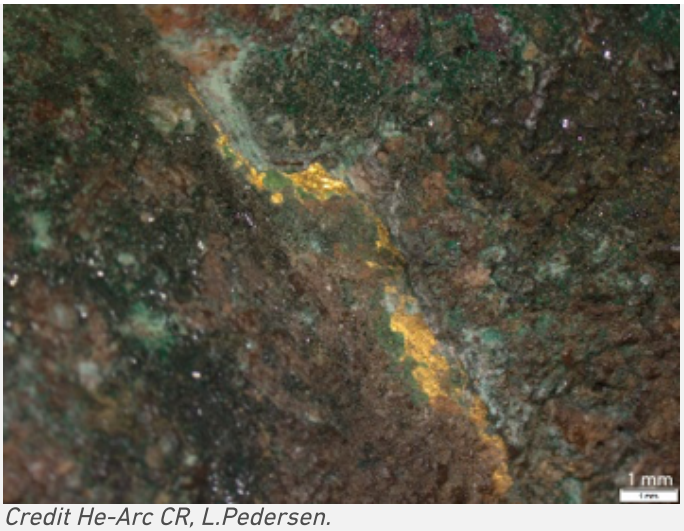
Fig. 3: Remains of foil-gilding on the corroded surface,

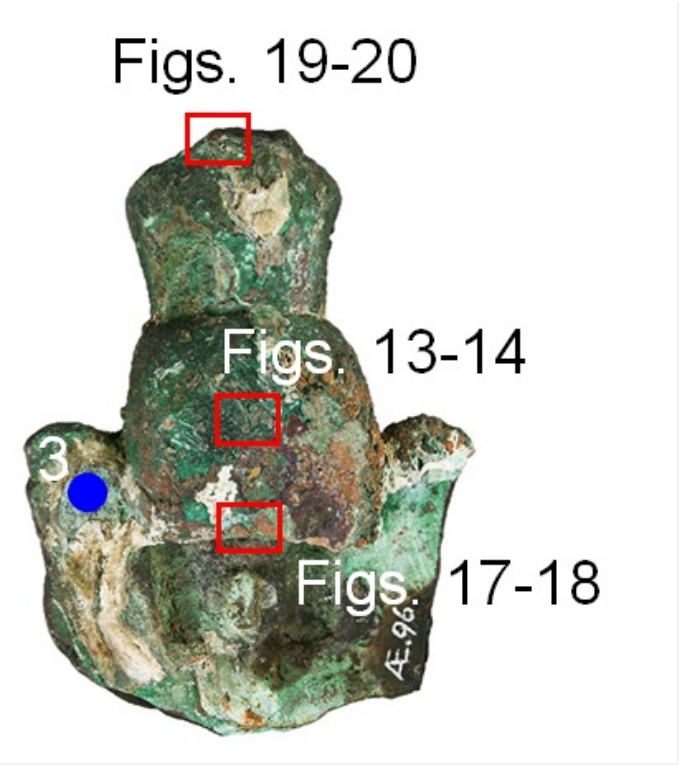
Fig. 5: Back face of the aegis with location of XRF measurement (blue spot) and powder samples (red squares),

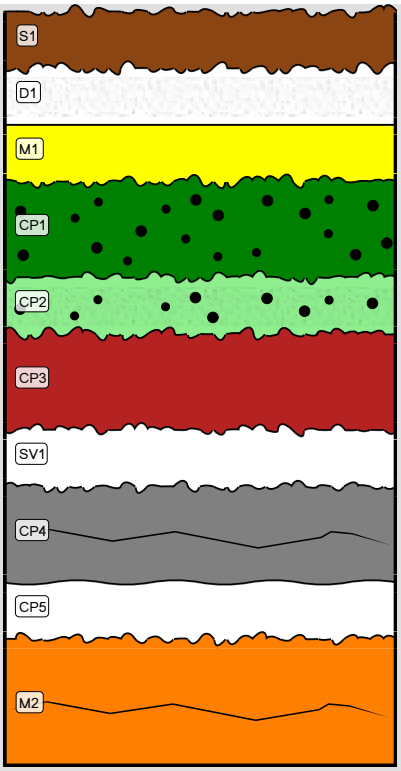
Fig.9: Schematic representation combining stratigraphies 1 and 2 under binocular microscope and using the MiCorr application. The characteristics of the strata are only accessible by clicking on the drawing that redirects you to the search tool by stratigraphy representation, Credit He-Arc CR, L.Pedersen.

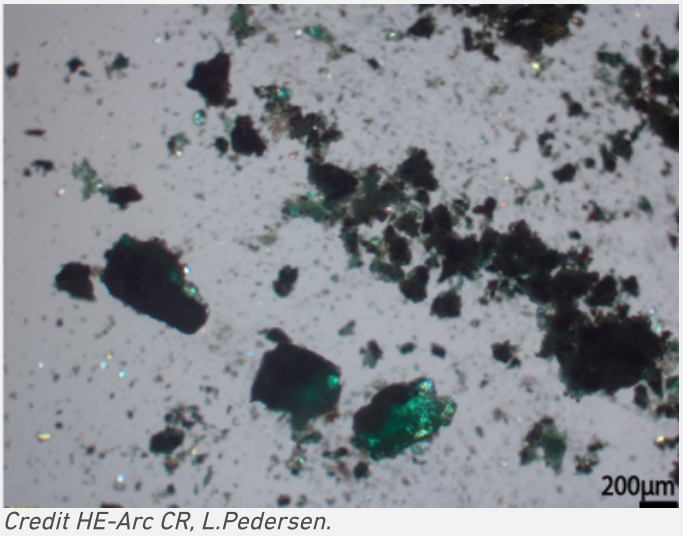
Fig. 14: Dark green corrosion product identified as paratacamite, atacamite Cu2Cl(OH)3 by XRD. Microscopic examination under polarized light,

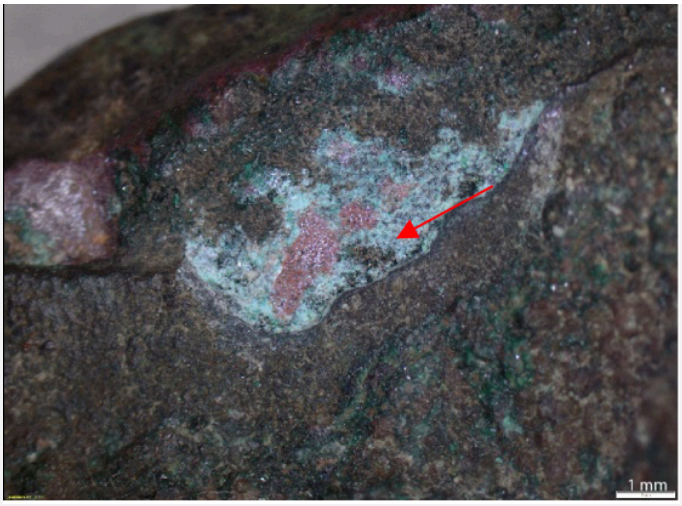
Fig. 15: Observation of the light green corrosion product,

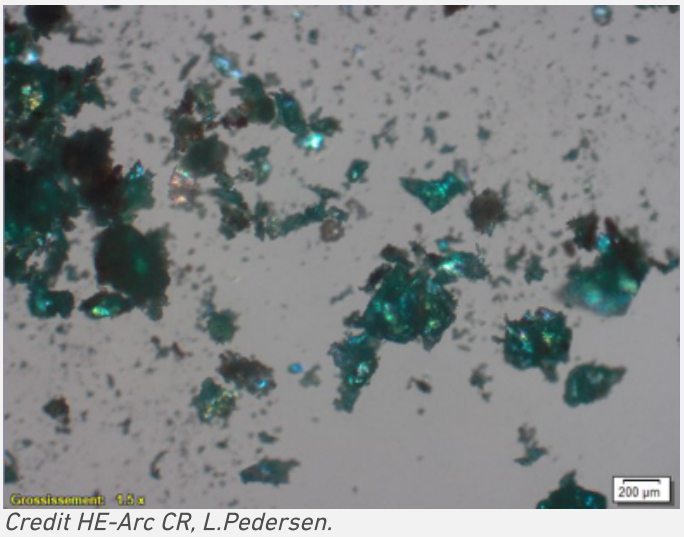
Fig. 16: Light green corrosion product identified as paratacamite, atacamite (Cu2Cl(OH)3) by XRD. Microscopic examination under polarized light,

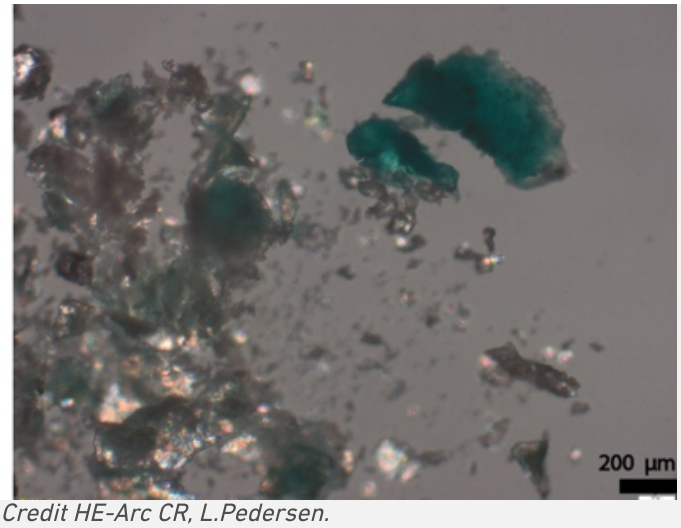
Fig. 18: Light blue corrosion product identified as chalconatronite Na2Cu(CO3)2·3H2O by XRD. Microscopic examination under polarized light,

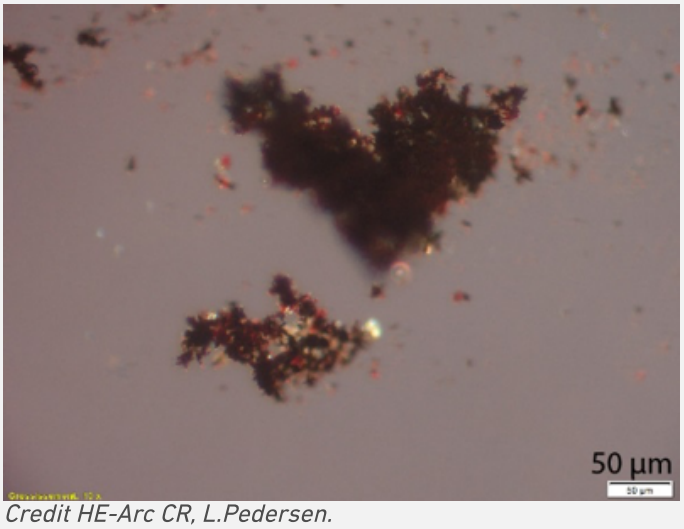
Fig. 20: Dark red corrosion product identified as cuprite Cu2O as major component and tenorite CuO as minor component. Microscopic examination under polarized light,
