FRAGMENT OF AN AEGIS OF NEÏTH 1886.305.0096 - LEADED BRONZE

Artefact name Fragment of an Aegis of Neïth 1886.305.0096

Authors Line. Pedersen (HE-Arc, Neuchâtel, Neuchâtel, Switzerland) & Christian. Degrigny (HE-Arc CR, Neuchâtel, Neuchâtel, Switzerland) & Valentin. Boissonnas (HE-Arc CR, Neuchâtel, Neuchâtel, Switzerland)

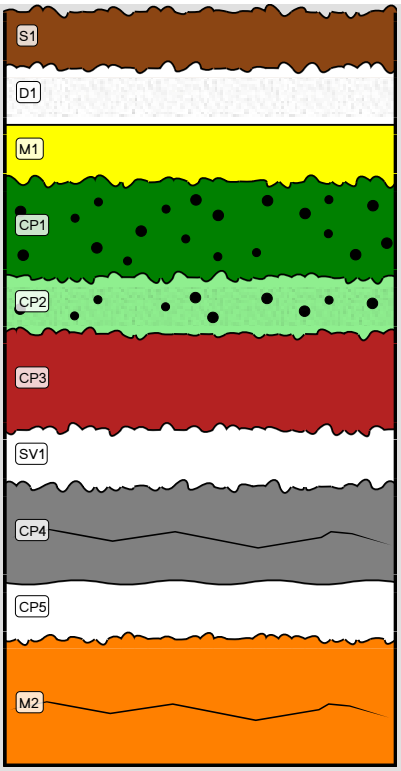
Fig.9: Schematic representation combining stratigraphies 1 and 2 under binocular microscope and using the MiCorr application. The characteristics of the strata are only accessible by clicking on the drawing that redirects you to the search tool by stratigraphy representation, Credit He-Arc CR, L.Pedersen.

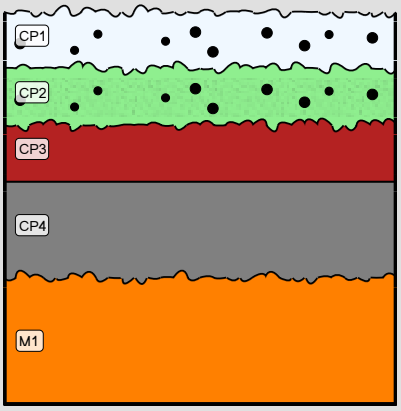
Fig.10: Schematic representation of stratigraphy 3 under binocular microscope and using the MiCorr application. CP1 is CP6 in Fig. 8. The characteristics of the strata are only accessible by clicking on the drawing that redirects you to the search tool by stratigraphy representation, Credit He-Arc CR, L. Pedersen.
