BRACELET WITH DRAGONFLIES IIB 4025.01 - LEADED BRONZE - LATE BRONZE AGE

Artefact name Bracelet with dragonflies IIb 4025.01

Authors Perret-Gentil. Emeline (HE-Arc, Neuchâtel, Neuchâtel, Switzerland) & Christian. Degrigny (HE-Arc CR, Neuchâtel, Neuchâtel, Switzerland)

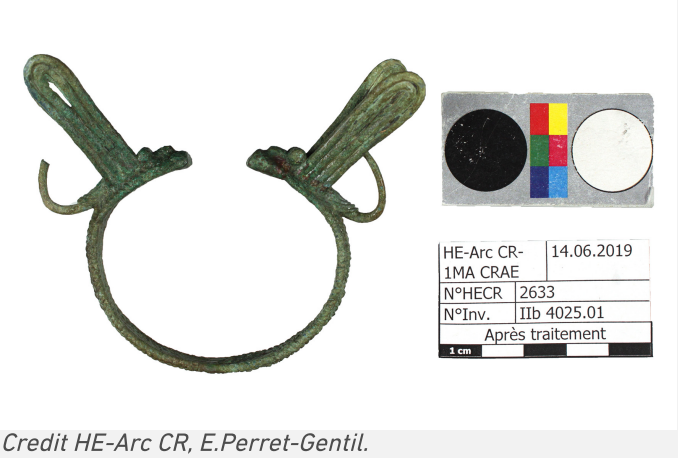
Fig. 1 : Bracelet with zoomorphic decorations before conservation interventions,

Decorated bracelet with zoomorphic extensions looking like dragonflies (Fig. 1 and 2), covered with dark green corrosion layers and sediments. Dimensions: Ø= 60mm, Lmax = 24mm, WT =

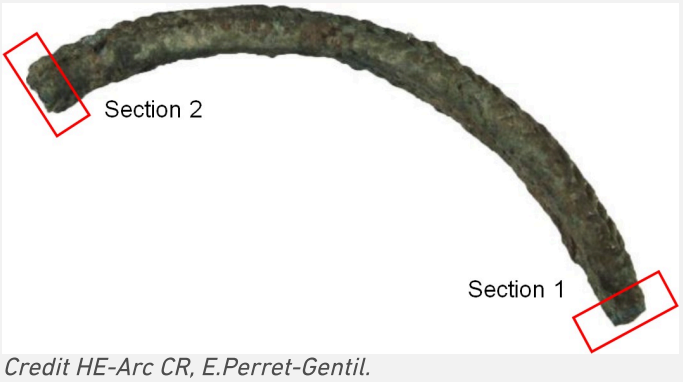
No information on the archaeological or historical context before 2008 (year of donation to the museum). The artefact was brought to HE-Arc CR in 3 fragments. Preliminary information on corrosion structures could be observed on cross-sections exposed.

Fig. 3 : Broken fragment of Fig. 1 without zoomorphic extensions and location of the cross-sections observed on Figs. 4 and 6,

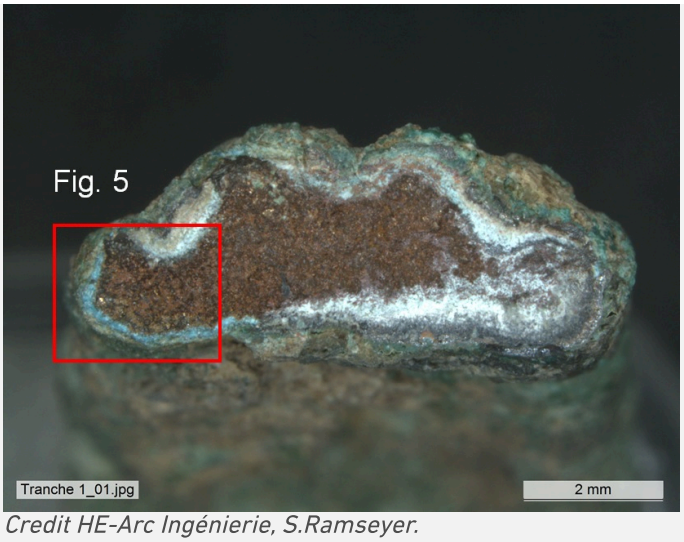
Fig. 4 : Visual observation on cross-section of section 2 of the broken fragment (Fig. 3),

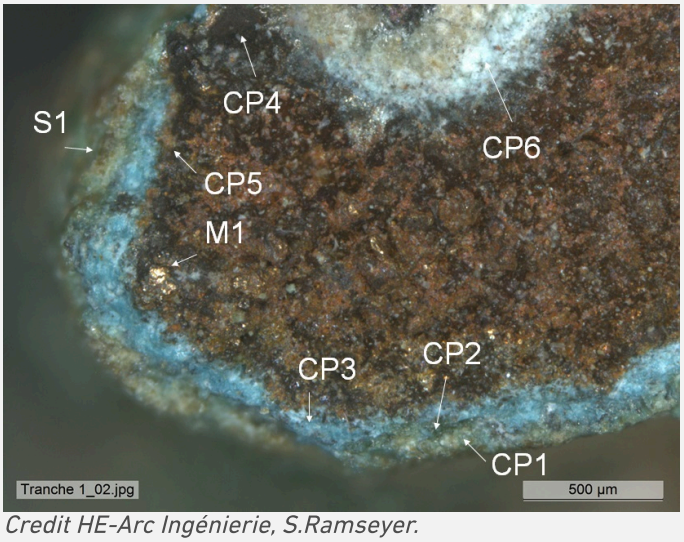
Fig. 5 : Detail of Fig. 4 with indication of the different strata represented on Fig. 7,

The schematic representation below gives an overview of the strata encountered on the bracelet from a first visual macroscopic observation under a binocular microscope both on the surface and section 2 exposed (Fig. 5).

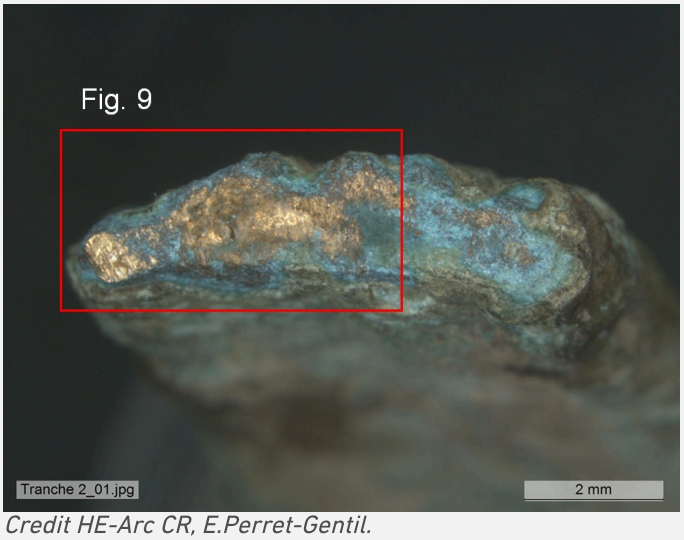
Fig. 6: Visual observation on cross-section of section 1 of the broken fragment (Fig. 3) with location of Fig. 9,

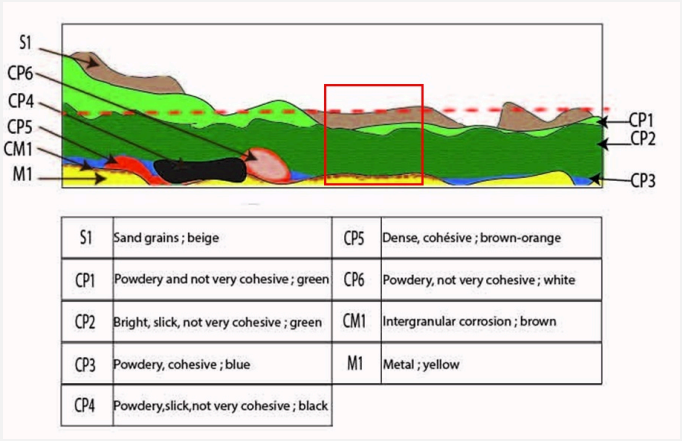
Fig. 7 : Stratigraphic representation of the fractured cutting edge of the bracelet in cross-section by macroscopic observation with indication of strata of Fig. 5 and the MiCorr stratigraphy in the red rectangle (Fig. 21) built from the polished surface of section 1.

S1	Sand grains ; beige	CP5	Dense, cohésive ; brown-orange
CP1	Powdery and not very cohesive ; green	CP6	Powdery, not very cohesive ; white
CP2	Bright, slick, not very cohesive ; green	CM1	Intergranular corrosion ; brown
CP3	Powdery, cohesive ; blue	M1	Metal ; yellow
CP4	Powdery,slick,not very cohesive ; black

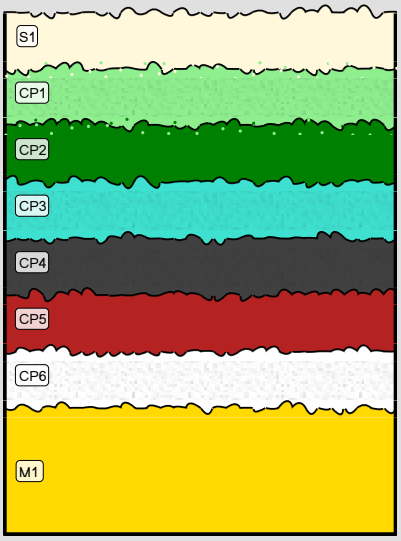
Fig. 8 : Stratigraphic representation of the corrosion structure of the bracelet observed macroscopically under binocular microscope from Fig. 5 (cross-section of section 2) using the MiCorr application. The characteristics of the strata are only accessible by clicking on the drawing that redirects you to the search tool by stratigraphy representation, Credit HE-Arc CR, E.Perret-Gentil.

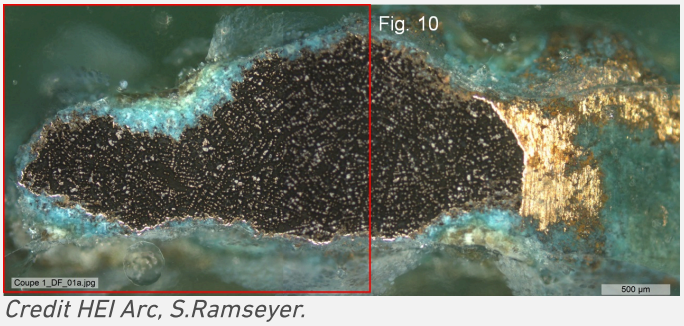
Fig. 9 : Polished cross-section of section 1 (detail of Fig. 6) with location of Fig. 10, unetched, dark field,

Description of sample	After section 1 of the fragment of Fig. 3 has been consolidated with Technovit 5071 (bicomponent resin (powder+liquid) from Dibenzoylperoxid and Methymethacrylate NN, N-dimethyl-p-tolviol), it was embedded, polished and observed on cross-section (Figs. 9 and 10) to build the MiCorr stratigraphic representation (Fig. 21). Once examined the fragment was extracted, the consolidant was dissolved in acetone and the fragment could be reintegrated on the artefact.
Alloy	Leaded Bronze
Technology	Cast and cold worked
Lab number of sample	1
Sample location	Museum der Kulturen, Basel
Responsible institution	Museum der Kulturen, Basel
Date and aim of sampling	14.05.2019, chemical and structural analyses

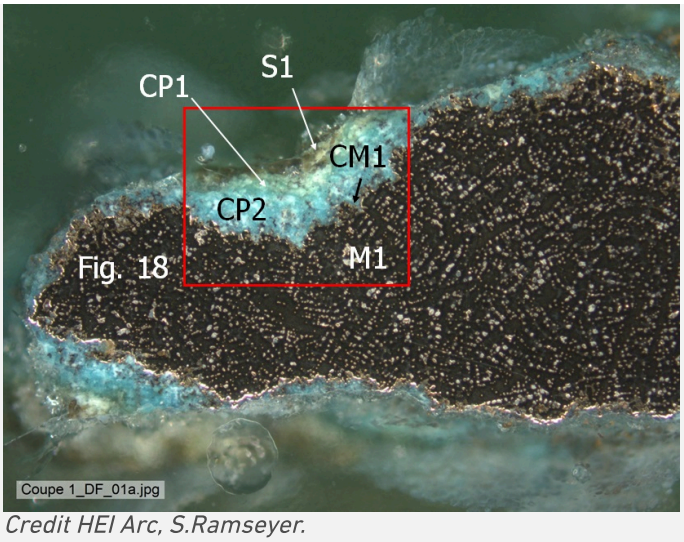
Fig, 10: Detail of Fig. 9 with indication of the strata represented in Fig. 21,

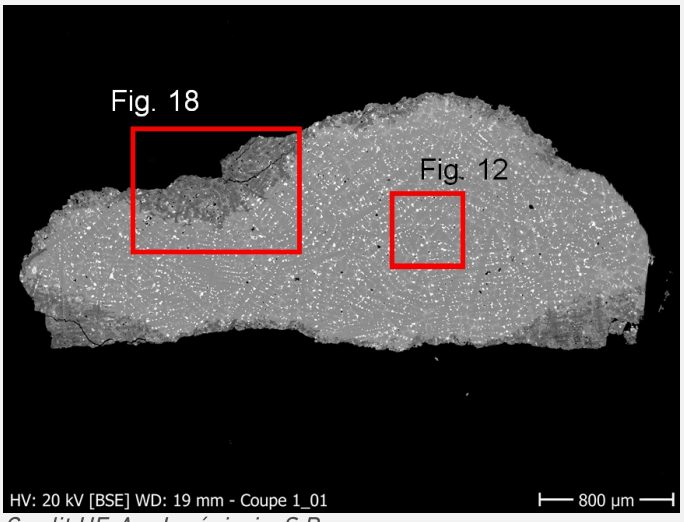
The remaining metal is a porous leaded bronze (Fig. 11) with a high concentration of Sn and Pb (Table 1 and Fig. 12). The 9% Pb concentration is due to the area analysed where Pb nodules false the result which should be more around 5%.

Fig. 11: SEM image of the cross-section similar to Fig. 9, BSE-mode. The area selected for elemental chemical analysis (Fig. 12) is marked by a rectangle. Fig. 18 is similarly indicated,

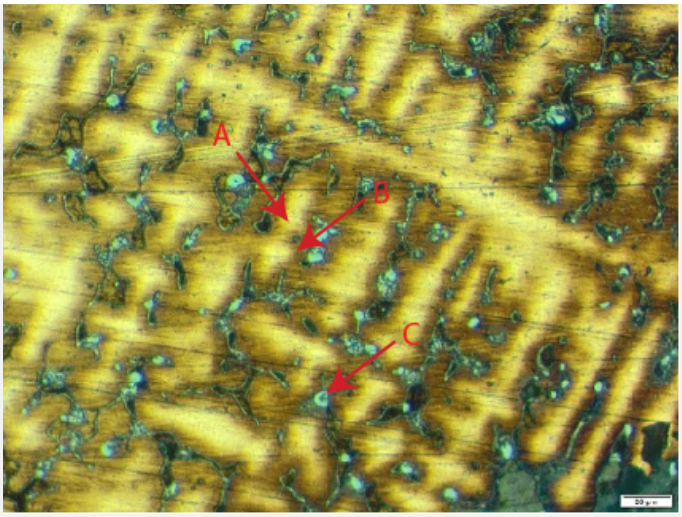
In bright field, the etched alloy shows a dendritic structure (Fig. 13). Therefore, the metal is as-cast. Fig. 14 shows that the yellow inner dendrite phase is richer in Cu (A; Fig. 15) while the orange-brown interdendritic phase is richer in Sn (B; Fig. 16) with lead nodules (C; Fig. 17).

Fig. 13 : Micrograph showing the dendritic microstructure (reversed picture of Fig. 12), etched, bright field,

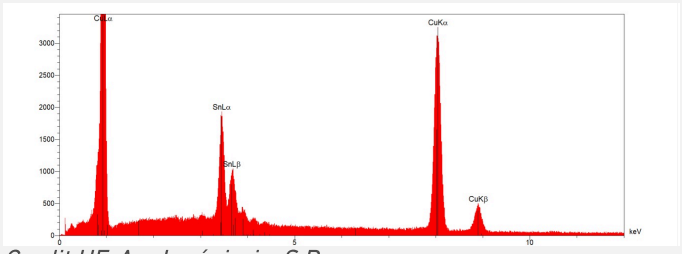
Fig. 15 : EDS spectrum of the dendritic phase,

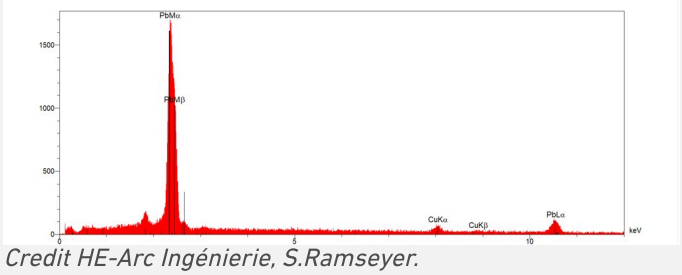
Fig. 16 : EDS spectrum of the interdendritic phase,

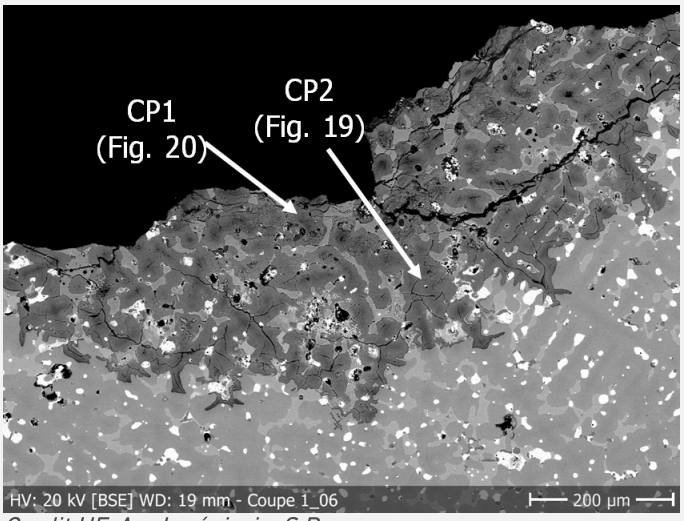
Interdendritic corrosion is visible at the interface metal/corrosion product (Fig. 18) and peudomorph of dendritic structure is visible in CP2 (Figs. 10 and 18). EDS analysis of CP2 and CP1 indicates the presence of higher concentration of Sn in CP2 than CP1 and the presence of P in both layers, validating the funeral context where the object was found. The results of the XRD analysis were irrelevant due to the instability of fragment of Fig. 3 on the support of the device.

Fig. 18: SEM picture showing interdendritic corrosion with locations of Figs. 19 and 20,

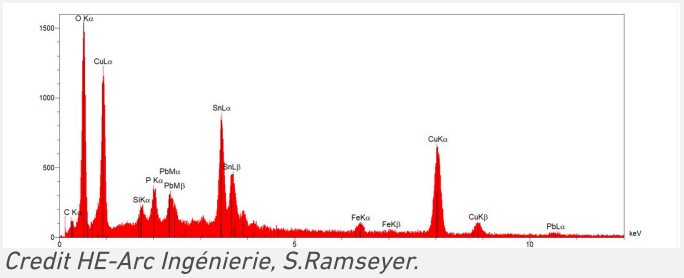
Fig. 19: EDS spectrum of the area (CP2) located in Fig. 18,

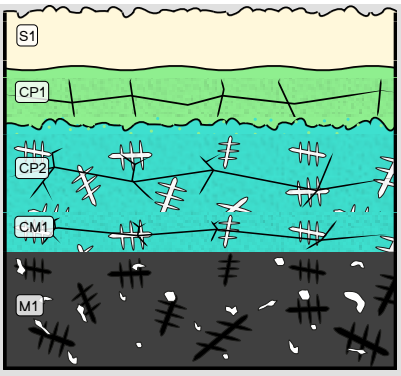
Fig. 21 : Stratigraphic representation of the bracelet in cross-section (dark field) using the MiCorr application with reference to Fig. 10. The characteristics of the strata are only accessible by clicking on the drawing that redirects you to the search tool by stratigraphy representation, Credit HE-Arc CR, E.Perret-Gentil.

The schematic representation of corrosion layers of Fig. 7 integrating additional information based on the analyses carried out is given in Fig. 22. Strata CP1 and CP2 in the stratigraphy of Fig. 8 are merged into CP1 in Fig. 21. Similarly, strata CP3 to CP6 in Fig. 8 are merged into CP2 and CM1 in Fig. 21.

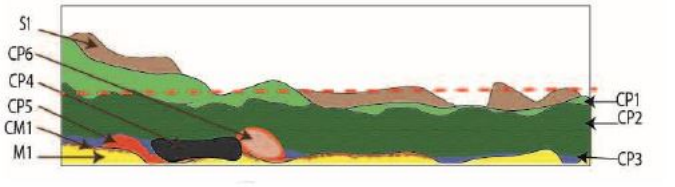
Fig 22 : Improved representation of the stratigraphy of corrosion layers of the bracelet from visual observations and analyses,

The metal of the bracelet is a leaded bronze with a high concentration of Sn et Pb. The object was cast and certainly cold-worked to smooth the surface. The metal is heterogeneously corroded with Robbiola types I and II. The limit of the original surface is at the CP1 and CP2 interface. Both layers contain high amounts of Sn and P, validating in the latter case, the funeral context where the object was found.
