BRACELET WITH DRAGONFLIES IIB 4025.01 - LEADED BRONZE - LATE BRONZE AGE

Artefact name Bracelet with dragonflies IIb 4025.01

Authors Perret-Gentil. Emeline (HE-Arc, Neuchâtel, Neuchâtel, Switzerland) & Christian. Degrigny (HE-Arc CR, Neuchâtel, Neuchâtel, Switzerland)

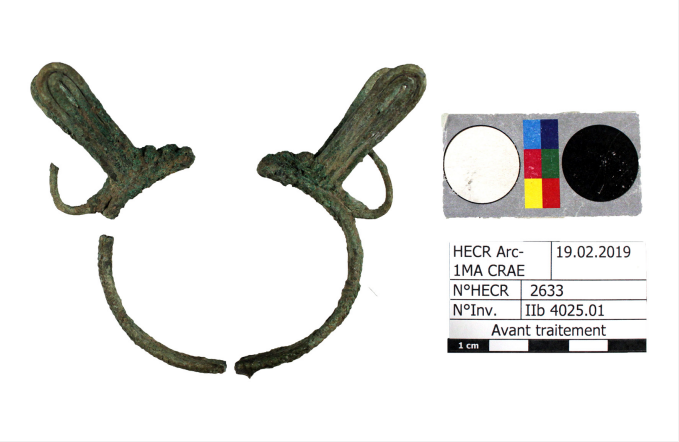
Fig. 1 : Bracelet with zoomorphic decorations before conservation interventions,

Decorated bracelet with zoomorphic extensions looking like dragonflies (Fig. 1 and 2), covered with dark green corrosion layers and sediments. Dimensions: Ø= 60mm, Lmax = 24mm, WT =

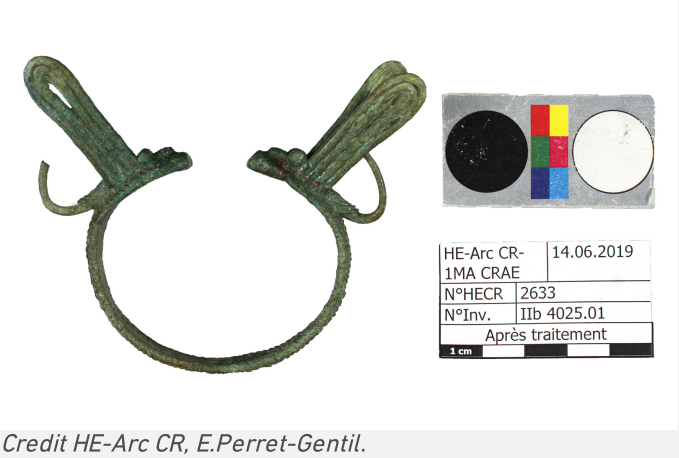
Fig. 2 : Bracelet with zoomorphic decorations after conservation interventions,

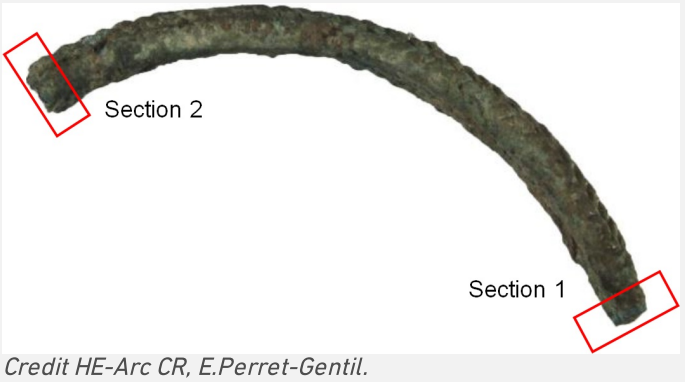
No information on the archaeological or historical context before 2008 (year of donation to the museum). The artefact was brought to HE-Arc CR in 3 fragments. Preliminary information on corrosion structures could be observed on cross-sections exposed.

Fig. 3 : Broken fragment of Fig. 1 without zoomorphic extensions and location of the cross-sections observed on Figs. 4 and 6,

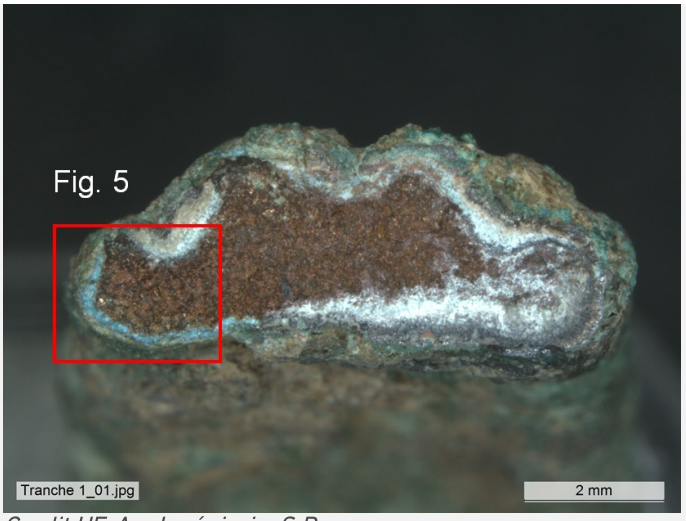
Fig. 4 : Visual observation on cross-section of section 2 of the broken fragment (Fig. 3),

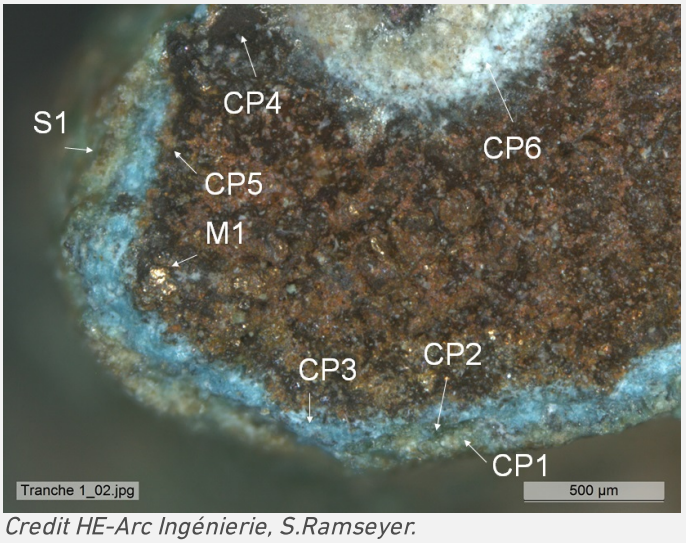
Fig. 5 : Detail of Fig. 4 with indication of the different strata represented on Fig. 7,

The schematic representation below gives an overview of the strata encountered on the bracelet from a first visual macroscopic observation under a binocular microscope both on the surface and section 2 exposed (Fig. 5).

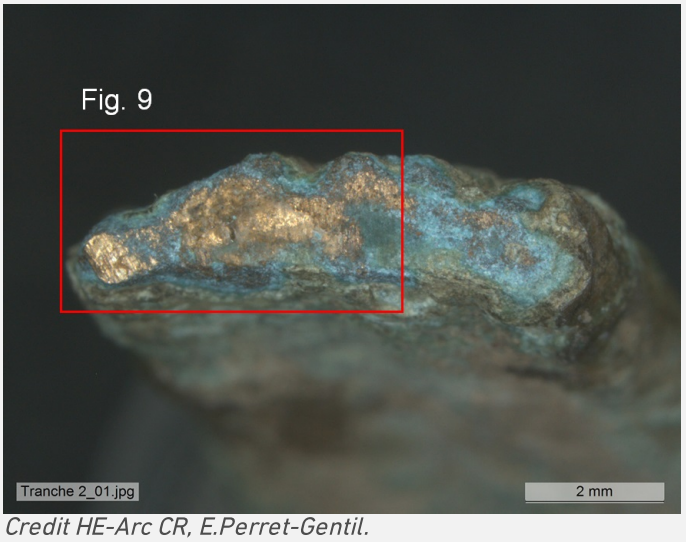
Fig. 6: Visual observation on cross-section of section 1 of the broken fragment (Fig. 3) with location of Fig. 9,

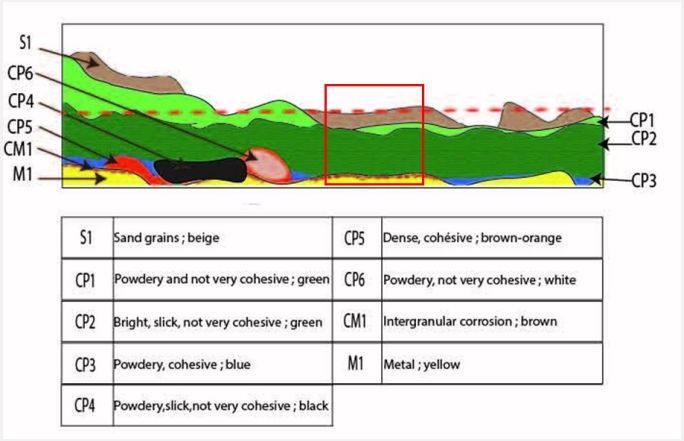
Fig. 7 : Stratigraphic representation of the fractured cutting edge of the bracelet in cross-section by macroscopic observation with indication of strata of Fig. 5 and the MiCorr stratigraphy in the red rectangle (Fig. 21) built from the polished surface of section 1.

The schematic representation of corrosion layers of Fig. 7 integrating additional information based on the analyses carried out is given in Fig. 22. Strata CP1 and CP2 in the stratigraphy of Fig. 8 are merged into CP1 in Fig. 21. Similarly, strata CP3 to CP6 in Fig. 8 are merged into CP2 and CM1 in Fig. 21.

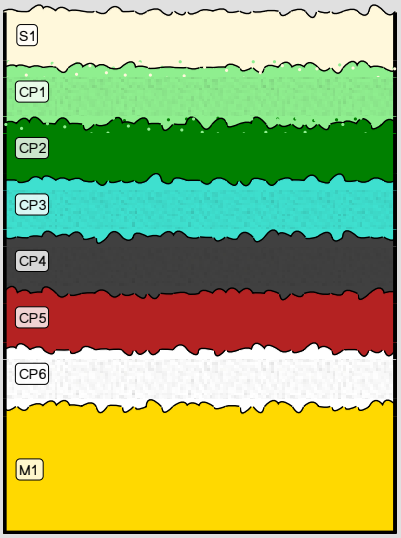
Fig. 8 : Stratigraphic representation of the corrosion structure of the bracelet observed macroscopically under binocular microscope from Fig. 5 (cross-section of section 2) using the MiCorr application. The characteristics of the strata are only accessible by clicking on the drawing that redirects you to the search tool by stratigraphy representation, Credit HE-Arc CR, E.Perret-Gentil.

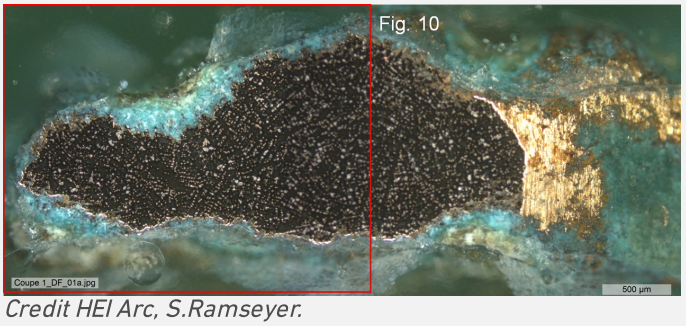
Fig. 9 : Polished cross-section of section 1 (detail of Fig. 6) with location of Fig. 10, unetched, dark field,

Description of sample	After section 1 of the fragment of Fig. 3 has been consolidated with Technovit 5071 (bicomponent resin (powder+liquid) from Dibenzoylperoxid and Methymethacrylate NN, N-dimethyl-p-tolviol), it was embedded, polished and observed on cross-section (Figs. 9 and 10) to build the MiCorr stratigraphic representation (Fig. 21). Once examined the fragment was extracted, the consolidant was dissolved in acetone and the fragment could be reintegrated on the artefact.
Alloy	Leaded Bronze
Technology	Cast and cold worked
Lab number of sample	1
Sample location	Museum der Kulturen, Basel
Responsible institution	Museum der Kulturen, Basel
Date and aim of sampling	14.05.2019, chemical and structural analyses

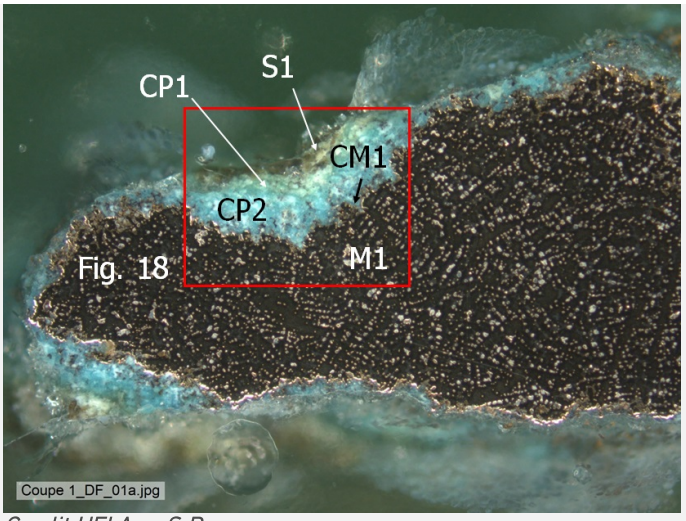
Fig, 10: Detail of Fig. 9 with indication of the strata represented in Fig. 21,

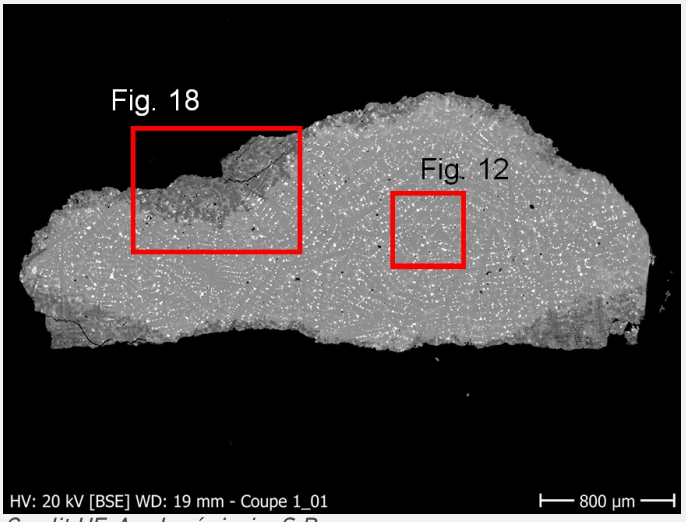
The remaining metal is a porous leaded bronze (Fig. 11) with a high concentration of Sn and Pb (Table 1 and Fig. 12). The 9% Pb concentration is due to the area analysed where Pb nodules false the result which should be more around 5%.

Fig. 11: SEM image of the cross-section similar to Fig. 9, BSE-mode. The area selected for elemental chemical analysis (Fig. 12) is marked by a rectangle. Fig. 18 is similarly indicated,

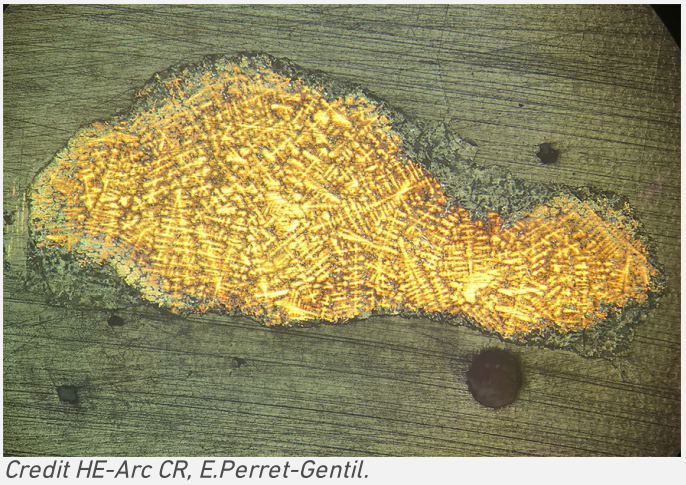
In bright field, the etched alloy shows a dendritic structure (Fig. 13). Therefore, the metal is as-cast. Fig. 14 shows that the yellow inner dendrite phase is richer in Cu (A; Fig. 15) while the orange-brown interdendritic phase is richer in Sn (B; Fig. 16) with lead nodules (C; Fig. 17).

Fig. 13 : Micrograph showing the dendritic microstructure (reversed picture of Fig. 12), etched, bright field,

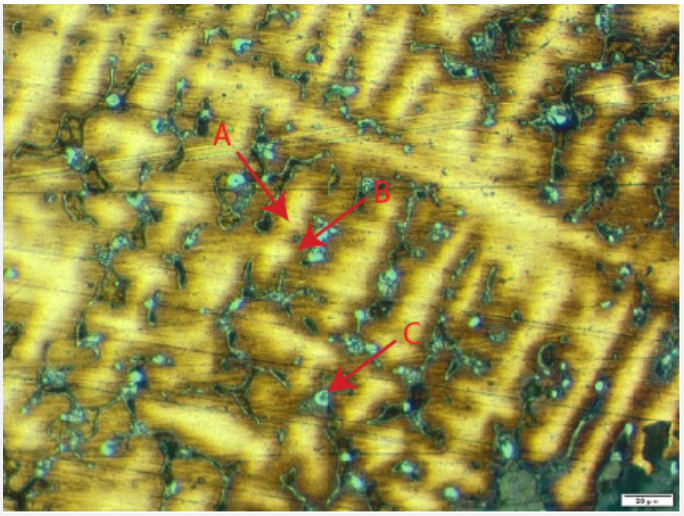
Fig. 14: Micrograph of a selected area of Fig. 13, etched, bright field, showing the dendritic (A), interdendritic (B) phases and lead nodules (C),

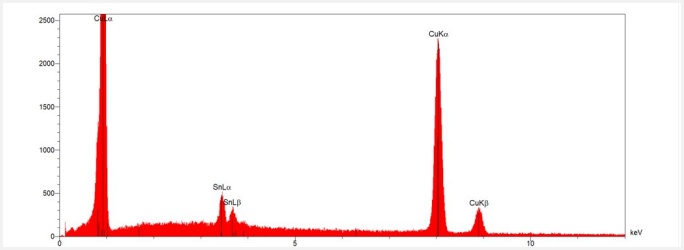
Fig. 15 : EDS spectrum of the dendritic phase,

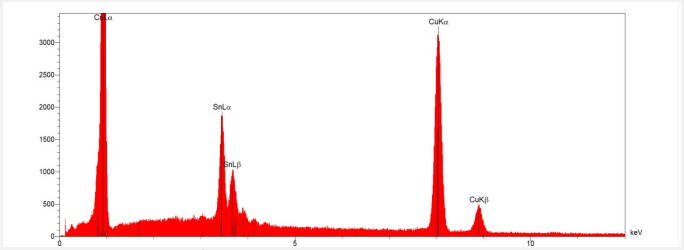
Fig. 16 : EDS spectrum of the interdendritic phase,

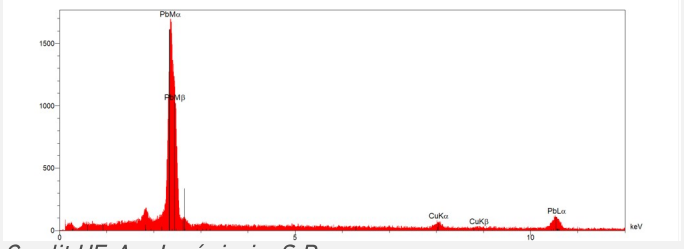
Fig. 17: EDS spectrum of Pb nodules,

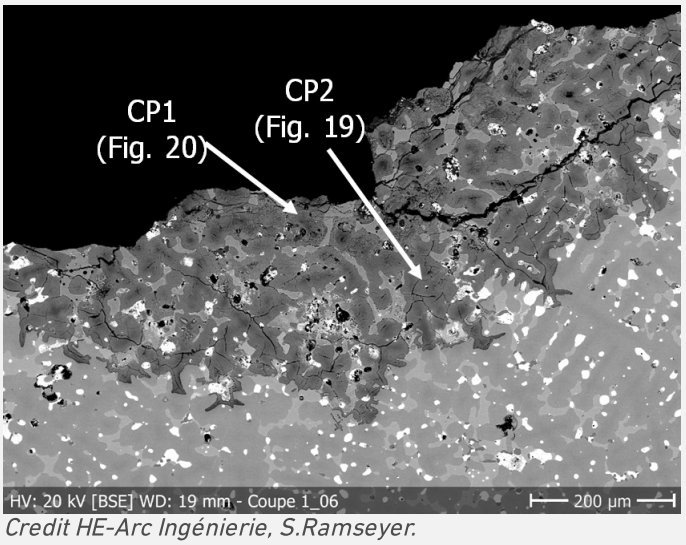
Interdendritic corrosion is visible at the interface metal/corrosion product (Fig. 18) and peudomorph of dendritic structure is visible in CP2 (Figs. 10 and 18). EDS analysis of CP2 and CP1 indicates the presence of higher concentration of Sn in CP2 than CP1 and the presence of P in both layers, validating the funeral context where the object was found. The results of the XRD analysis were irrelevant due to the instability of fragment of Fig. 3 on the support of the device.

Fig. 18: SEM picture showing interdendritic corrosion with locations of Figs. 19 and 20,

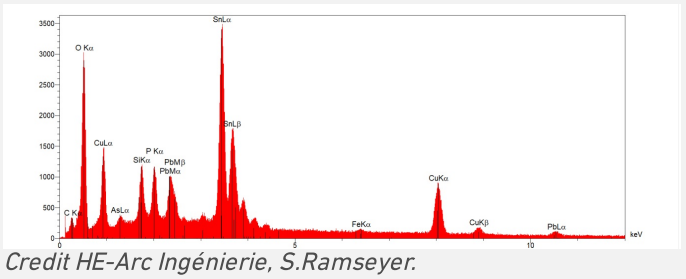
Fig. 19: EDS spectrum of the area (CP2) located in Fig. 18,

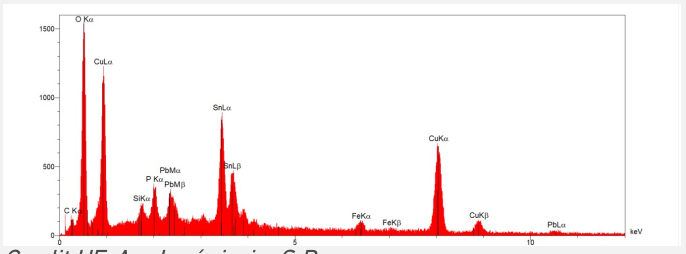
Fig. 20: EDS spectrum of the area (CP1) located in Fig. 18,

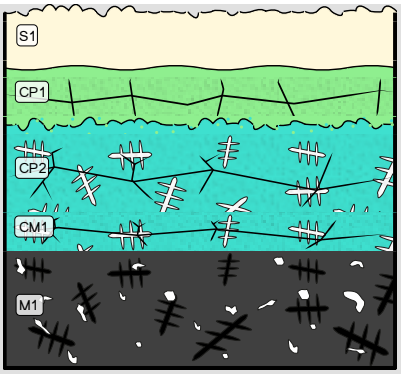
Fig. 21 : Stratigraphic representation of the bracelet in cross-section (dark field) using the MiCorr application with reference to Fig. 10. The characteristics of the strata are only accessible by clicking on the drawing that redirects you to the search tool by stratigraphy representation, Credit HE-Arc CR, E.Perret-Gentil.
