VOTIVE FIGURE OF A BAT IVB4168 – GILDED BRASS – MODERN TIMES

Artefact name Votive figure of a bat IVb4168

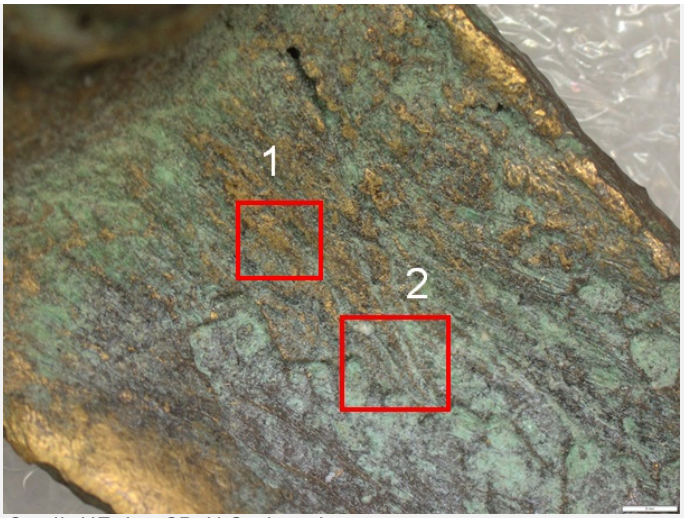
Fig. 3: Stratigraphic representation of the bat by visual macroscopic observation,

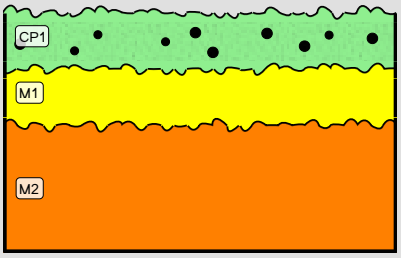
Fig 5: Stratigraphic representation of the corrosion structure of area 1 (Fig. 4) observed macroscopically under binocular microscope using the MiCorr application. The characteristics of the strata are only accessible by clicking on the drawing that redirects you to the search tool by stratigraphy representation, Credit HE-Arc CR, N.Gutknecht.

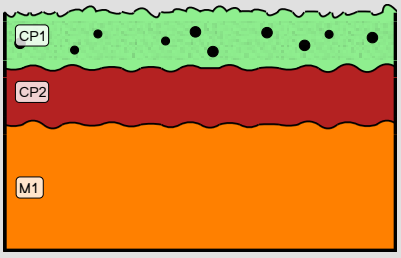
Fig. 6: Stratigraphic representation of the corrosion structure of area 2 (Fig. 4) observed macroscopically under binocular microscope using the MiCorr application. M1 is M2 in Fig. 5. The characteristics of the strata are only accessible by clicking on the drawing that redirects you to the search tool by stratigraphy representation, Credit HE-Arc CR, N.Gutknecht.
