FRAGMENT OF AN AEGIS OF NEÏTH 1886.305.0096 – LEADED BRONZE

Artefact name	Fragment of an Aegis of Neïth 1886.305.0096
Authors	Line. Pedersen (HE-Arc, Neuchâtel, Neuchâtel, Switzerland) & Christian. Degrigny (HE-Arc CR, Neuchâtel, Neuchâtel, Switzerland) & Valentin. Boissonnas (HE-Arc CR, Neuchâtel, Neuchâtel, Switzerland)
Url	/artefacts/1050/

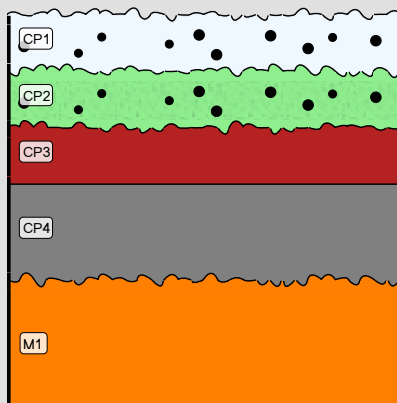
Fig.9: Schematic representation combining stratigraphies 1 and 2 under binocular microscope and using the MiCorr application. The characteristics of the strata are only accessible by clicking on the drawing that redirects you to the search tool by stratigraphy representation, Credit He-Arc CR, L.Pedersen.

The metal (M2 in Fig.9 and M1 in Fig. 10) was analysed on the broken edge of the bottom of the artefact where despite a highly corroded surface, the metal seems to be the best preserved. The XRF analyses revealed that the metal is a leaded bronze with remains of gold leaf on the surface (Table 1, Au was detected in the measurement spots 4,5 and 6) (Scott 2002; Gouda 2012; Mohammed 2012).
