# BUGATTI 37 CYLINDER HEAD GASKET 0416 – AL ALLOY – MODERN TIMES – FRANCE

**Artefact name** Bugatti 37 cylinder head gasket 0416

**Authors** Christian. Degriigny (HE-Arc CR, Neuchâtel, Neuchâtel, Switzerland) & Elodie. Granget (HE-Arc CR, Neuchâtel, Neuchâtel, Switzerland) & Brice. Chalançon (MNAM (Musée National de l'Automobile de Mulhouse), Mulhouse, Alsace, France)

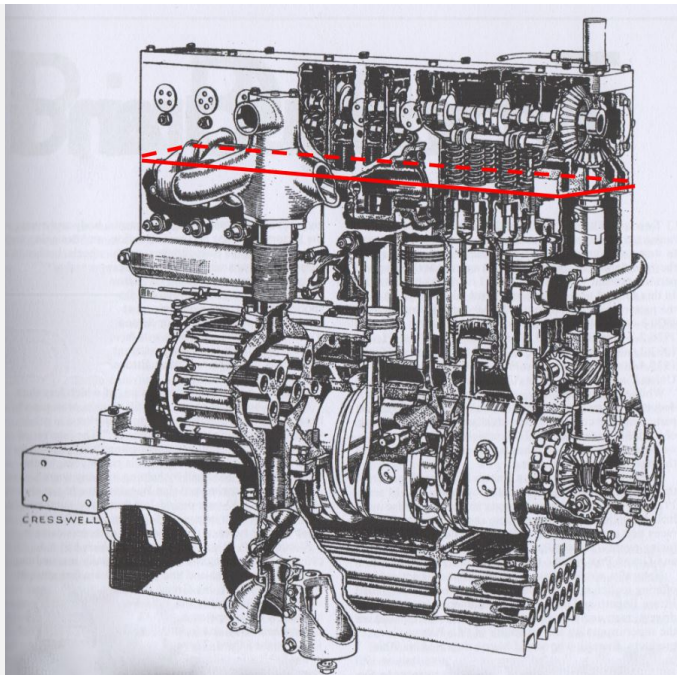
Fig. 2: Gasket located in red on technical drawing of the engine from Cresswell,

A coolant flows through the cylinder block inside galleries. This aluminium gasket is making a tight junction between the camshaft and the top of the block (Fig. 2). It keeps the water or coolant (water + glycol-based antifreeze) from mixing with the lubricant used on the shaft, the pistons and the cylinders. The wet side is facing the cylinder block. The other side is dry.

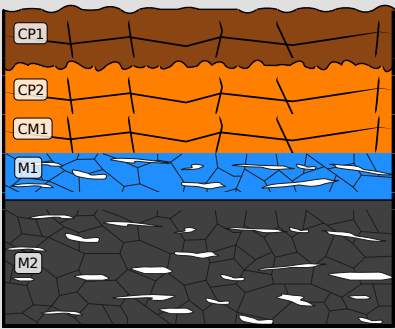
Fig. 7 shows that the corrosion products progress through M1 and develop a network of cracks. Fig. 8 shows that the corrosion can expand even further through M2 (zone 2), the corrosion products being more stratified (Fig. 9).

Fig. 14: Stratigraphic representation of the gasket (zone 1) in cross-section (dark field), using the MiCorr application. The characteristics of the strata are only accessible by clicking on the drawing that redirects you to the search tool by stratigraphy representation. This representation can be compared to Fig. 7, Credit HE-Arc CR, E.Granget.

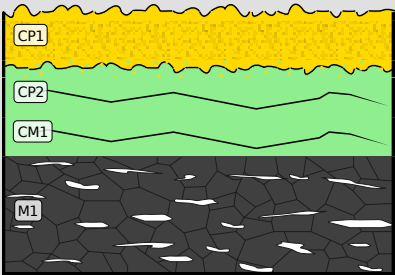
Fig 9: SEM detail (BSE mode) of zone 2 of the gasket in cross-section. The colaminated Al is missing. The core metal (now M1) is porous (black spots) and shows oriented inclusions (in white). The corrosion products (CP1) are very friable and retain clusters of inclusions that are also corroded (CP2),

Fig. 15: Stratigraphic representation of the gasket (zone 2) in cross-section (dark field), using the MiCorr application. The characteristics of the strata are only accessible by clicking on the drawing that redirects you to the search tool by stratigraphy representation. This representation can be compared to Fig. 9, Credit HE-Arc CR, E.Granget.
