BUGATTI COOLING SYSTEM PIPE - AL ALLOY - UNKNOWN - FRANCE

Artefact name Bugatti cooling system pipe

Authors Christian. Degrigny (HE-Arc CR, Neuchâtel, Neuchâtel, Switzerland) & Elodie. Granget (HE-Arc CR, Neuchâtel, Neuchâtel, Switzerland) & Brice. Chalançon (MNAM (Musée National de l'Automobile de Mulhouse), Mulhouse, Alsace, France)

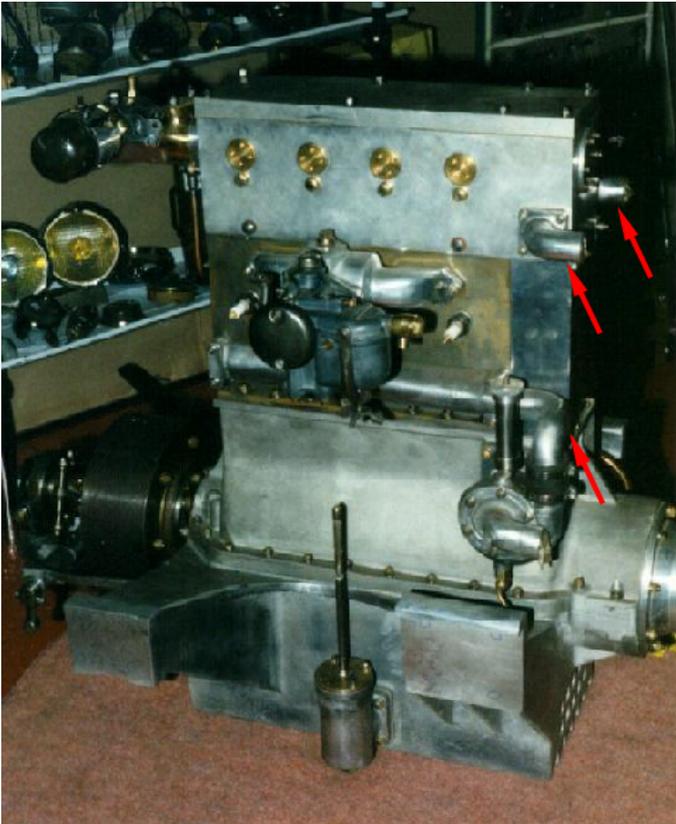
Fig. 2: Examples of water pipes located on a Type 37 engine,

A combustion engine transforms thermal energy into kinetic energy. This process is imperfect and releases a lot of heat through the block of the engine. Therefore, these parts need to be cooled down. A cooling system circulating water between the block [hot] and a heat exchanger (or radiator) [cold] is frequently used to fulfill this function (Poulain, 1995, p.86). Most of the time, the Bugatti inline cylinder engines have aluminium water pipes entering the block from below and exiting it from above, as shown on Fig.2.

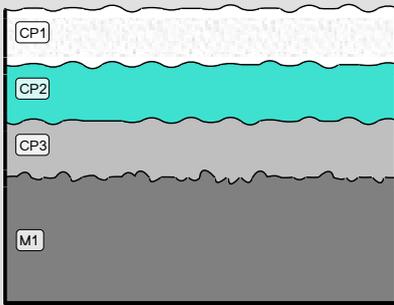
The stratum M is an aluminium alloy. Three CP strata have been identified. CP3 has a greyish mate color and is covering all of the corroded side of the pipe. Scattered over this uniform layer, blue-green (CP2) and white (CP1) spots of corrosion products can be found.

Fig. 5: Stratigraphic representation of the corrosion structure of the Bugatti water pipe observed macroscopically under binocular microscope using the MiCorr application. The characteristics of the strata are only accessible by clicking on the drawing that redirects you to the search tool by stratigraphy representation. This representation can be compared to Fig. 4, Credit HE-Arc CR, E.Granget.

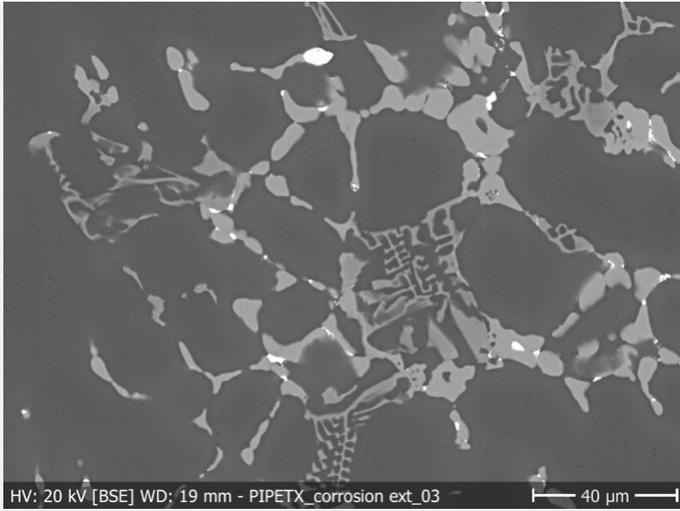
Fig. 10: Close-up image of Fig. 9,

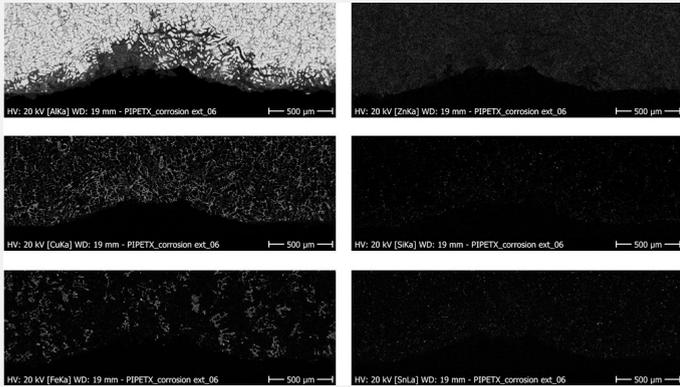
Zn is uniformly present in the alloy. There are two interdendritic phases (Fig. 12): a eutectic phase containing Al, Fe and Cu, and a second phase containing mostly Al, Cu. Additionally Sn and Si precipitates could be identified.

Fig. 11: SEM image and EDS elemental chemical distribution of main and interdendritic phases of the pipe. 20kV,

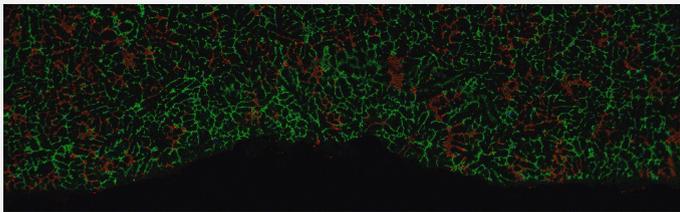
Fig. 12: Fe (red), Cu (green) and Sn (blue) chemical distribution of the area of Fig. 8. Method of analysis: SEM-EDS. Lab. of Electronic Microscopy and Microanalysis, Néode, HEI Arc,

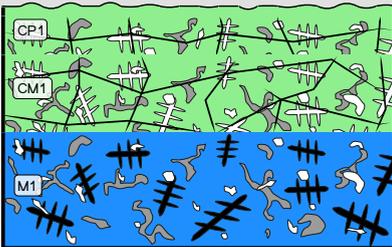
Fig. 14: Stratigraphic representation of the sample taken from the Bugatti water pipe in cross-section (dark field) using the MiCorr application. The characteristics of the strata are only accessible by clicking on the drawing that redirects you to the search tool by stratigraphy representation. This representation can be compared to Fig. 7 and 8, Credit HE-Arc CR, E.Granget.

The external surface shows a uniform interdendritic corrosion preferentially consuming the dendritic phase (Al, Cu, Zn). Pitting corrosion has been identified, with Cl pockets at the base of the pit.
