BUGATTI COOLING SYSTEM PIPE – AL ALLOY – UNKNOWN – FRANCE

Artefact name Bugatti cooling system pipe

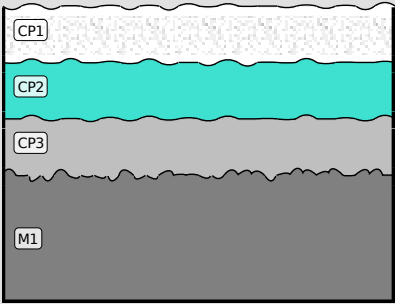
The stratum M is an aluminium alloy. Three CP strata have been identified. CP3 has a greyish mate color and is covering all of the corroded side of the pipe. Scattered over this uniform layer, blue-green (CP2) and white (CP1) spots of corrosion products can be found.

Fig. 5: Stratigraphic representation of the corrosion structure of the Bugatti water pipe observed macroscopically under binocular microscope using the MiCorr application. The characteristics of the strata are only accessible by clicking on the drawing that redirects you to the search tool by stratigraphy representation. This representation can be compared to Fig. 4, Credit HE-Arc CR, E.Granget.

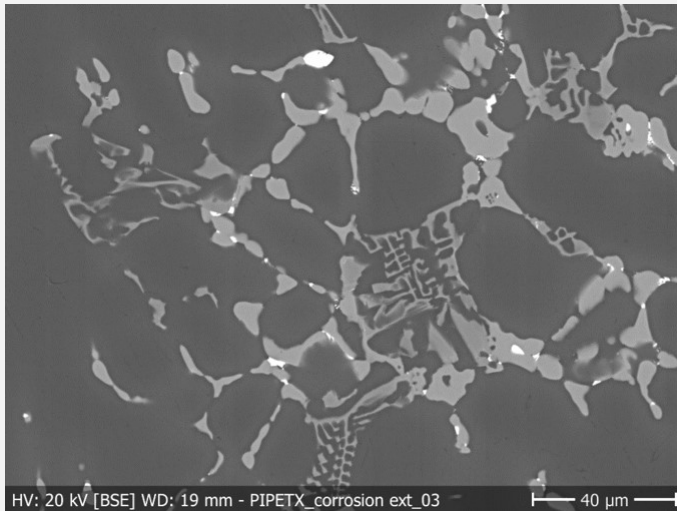
The metal is an aluminium alloy containing both Cu and Zn. It is slightly porous (Fig. 7, red circles). Its dendritic microstructure is revealed by observation in bright field (Fig. 8) and with SEM (Fig. 9).

Fig. 9: SEM image (BSE mode) of the metal sample from Fig. 8 showing the microstructure of the pipe. Dark grey = main phase (Al), medium grey = interdendritic phase 1 (eutectic Al, Fe, Cu), light grey = interdendritic phase 2 (Al, Cu) and white = precipitates (Si, Sn),

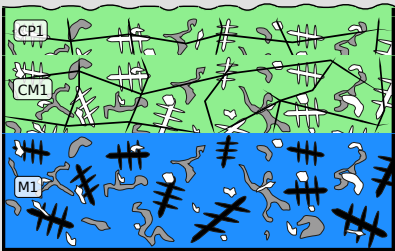
Fig. 14: Stratigraphic representation of the sample taken from the Bugatti water pipe in cross-section (dark field) using the MiCorr application. The characteristics of the strata are only accessible by clicking on the drawing that redirects you to the search tool by stratigraphy representation. This representation can be compared to Fig. 7 and 8, Credit HE-Arc CR, E.Granget.
