SETTINGS OF THE GREAT SHRINE OF SAINT MAURICE – AG ALLOY – HIGH MEDIEVAL TIMES

Artefact name	Settings of the Great Shrine of saint Maurice
Authors	Romain. Jeanneret (Abbaye de St-Maurice, Saint-Maurice, Valais, Switzerland)
Url	/artefacts/1175/

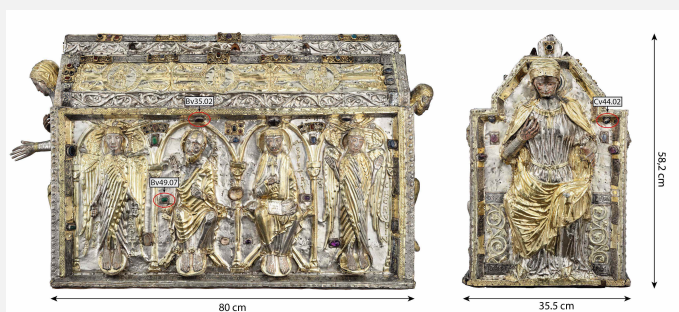
Fig. 1: General and side views of the Great Shrine of saint Maurice, showing the location of the arcature settings of Fig. 2,

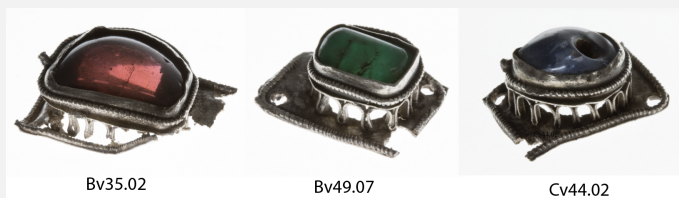
Fig. 2: Arcature settings located in Fig. 1,

Set of arcature settings from the Great Shrine of saint Maurice. In large quantities (62 pieces) on the reliquary, these decorations have a structure showing a rationalization of the manufacturing process. Openwork plates, twisted wires and folded bands (arcatures) are welded together to form a decorative whole. The surfaces of these mounts seem to indicate a fire passage at the limit of the silver's fusion, which could be attributed to a copper salt soldering since the difference in fusion temperature between the solder and the alloy is very close.
