SETTINGS OF THE GREAT SHRINE OF SAINT MAURICE – AG ALLOY – HIGH MEDIEVAL TIMES

Artefact name	Settings of the Great Shrine of saint Maurice
Authors	Romain. Jeanneret (Abbaye de St-Maurice, Saint-Maurice, Valais, Switzerland)
Url	/artefacts/1175/

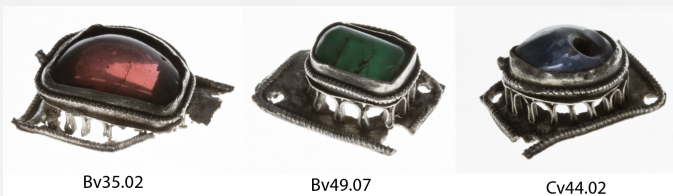
Fig. 2: Arcature settings located in Fig. 1,

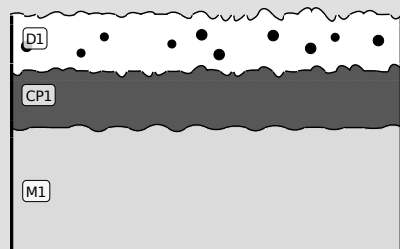
Fig.7: Stratigraphic representation of the corrosion structures of the Bv35.02, Bv49.07 & Cv44.02 settings observed macroscopically under binocular microscope using the MiCorr application with reference to Fig. 6. The characteristics of the strata are only accessible by clicking on the drawing that redirects you to the search tool by stratigraphy representation. Credit HE-Arc CR, N. Gutknecht.

The metal is covered with a thin layer of greyish and yellowish tarnish (CP1) on which residues of cleaning products are detected (D1). This tarnish has not been analyzed, but other work shows that the silver tarnish of the objects in the Treasury of the Abbey of Saint-Maurice usually consists of silver sulphide and silver chloride (Degrigny et al. 2015). This type of tarnishing is typical for silver alloys containing low copper content (Costa 2001, Graedel 1992 and Tissot et al. 2016). The metal of the settings is the site of intergranular corrosion (Wanhill, 2013) which appears to be limited to a thickness of 150-200 microns (Figs. 8 and 10).

The observation in cross-section does not allow the identification of the surface deposits observed under the binocular microscope. This is probably due to the fact that they are localized and not very adherent. The surface tarnishing (CP1) is easily recognizable to the eye even though its thickness is very thin and not very visible in cross-section.
