GILDED SILVER PLATES OF THE GREAT SHRINE OF ST MAURICE – AG ALLOY – HIGH MEDIEVAL TIMES

Artefact name Gilded silver plates of the Great Shrine of st Maurice

Authors Romain. Jeanneret (Abbaye de St-Maurice, Saint-Maurice, Valais, Switzerland)

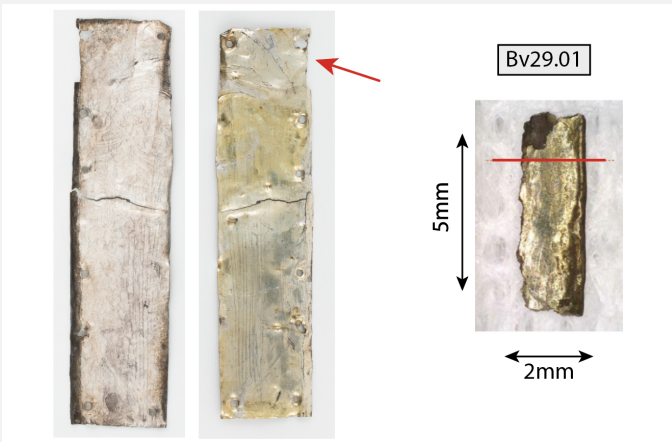
Fig. 3: Location of the loose analysed fragment of gilded plate Bv29.01 and its sampling area. Size of the sample: 5 x 2 mm,

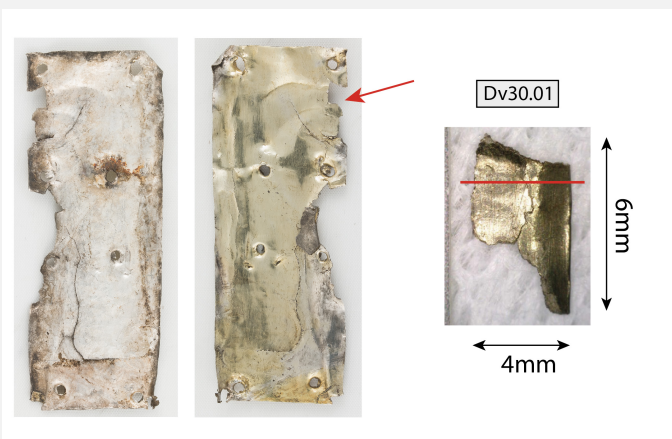
Fig. 4: Location of the loose analysed fragments of gilded plate Dv30.01 and its sampling area. Size of the sample: 6 x 4 mm,

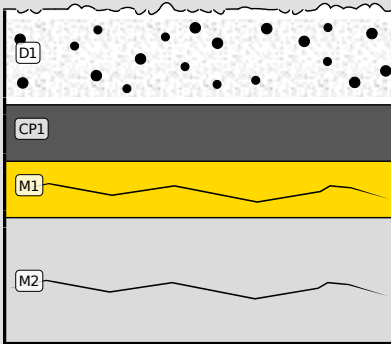
Fig.6: Stratigraphic representation of the corrosion structures of the both Bv29.01 and Dv30.01 gilded plates (before conservation treatment) observed macroscopically under binocular microscope using the MiCorr application with reference to Fig. 5. The characteristics of the strata are only accessible by clicking on the drawing that redirects you to the search tool by stratigraphy representation. Credit ABSM, R.Jeanneret.
