# CHISEL POINT DEV 995 1069 PR – EUTECTOID TO HYPEREUTECTOID STEEL – EARLY MEDIEVAL TIMES – SWITZERLAND

**Artefact name** Chisel point DEV 995 1069 PR

**Authors** Marianne. Senn (Empa, Dübendorf, Zurich, Switzerland) & Christian. Degryny (HE-Arc CR, Neuchâtel, Neuchâtel, Switzerland)

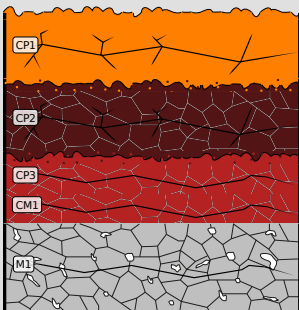
The metal is heavily corroded and the thickness of the corrosion crust is irregular, but averages about 0.5mm. The corrosion products enclose different ghost structures: the corrosion crust has preserved the shape of polygonal grains (Figs. 10 and 12) and cementite needles (Fig. 11). Under polarised light, the corrosion products at the metal - corrosion crust interface are dark-red and form an inner S-rich layer (CP3, Figs. 10 and 12). Cl occurs locally (CP3) and C is present in layers CP2 and CP3 (Fig. 12). The outer layer of the corrosion products (CP1) is orange and contains more O than the inner layer CP3 (Figs. 10 and 13).

Fig. 14: Stratigraphic representation of the chisel point in cross-section (dark field) using the MiCorr application. The characteristics of the strata are only accessible by clicking on the drawing that redirects you to the search tool by stratigraphy representation. This representation can be compared to Fig. 10, Credit HE-Arc CR.
